Corrosion Control Treatment: Lessons Learned from the Field

Milt Larsen,
Kennedy/Jenks

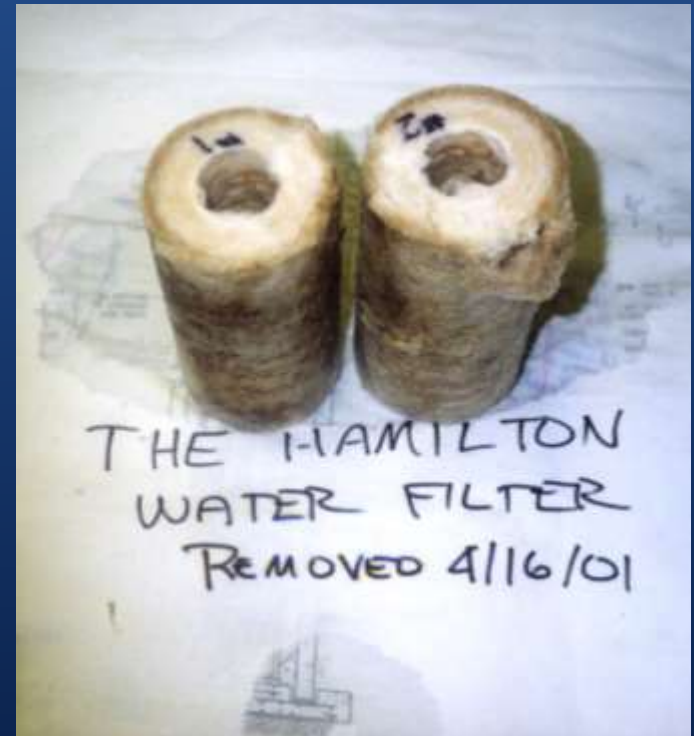
- ◆ 3-Year-old building housing
- ◆ 35 luxury residences for elderly
- ◆ Kitchen and dining room
- ◆ All copper piping
- ◆ Black greasy scum in tubs and sinks
- ◆ Particulate matter clogging faucets in a week
- ◆ Discoloration of kitchen cartridge filters in a week
- ◆ Plumber/contractor responsible under warranty

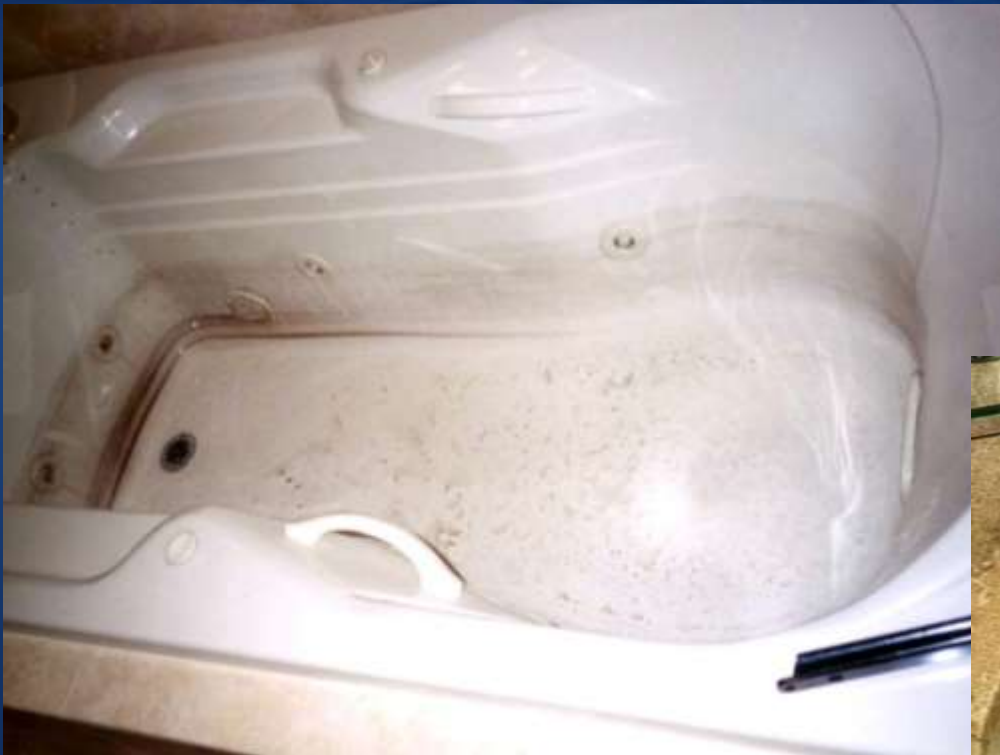
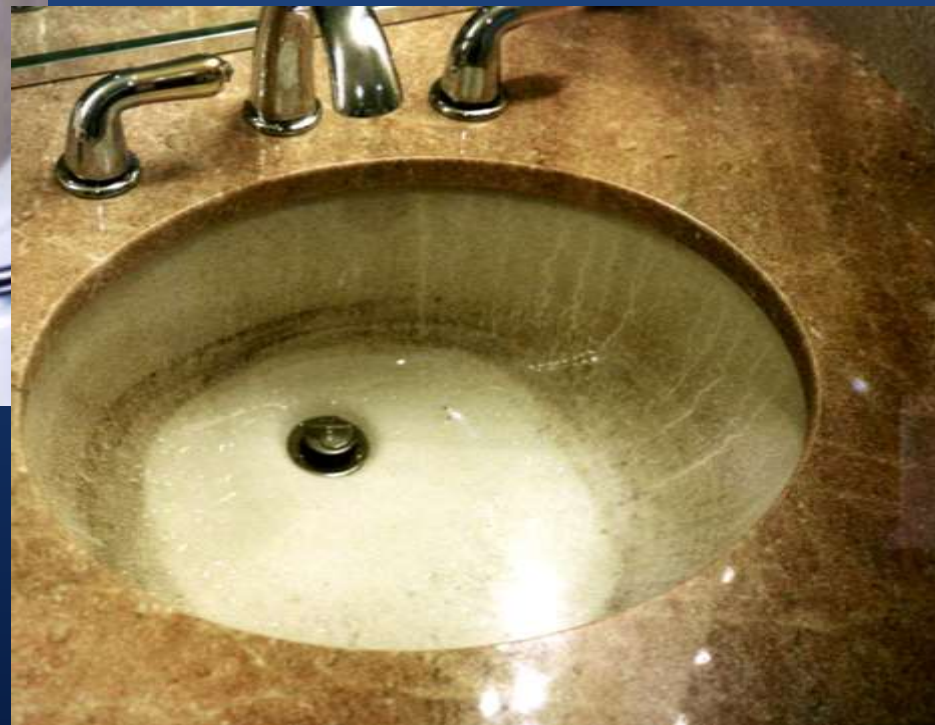
Excess Flux and Dirt Deposits in Luxury Apartment Residence – Palo Alto, CA

Corps of Engineers Hot Water Flushing Technique to Dissolve Excessive Flux

- Temperature: 160 – 180°F
- Velocity: > 7 FPS
- Time: 4 Hours
- Facilities Engineering Application Program
 - FEAP - TR – FM – 94109 – June 1994
- “Demonstration of a field rehabilitation technique for removing corrosive solder flux in cold water copper piping systems.”

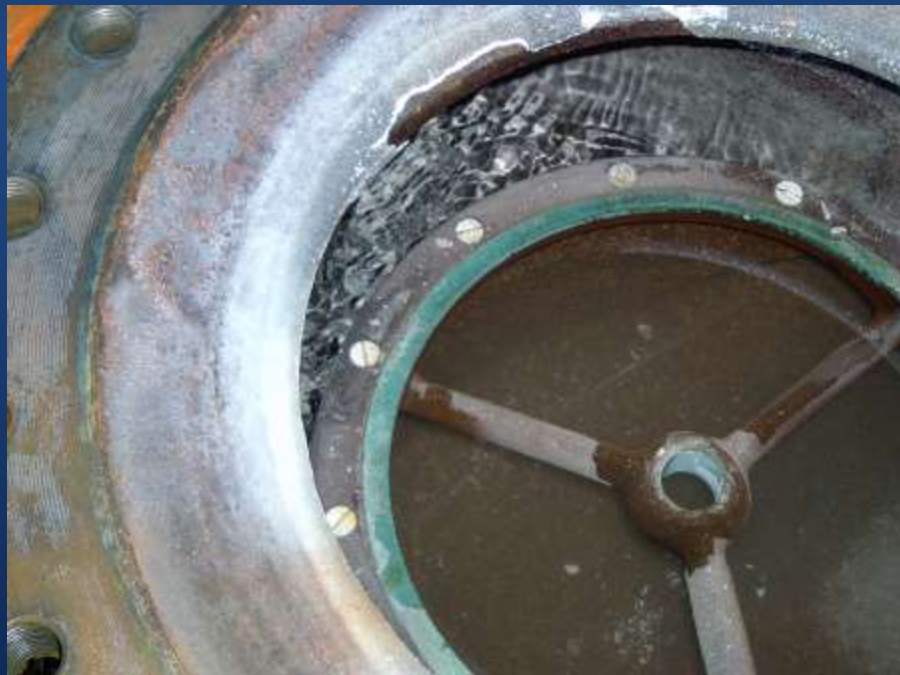
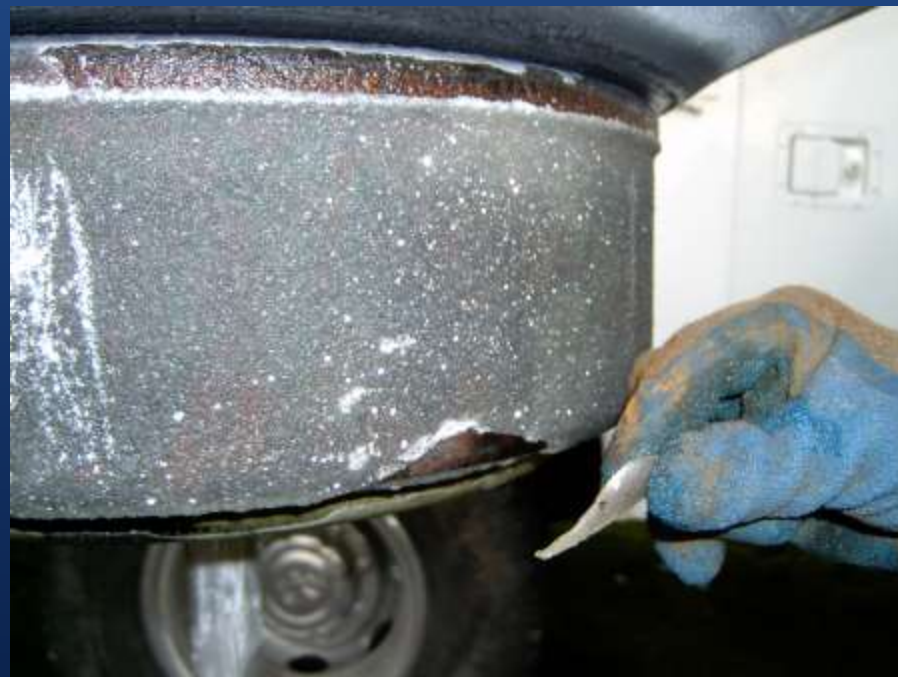
- Pipeline immediately downstream of NaOH can have a pH significantly higher than the downstream distribution system
- Do not feed NaOH near a control valve
- Have a positive NaOH shutoff at the injector

Do Not Feed NaOH in Front of a Control Valve

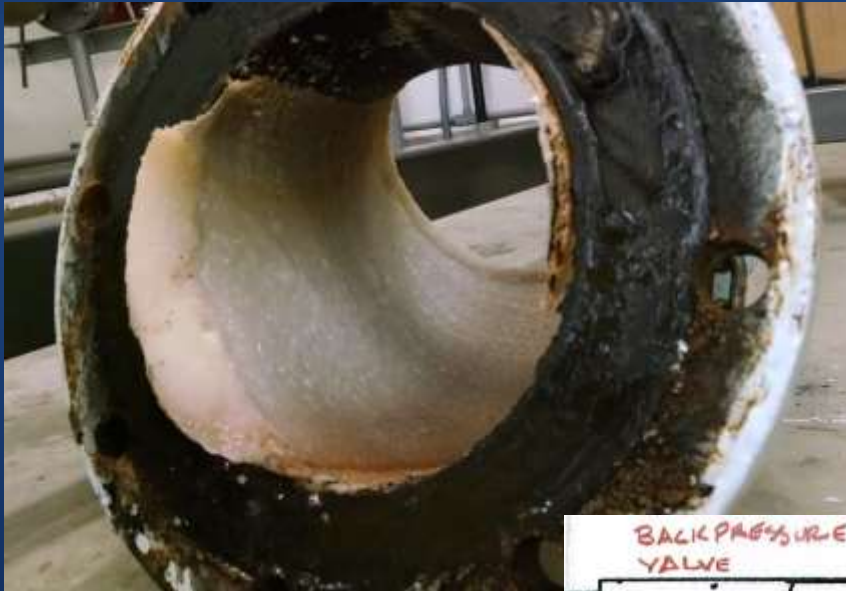
NaOH Injected Above the Pipe

- NaOH may leak into water main when the well shuts down
- CaCO_3 precipitate will form in the pipe
