PAINE FIELD RESERVOIR RECOATING

HOW DO YOU RECOAT A RESERVOIR IN HALF
THE TIME YOU NEED?

Eric Delfel, P.E. and
Lance Stevens, P.E., NACE Certified Level 3 CIP

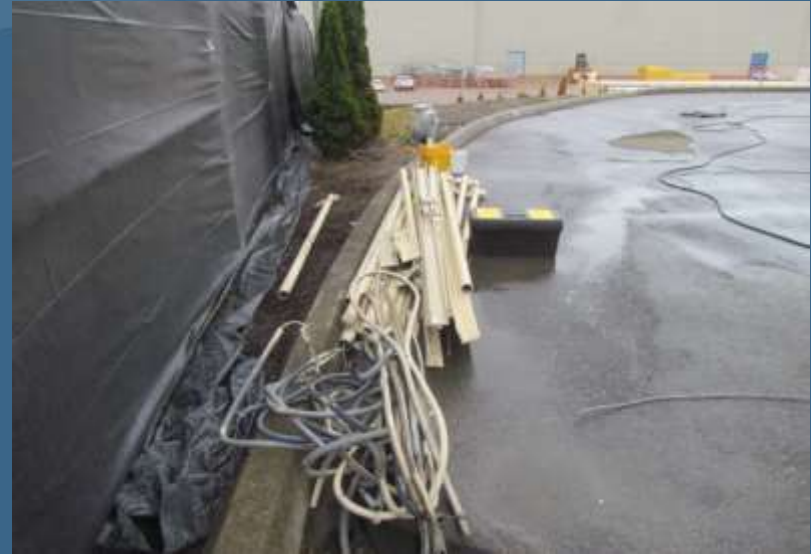
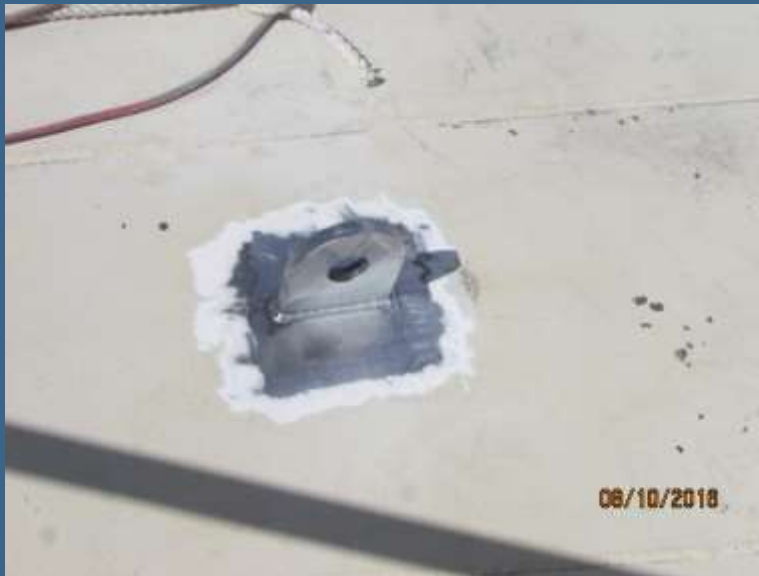
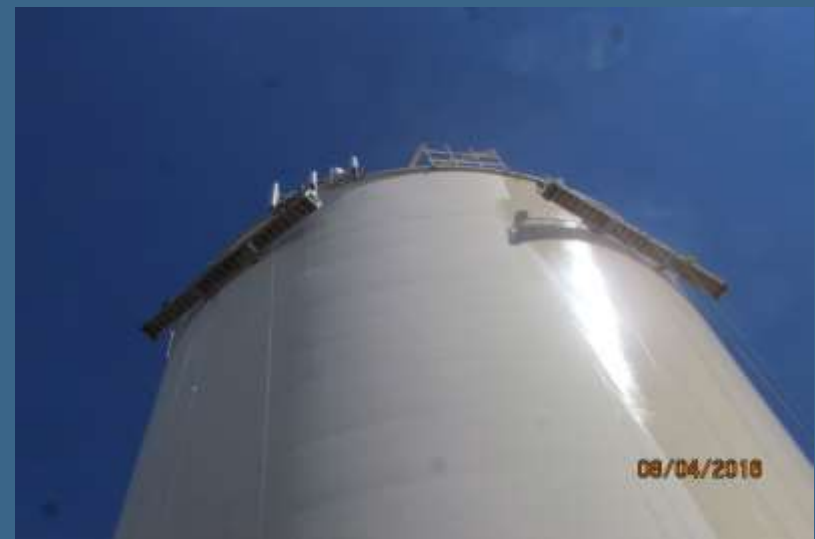
- Exterior
 - Prepped and primed
 - Swing stages to paint
 - Issues
 - Very windy
 - Tiny drips from rollers landed in car parking lot
 - (Better than the planes that were there!!!)
 - Contractor immediately resolved the issue

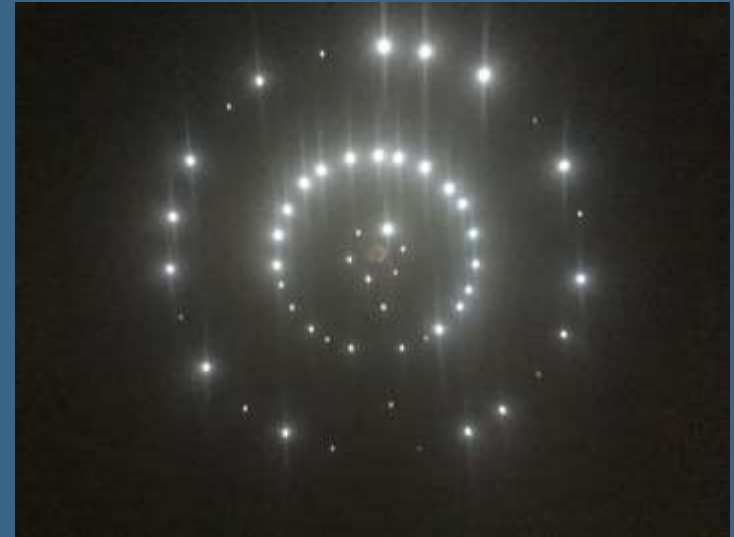
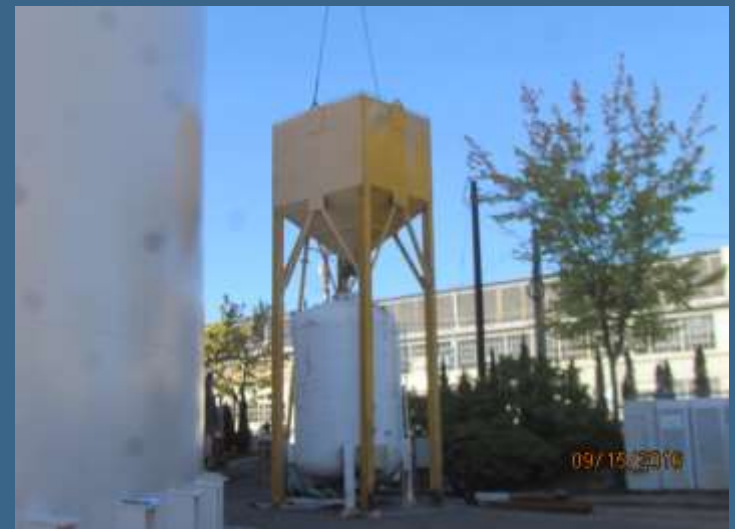
- Interior
 - Contractor brought in heavy equipment
 - Meetings every morning to discuss the work
 - Started with 10-12 hour days
 - 8 men blasting at a time
 - Issues
 - Mill scale found in the roof
 - Compressor and generator issues
 - Crews performed other work if equipment was down
 - Rigging
 - Dryspray

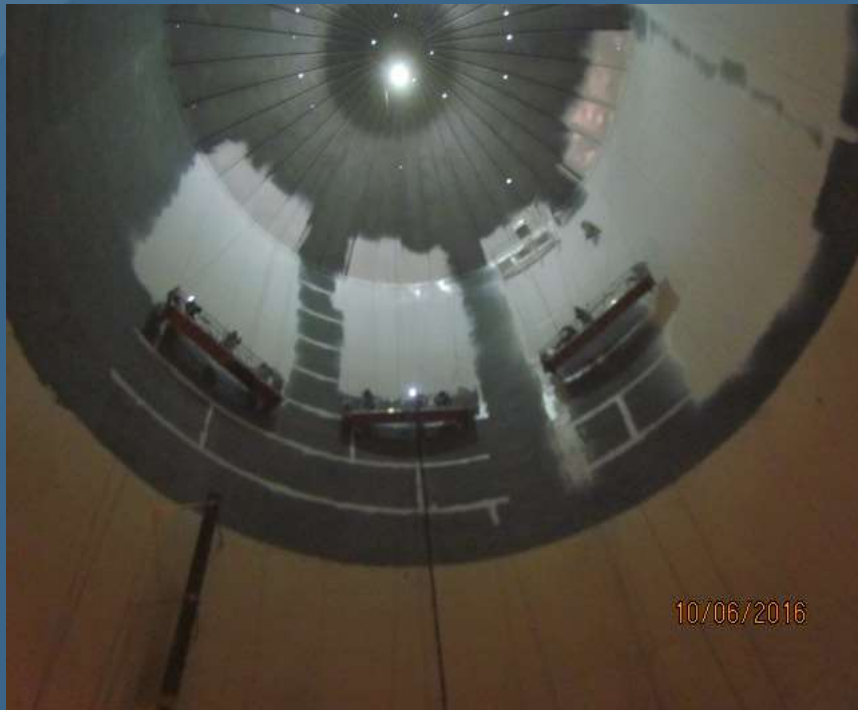
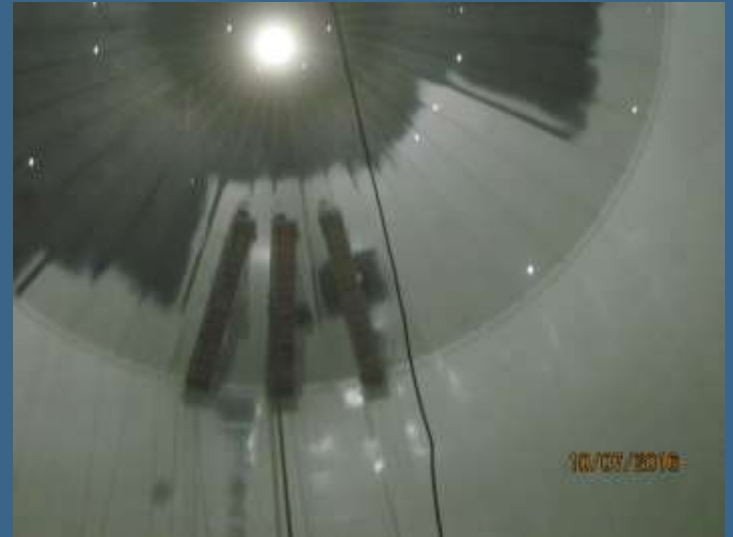
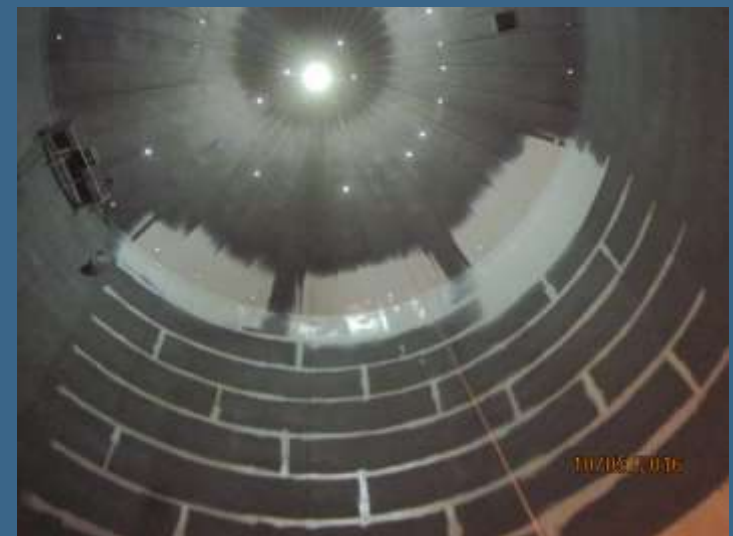
- Interior
 - Stripe and finish coats

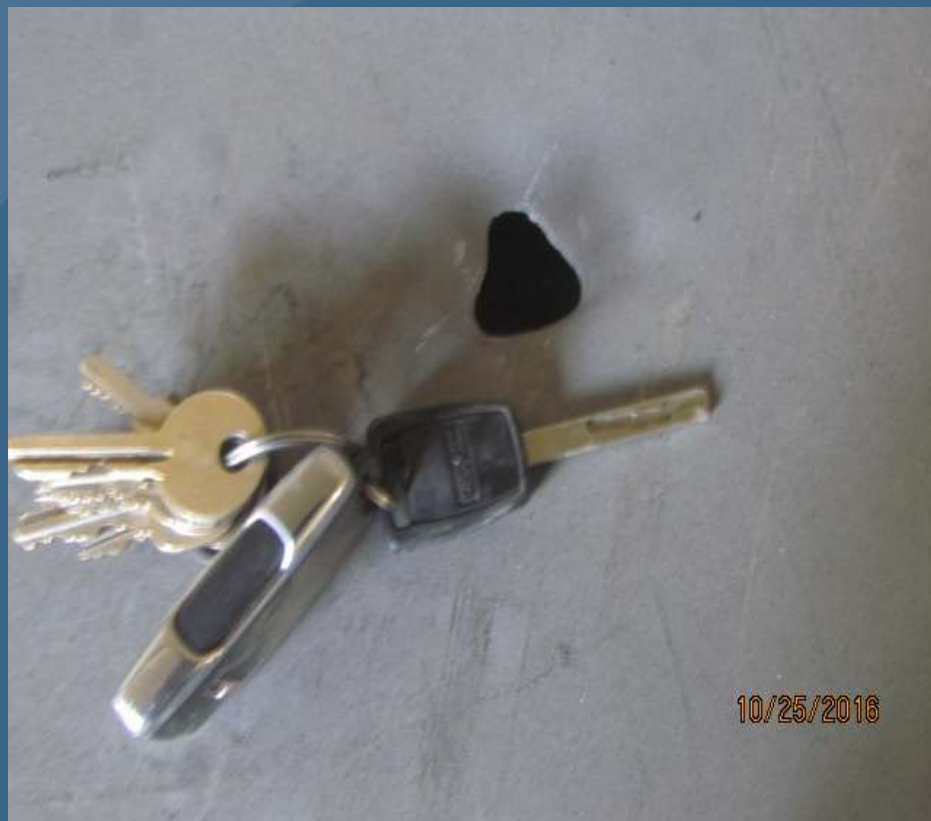
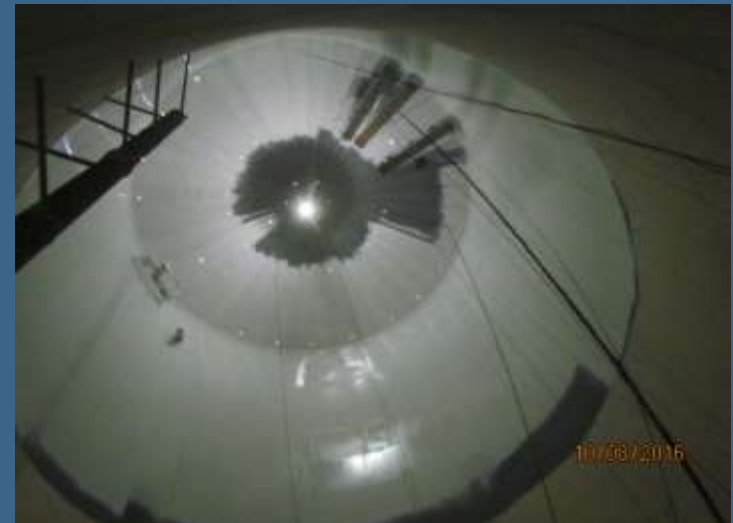
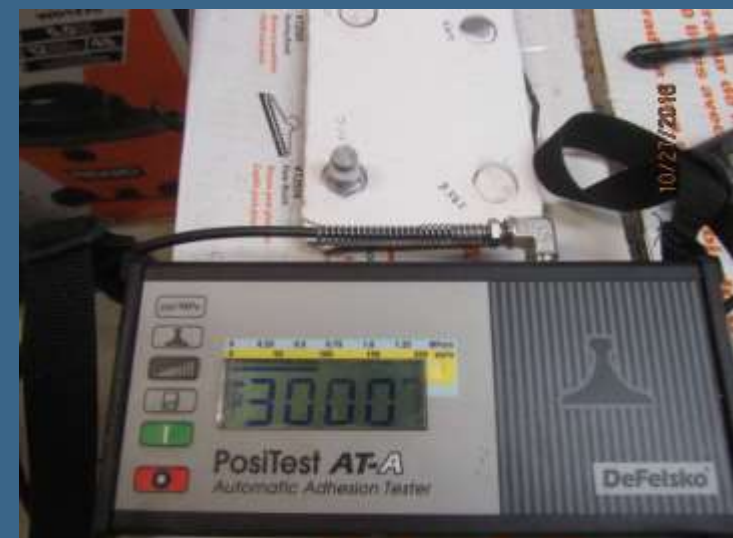
- Oops – when blast hoses spring a leak!

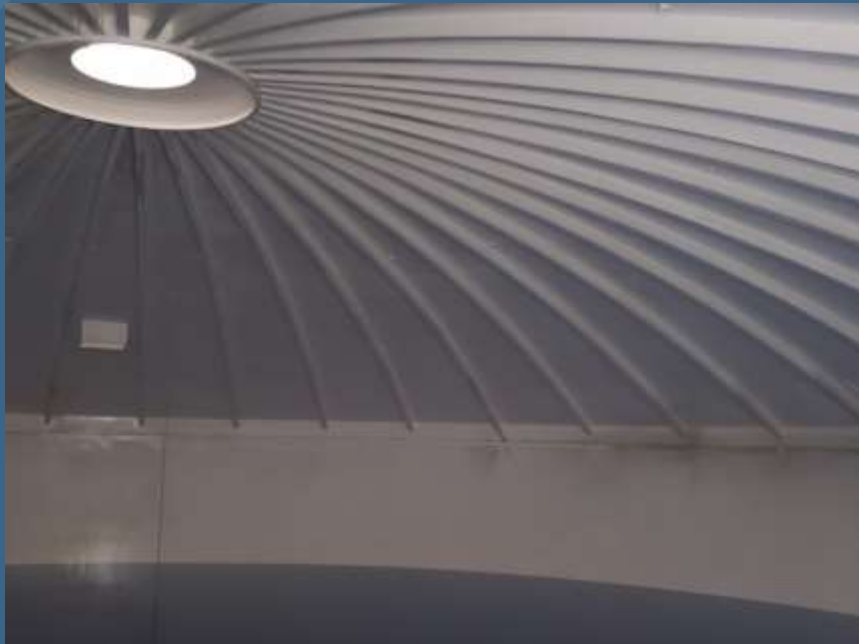
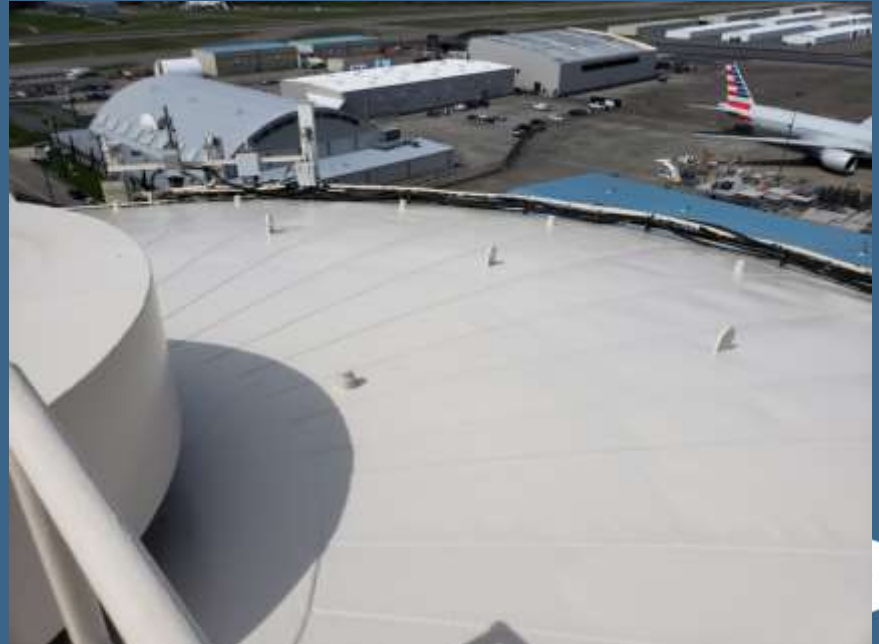
- Performed at 1.5 years
- 3-year warranty
- How to inspect below the waterline?
