Repair or Replace? Using Inline Technology to Assess Critical Steel Transmission Mains

Presented By:
Seth McIntosh
Jeanne Finger, P.E.
Christopher Kyea
April 27, 2018

City of Spokane Water Department Overview

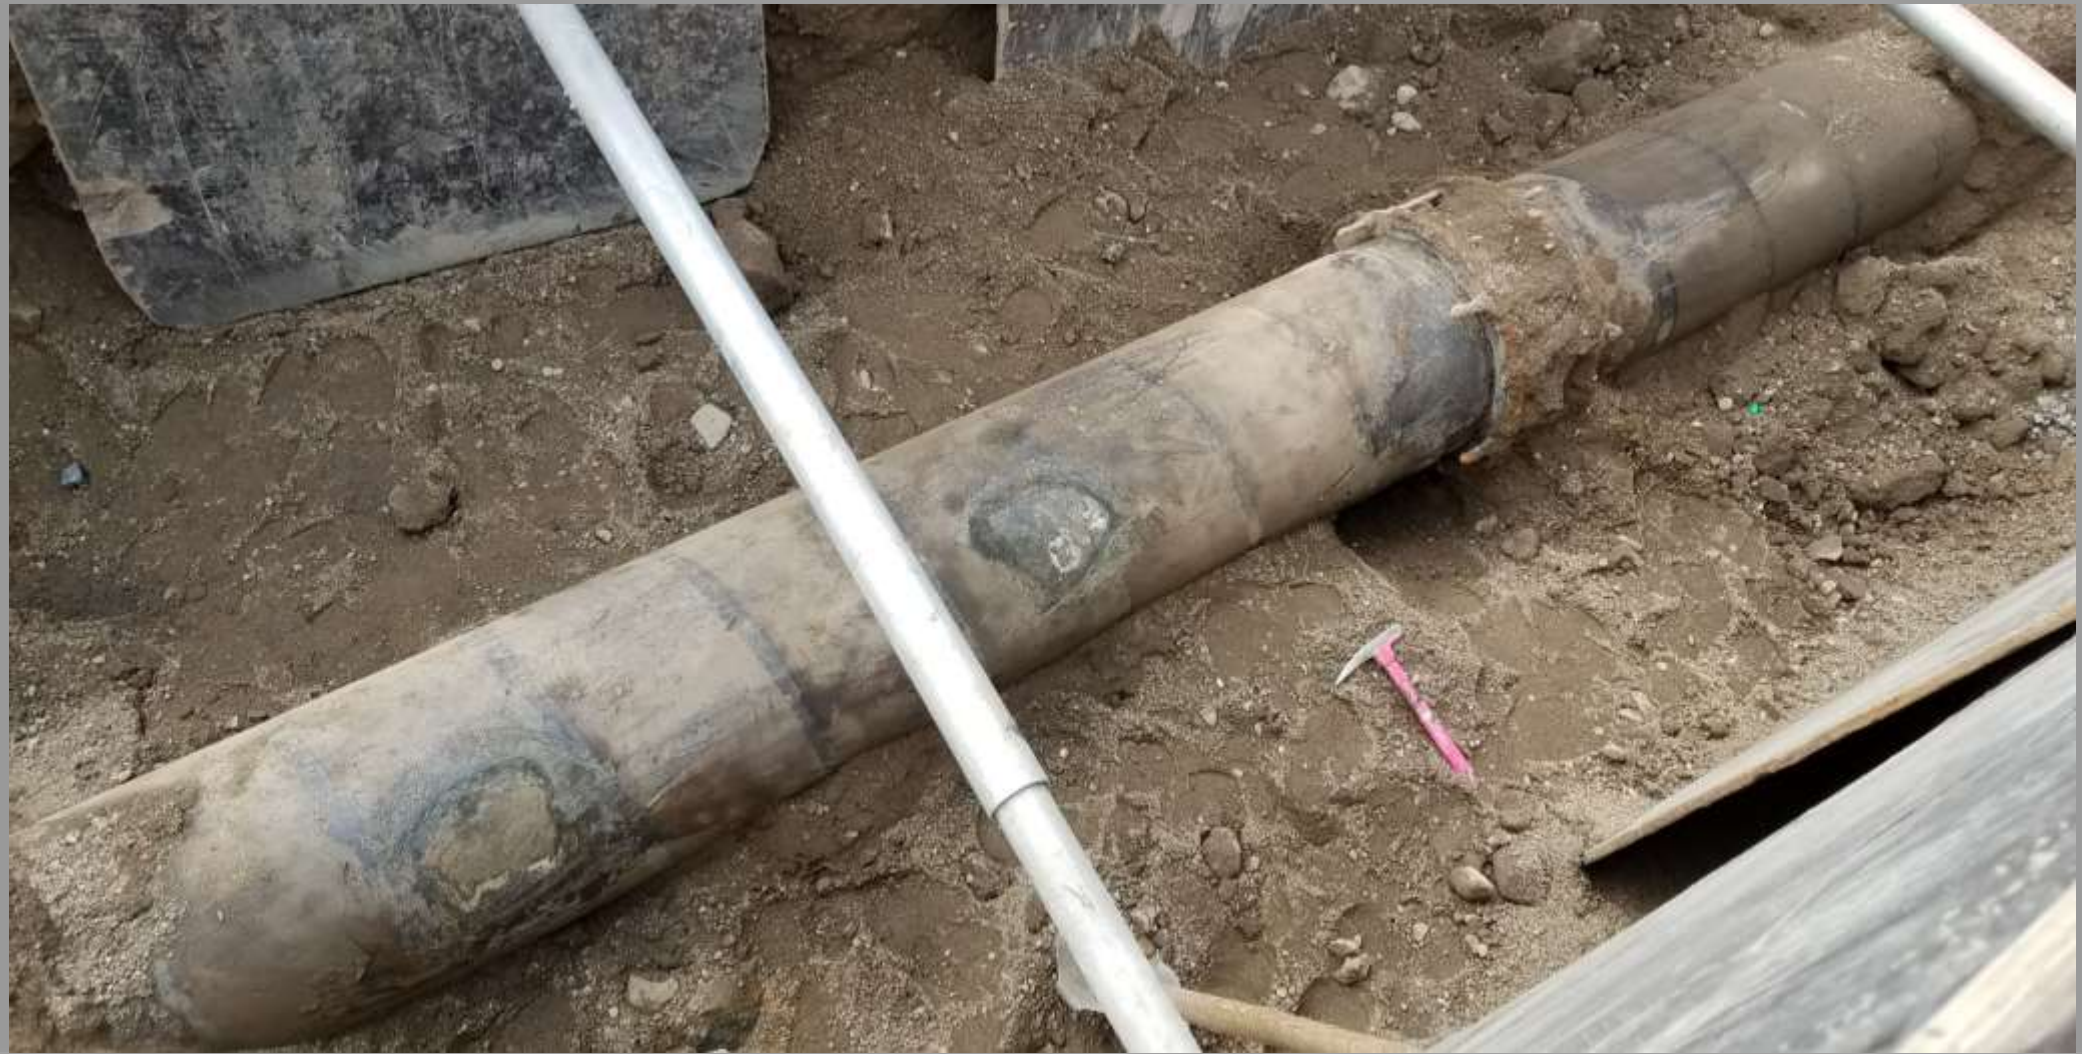
Pipe 11 - 57th Avenue and Helena

- Pipe 11 – S Helena St
 - 1 EM corrosion anomaly
 - Approximately 20% wall loss
- Pipe 1080 - S Lee St
 - 1 EM Anomaly not characteristic of corrosion
- Pipe 1172 – S Palouse Hwy
 - 2 EM corrosion anomalies
 - Approximately 35% and 45% wall loss
- Pipe 1174
 - 3 EM corrosion anomalies
 - Approximately 50%, 50% and 45% wall loss

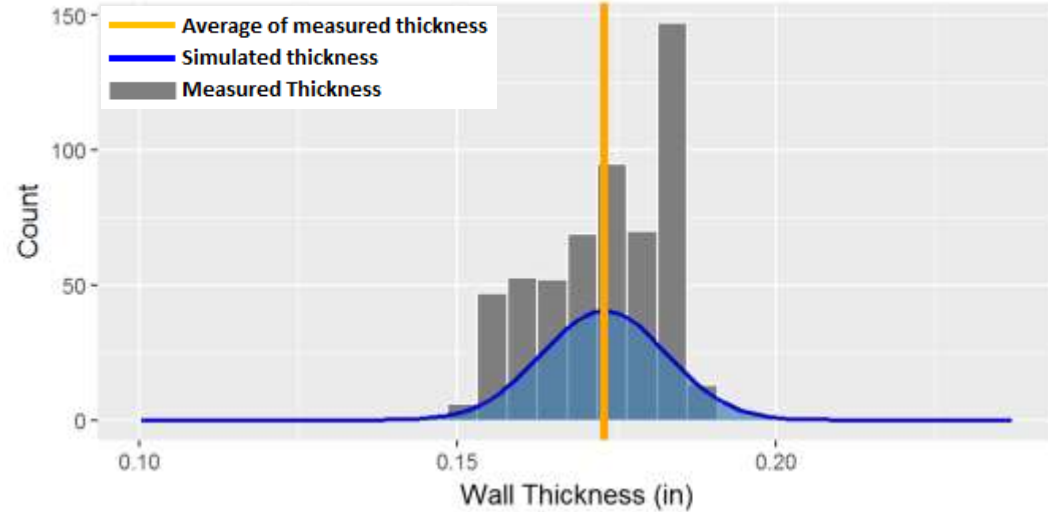
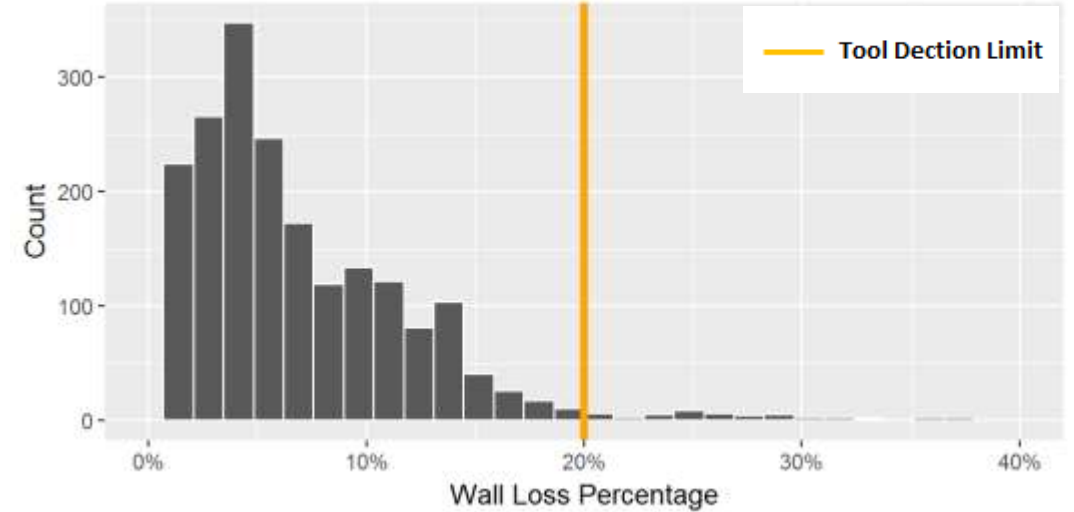
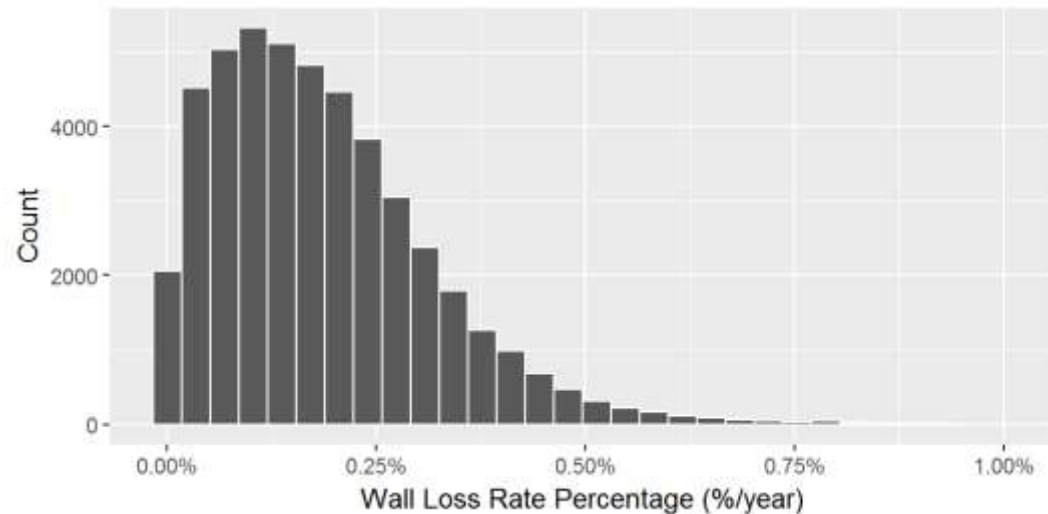
57th Avenue Transmission Main Degradation Prediction

- Leaks possible in 4 years
- Possible to detect corrosion with current technology in 15 years
