RESTORING STORAGE

Recycling an Existing Storage Tank

Michelle L. Johnson, P.E.

2018 PNWS AWWA Conference

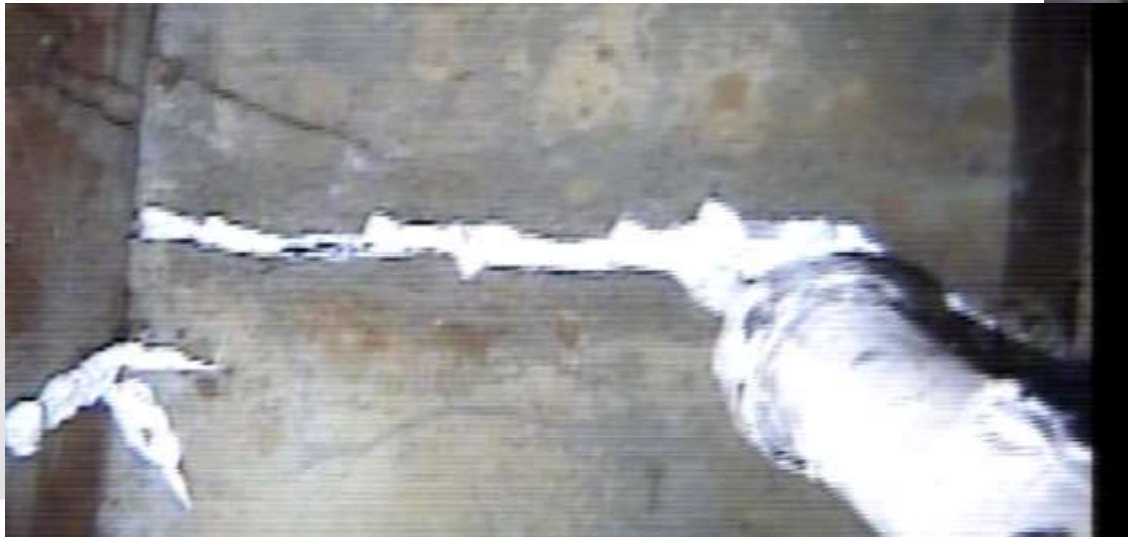
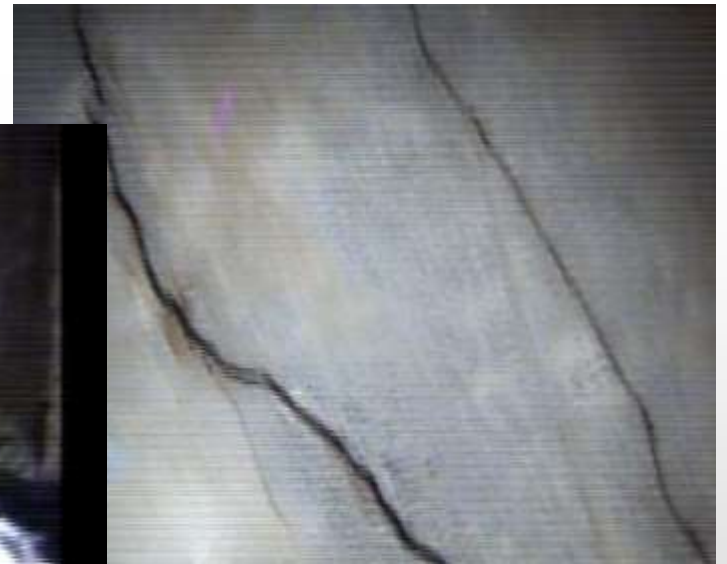
- Tank inspection in 2008 identified cracks
- “Live” repairs were made

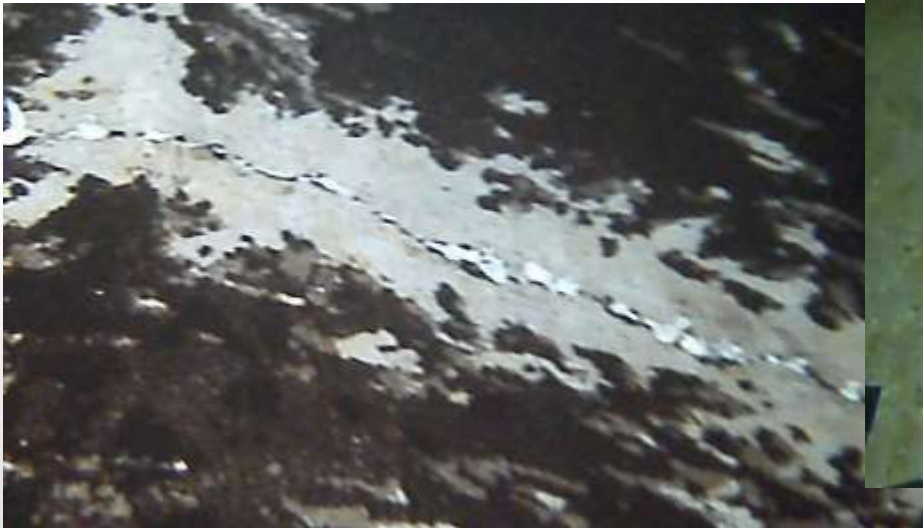
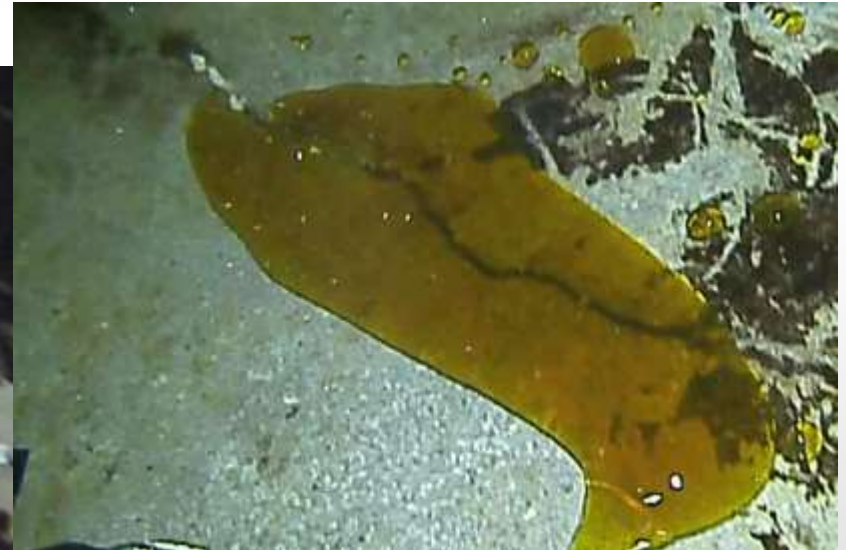
- Experiencing losses of 115,000 gpd
- Tank Inspection and Repair
 - Evaluate condition post fire storm condition August 2014
 - “Live” repairs were made
- Losses reduced to under 60,000 gpd

- "360"- A video inspection done around the entire perimeter of the inside wall, this crack would be around the ground level on the outside of the crack.

- "floorcrack"- A video of a very large crack that is feeding water from the floor. This crack begins on the wall and continues down the floor right up to a supporting column. In this video, one can see that sediment is flowing straight into the crack. This is most likely the main feeder causing most of the water loss, but certainly not all of it.

- "floorcrack_2"- a second crack that appears to also have been addressed but is failing. This split, like "floorcrack," is approximately 18' long.
- "rootmass_1" is a video of "d1_1" rootmass growing out of the floor. Evidence that water has been flowing freely from the tank for some time. notice the sediment flowing straight into the crack?

- "d1_2" is a picture of the rootmass in "d1_1" coming up from the floor.
- "d2_1" is a picture of another rootmass coming out of the wall in another area. This crack is still below grade and is also allowing water to flow freely out of the tank.

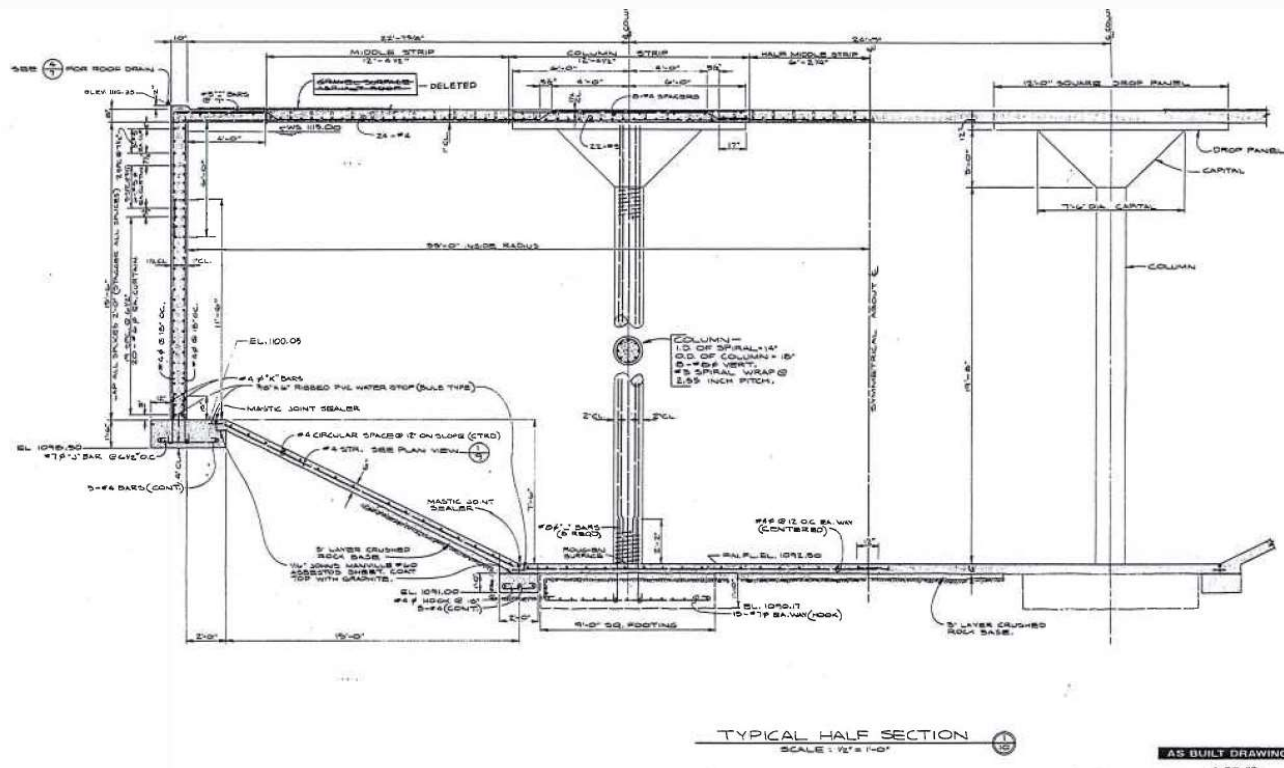
AS BUILT DRAWING

- What about building a tank inside the tank?
 - Existing walls are 10-inches
 - Floor is 6-inches

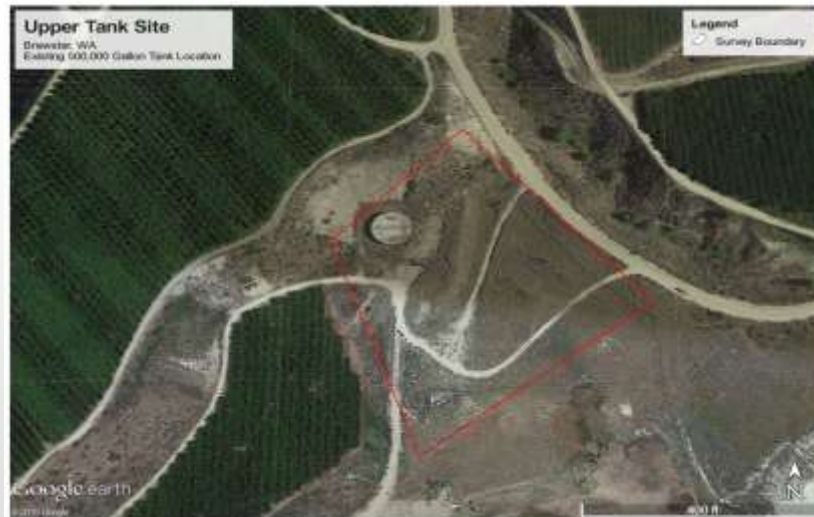
- Locate new tank
 - Wet layers near tank bottom
 - Raised concerns about voids under slab
 - Complicates location of adjacent tank

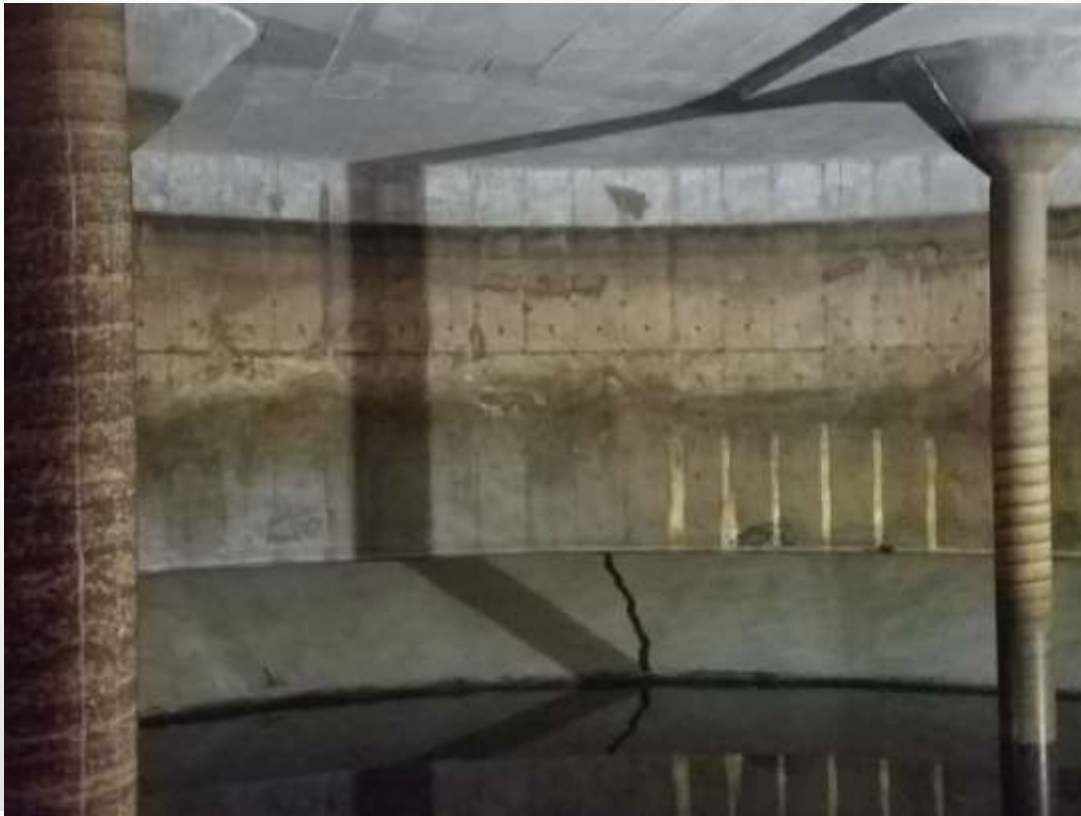
- Drained the tank - First visual inspection of the tank interior

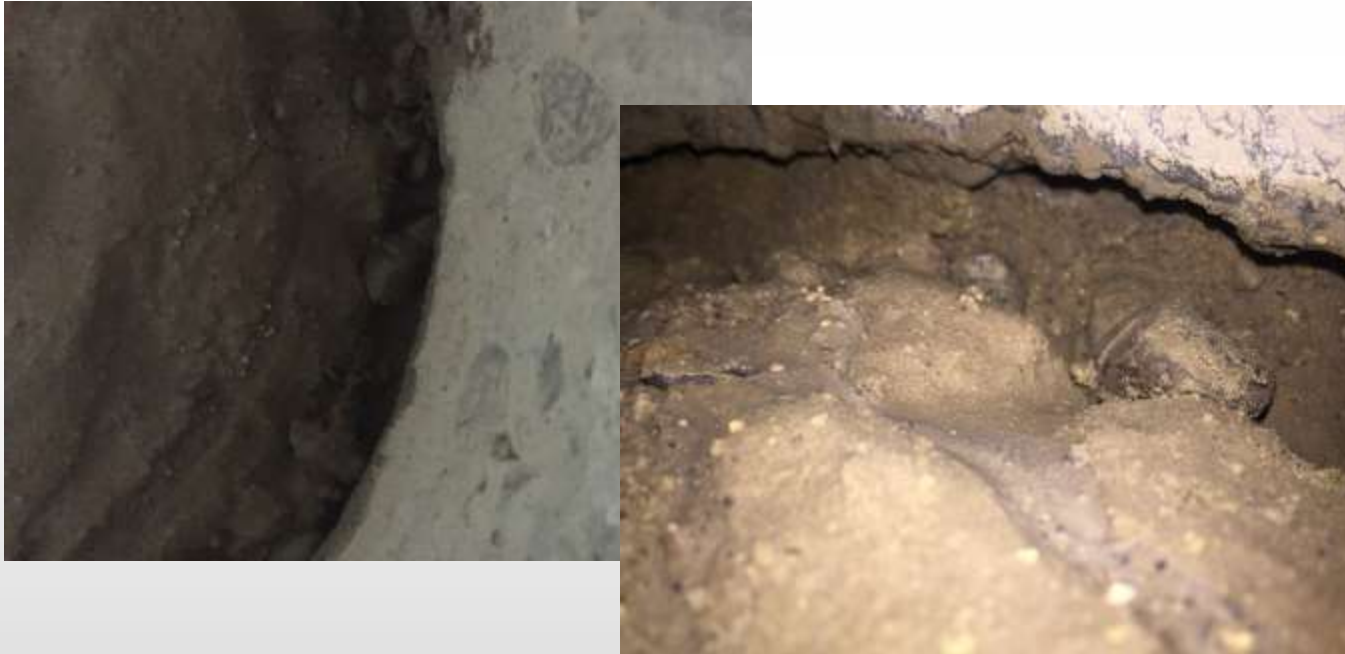
- Determine grout injection is not needed.
- Crack repair at tank perimeter and seal floor joints.

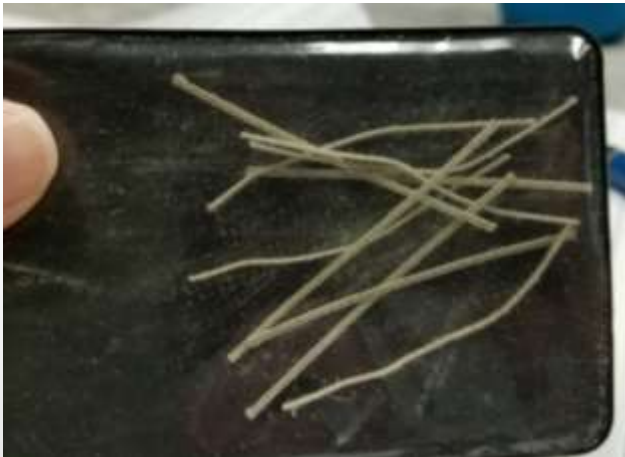
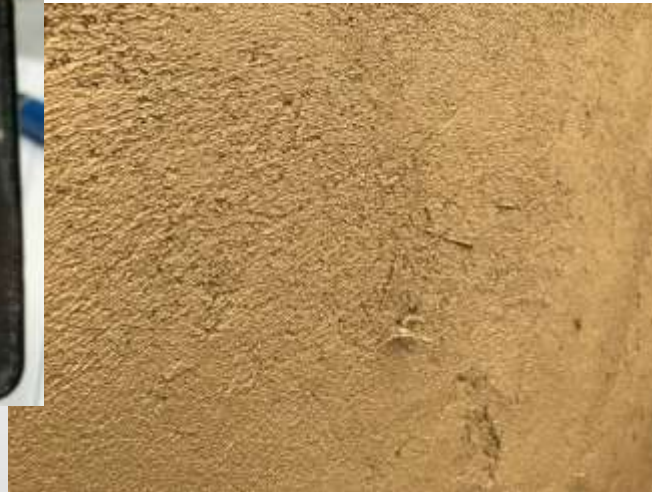
- Shotcrete prep was critical
 - Pre-application meeting a few days before to get testing firm and applicator on the same page.
 - Test panels led to modifying the mix.

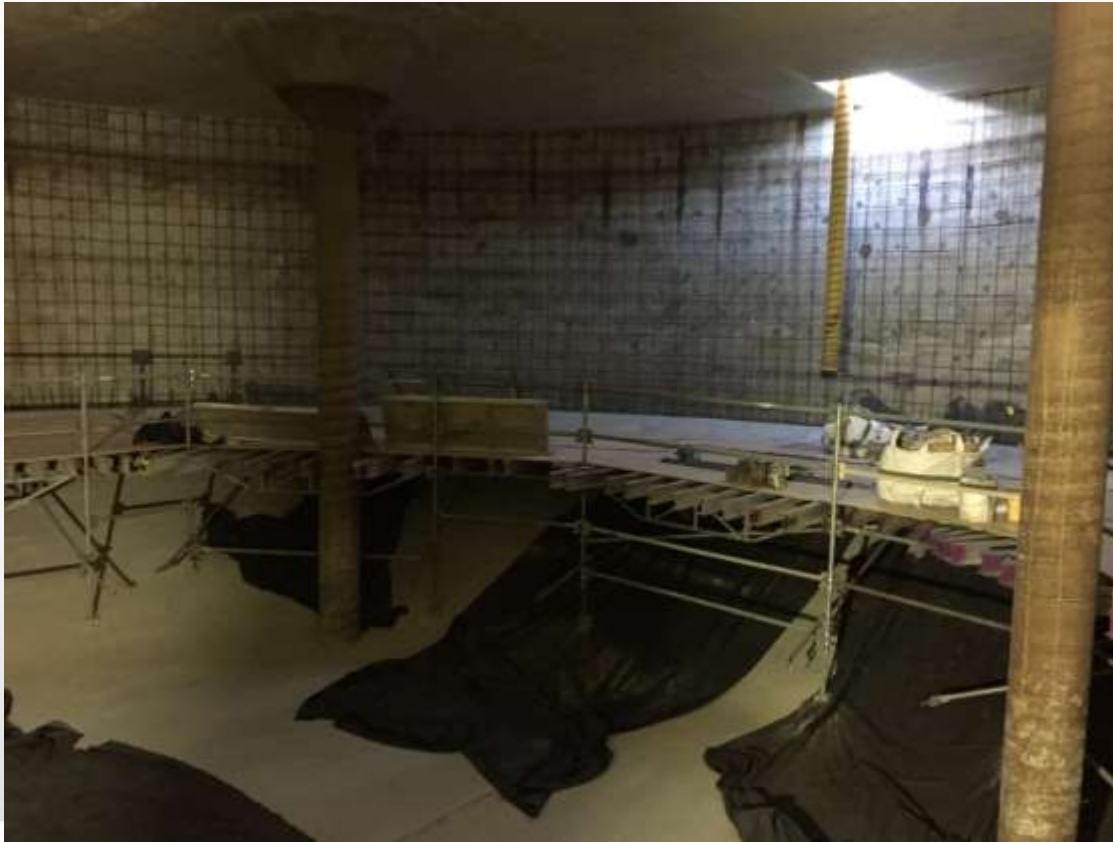
- False floor and rebar curtain for shotcrete application.

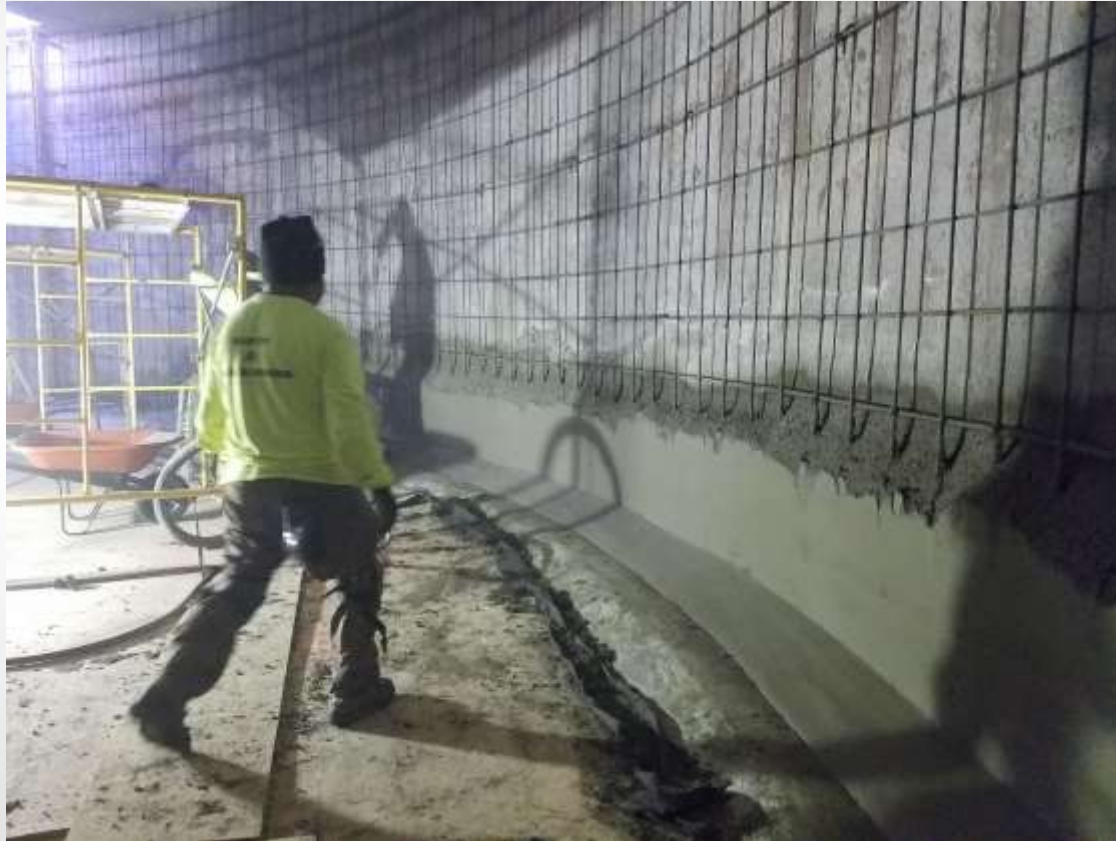
- Finishing Challenges

- Complications with finishing
 - Slow to finish – short loads of mix were helpful
 - Work from the bottom up, overspray falls down over finished work
 - Were finishing and refinishing lower wall portions
 - Cold joint finishing was challenging
- No water stop due to application – something to consider
