Solving a 19th Century Challenge with a 21st Century Solution:

Cascade Water Alliance's Improvements to a +100-year-old Reservoir

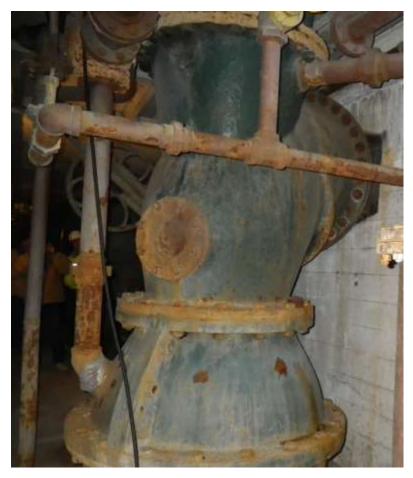
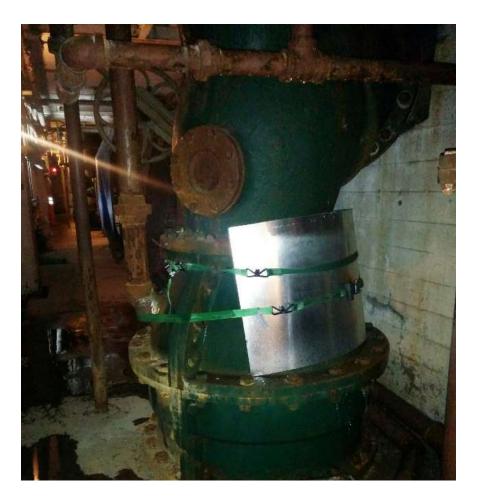
Unique, Vintage Construction under Duress

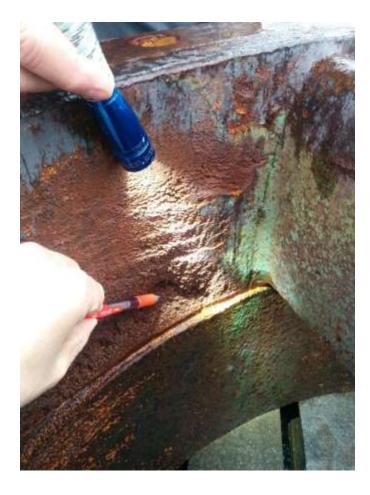
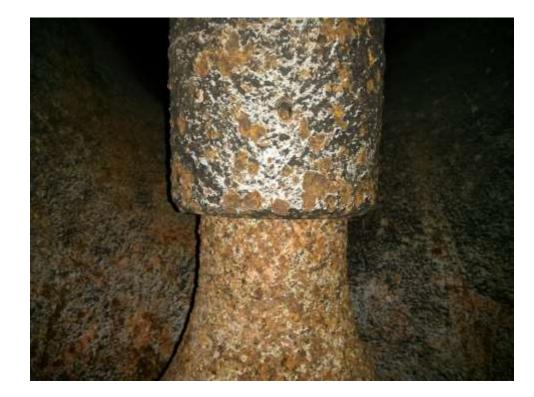
High Head and Cavitation Potential

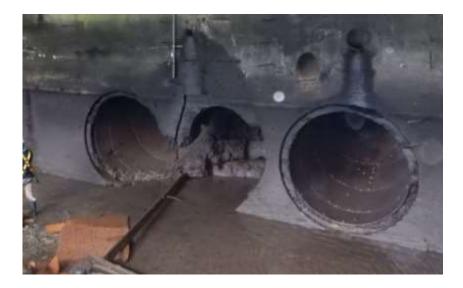
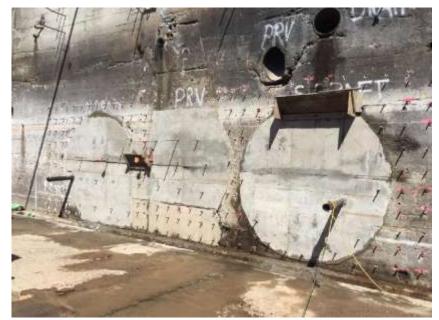
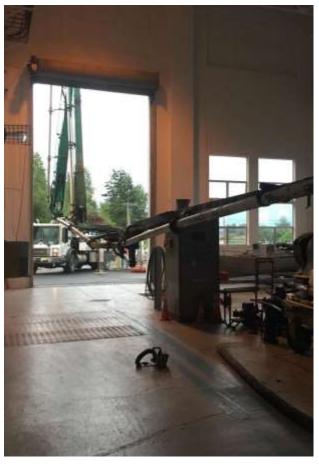
Erosion Cavity Repairs

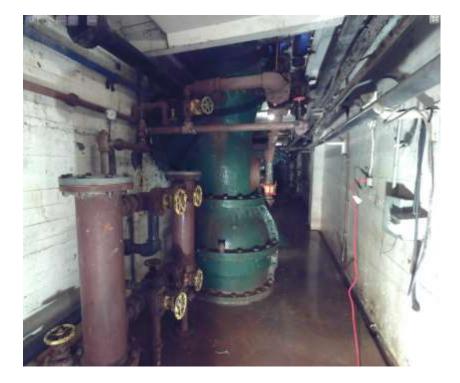
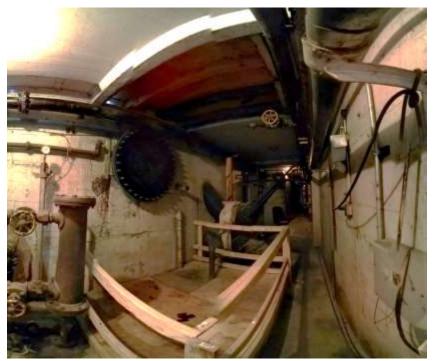
Failed Valve Removal

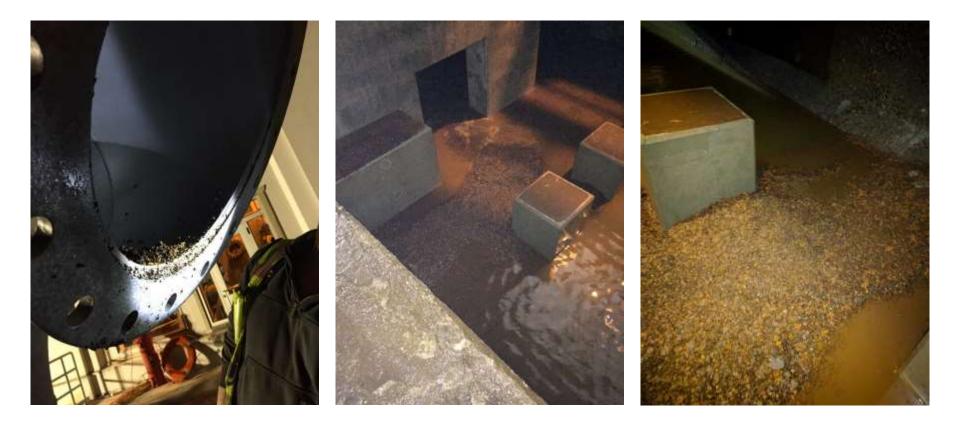
Post Test Observations

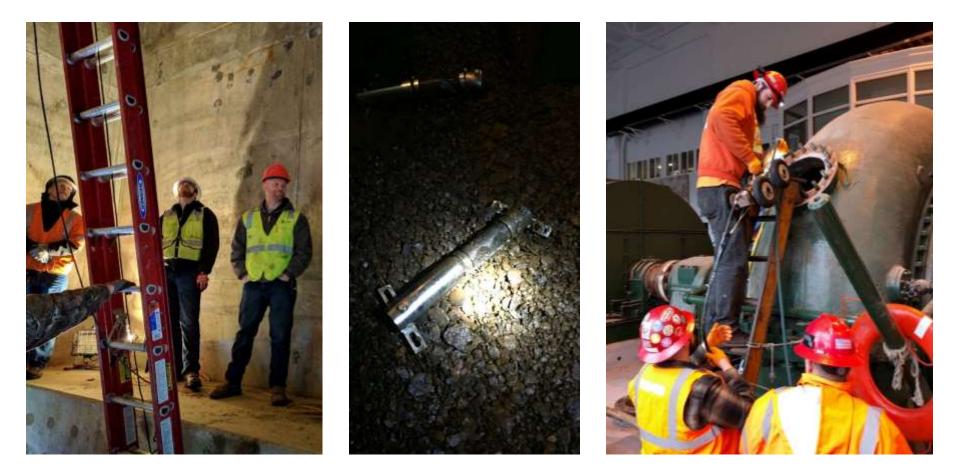
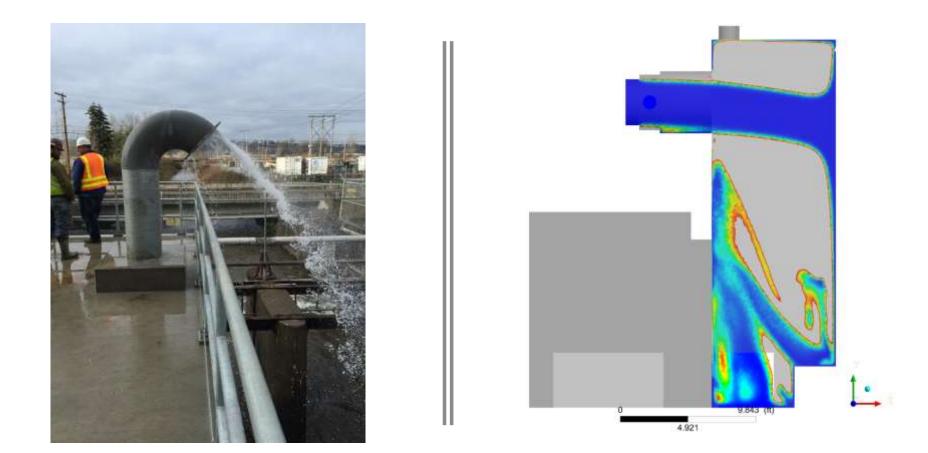
Post Test Inspection

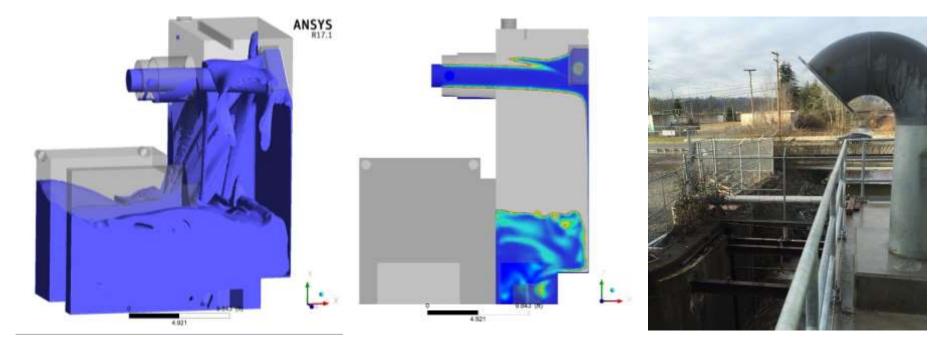
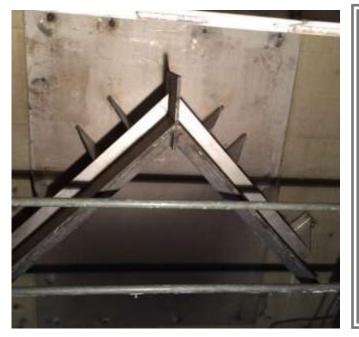
CFD Modeling Confirmed Vent Spray

Field Modifications to Improve Performance
