WELL REHABILITATION IN ALASKA'S BUSH COUNTRY: TECHNIQUES TO IMPROVE WELLFIELD PRODUCTIVITY

2019 PNWS-AWWA

Ida Fischer, HDR, Hydrologist

CASE STUDY KING COVE, ALASKA

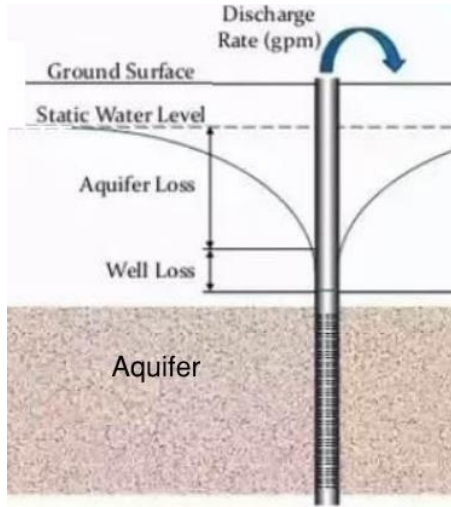
**Pumping Tests –
Specific capacity**

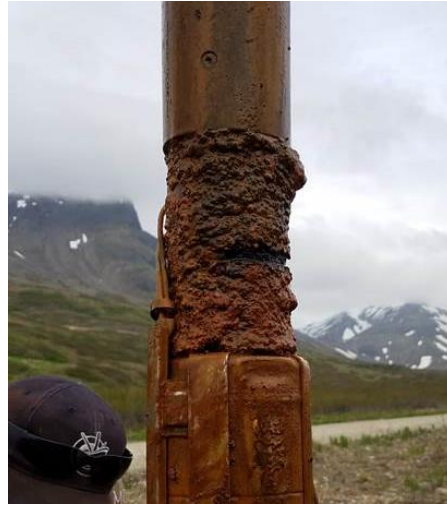
**Visual Inspection –
Inspection of column
pipe and pumps**

- **VISUAL INSPECTION:** Formation of biological slime and mineral encrustation

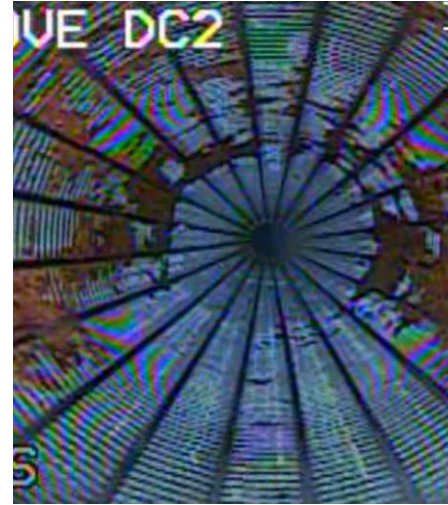
**Visual Inspection -
Video logging**

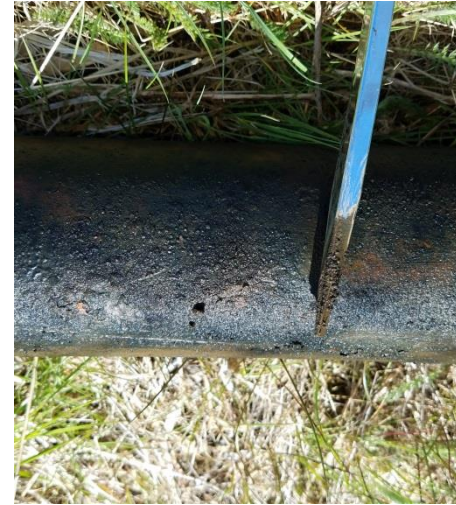
**Sample Collection –
Mineral scale and water**

Well 9 – deposits of manganese

Wells 2, 6, 8, 16 – deposits of iron, manganese, calcium and decomposed organic matter (biological slime)

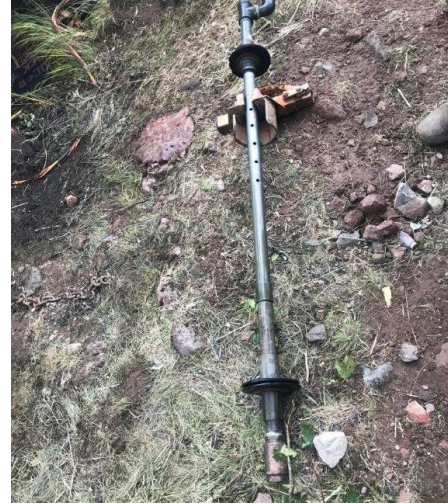
**Developed with air +
Airlift debris from well**

- Step 2 Installing chemistry:** IF < 200' water: Pour 70 lbs of HCl into the well from surface, followed by 8 gal gal of Catalyst.
- Step 3 Development:** Start development immediately. **BEST OPTION:** Use a surge block but operate in the screen area only. A block speed of 2-3'/second is important to gain velocity through the screen. Start at the bottom of the well screen and work upwards in 3' or 5' increments spending 15 minutes per increment. When reach the top of screen, repeat this procedure for 2.5-3 hours. Monitor pH/color with a baller within the middle portion of the screen. Note: this option may be difficult without a cable tool rig. Use a 6" surge block. Airlift debris when when done. If debris enters into the screen, you can bail to determine if debris or sand/silts. **OPTION:** Air lift the chemistry from the bottom of the well upwards without blowing chemistry out of the well. Use a simple quick release gate valve on the air line to the well. Shut this gate valve, engage the air, and when chemistry reaches 7-10' from surface, shut the air off from the compressor and open this gate valve releasing pressure from this line. Chemistry will fall for two directional development. Repeat for 3 hours. Monitor chemistry with a ball check bailer from the bottom of the well. See Monitoring. Note, in a 10' long screen, this type of development has a tendency to allow acidic flow out into the aquifer in areas of an open screen and may not be as effective as the localized development of a surge block.
