# 2024 PNWS-AWWA Spring Conference

## Under Pressure! Emergency Repair of Sherwood's Prestressed Concrete Tank

Matt Hickey | Consor

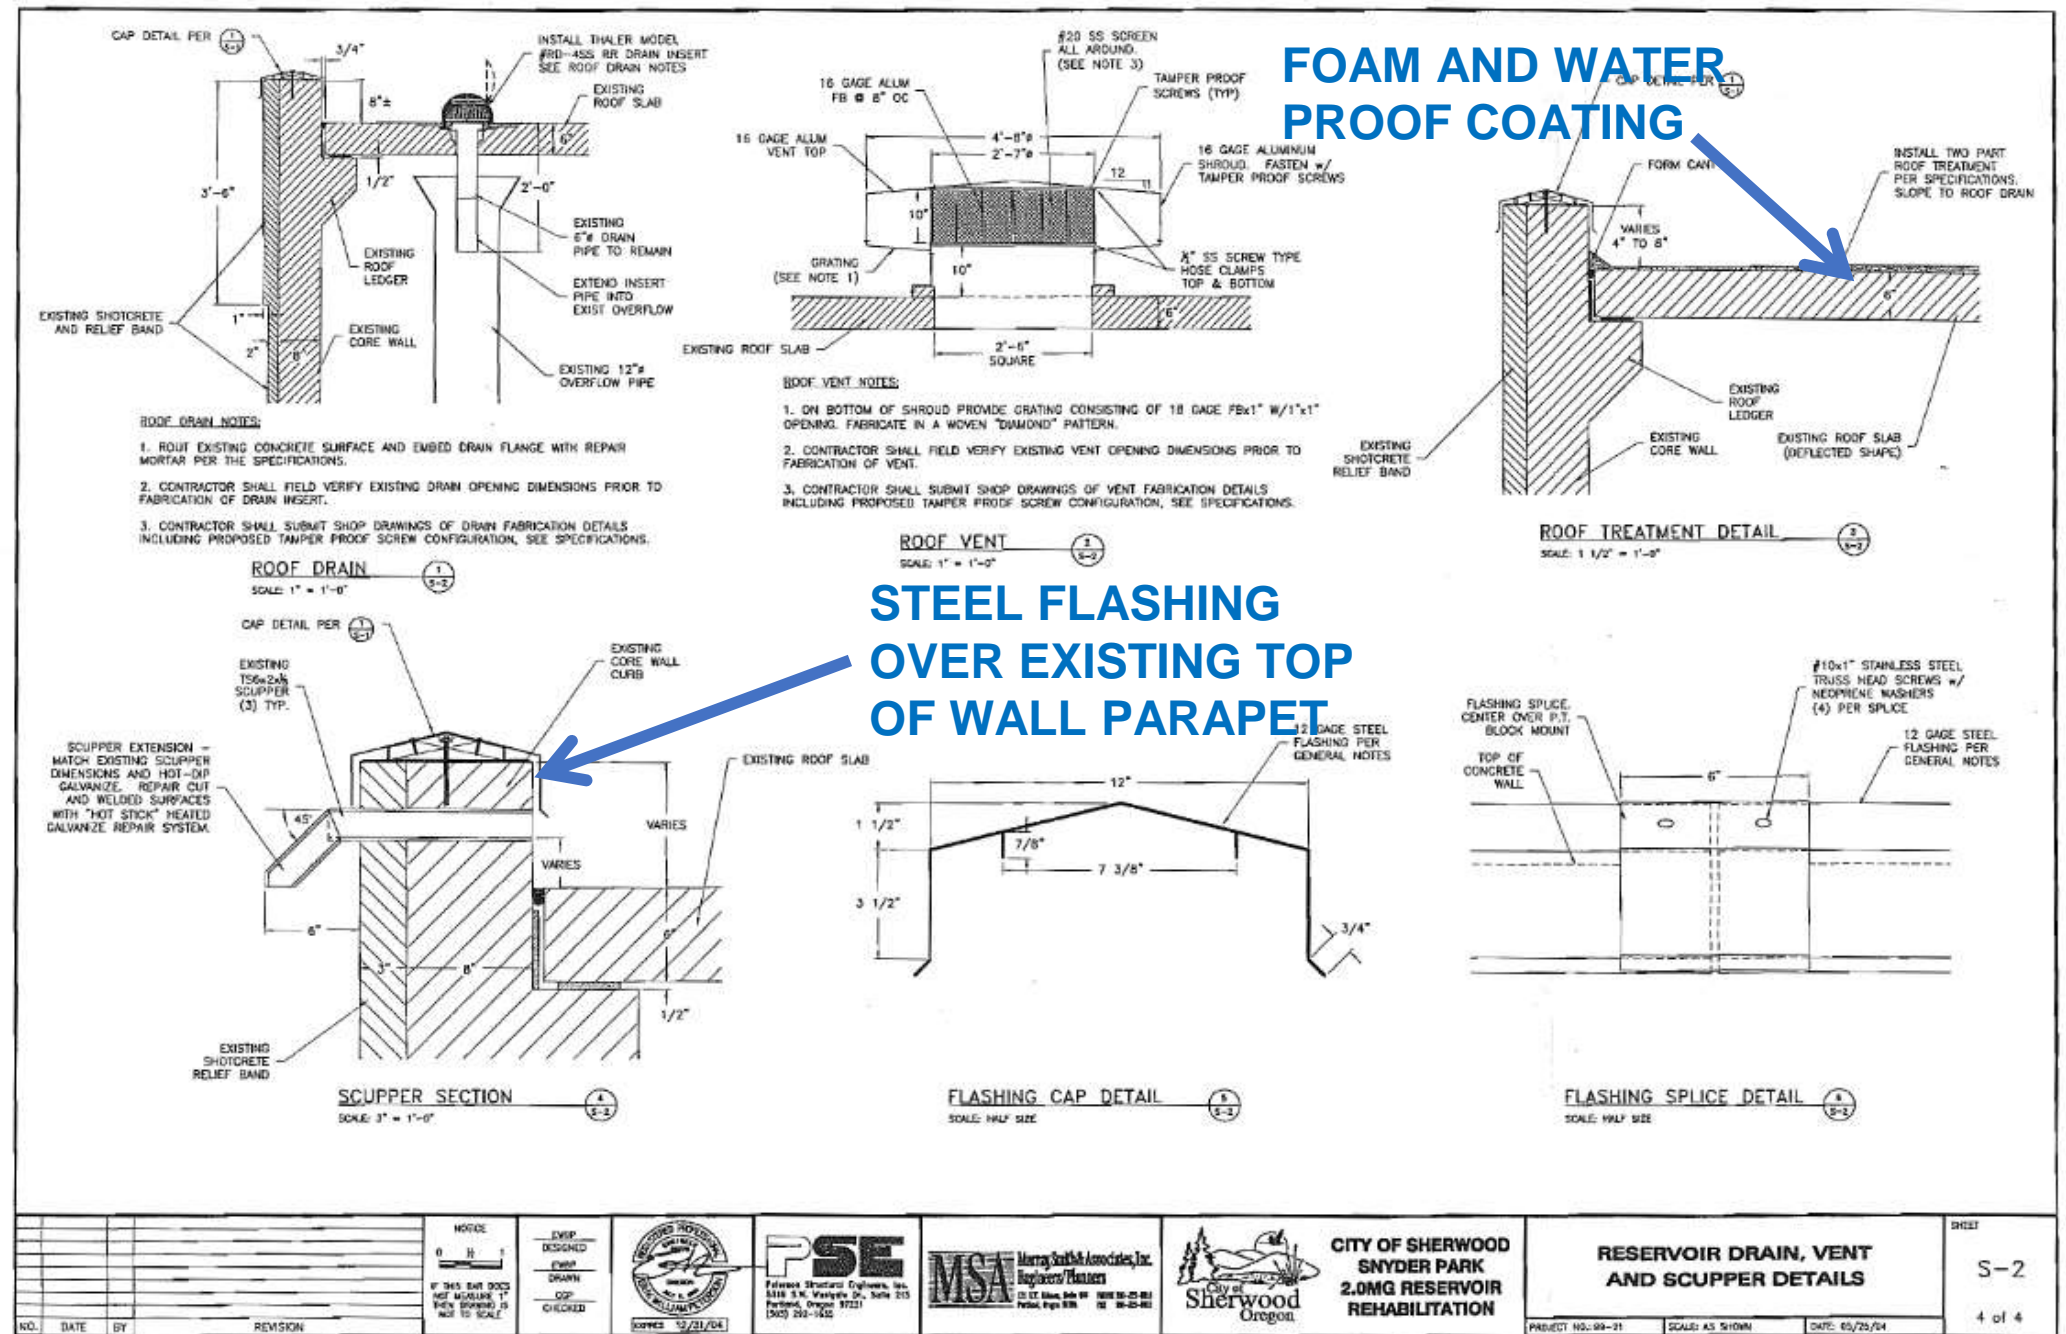
- 1 1/2" gap at edge of wall
- Overstressing columns
- Shims at roof perimeter
- Flashing added at top of wall
- Foam on roof to increase slope for drainage
- New drain, vents, hatch
- Contractor cut flashing to deal with curved tank wall - Possible path for water intrusion

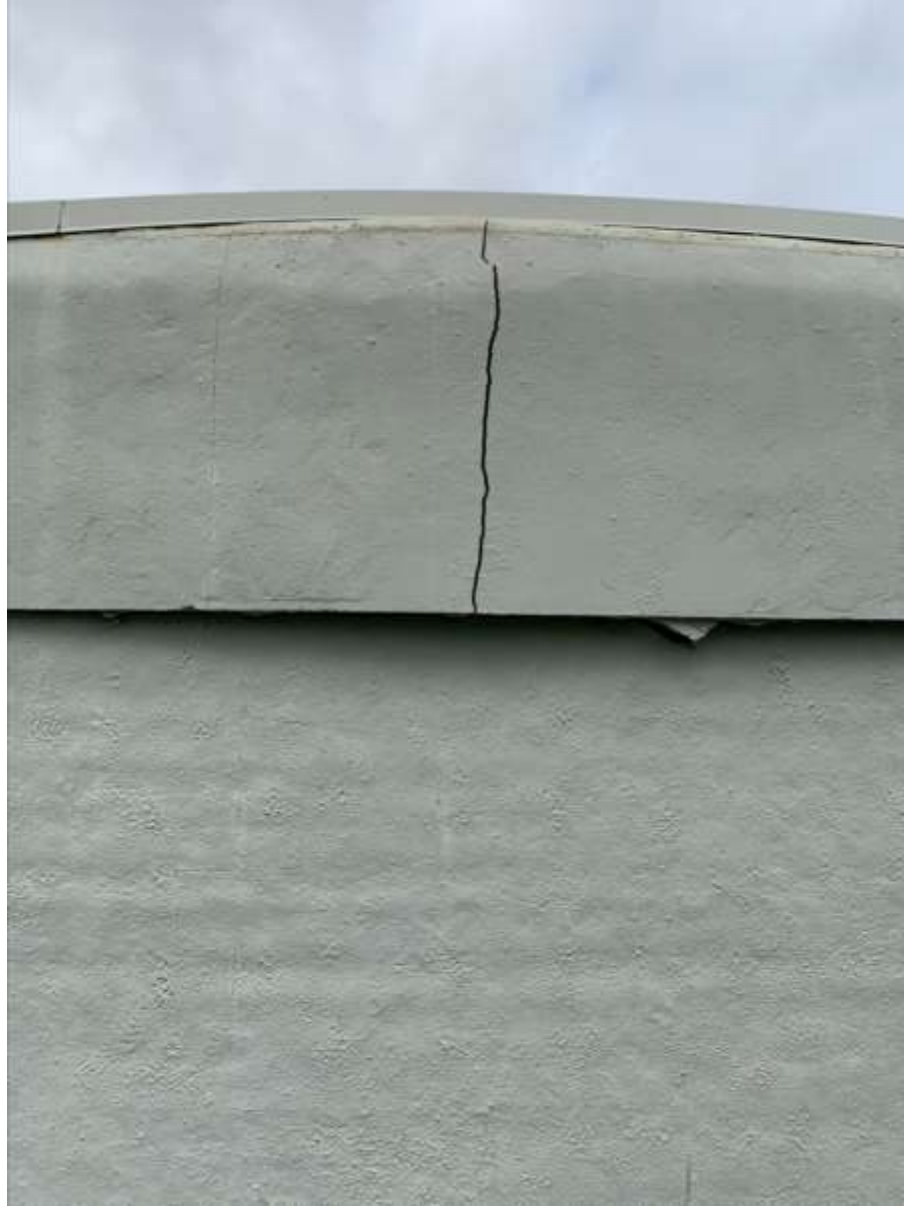
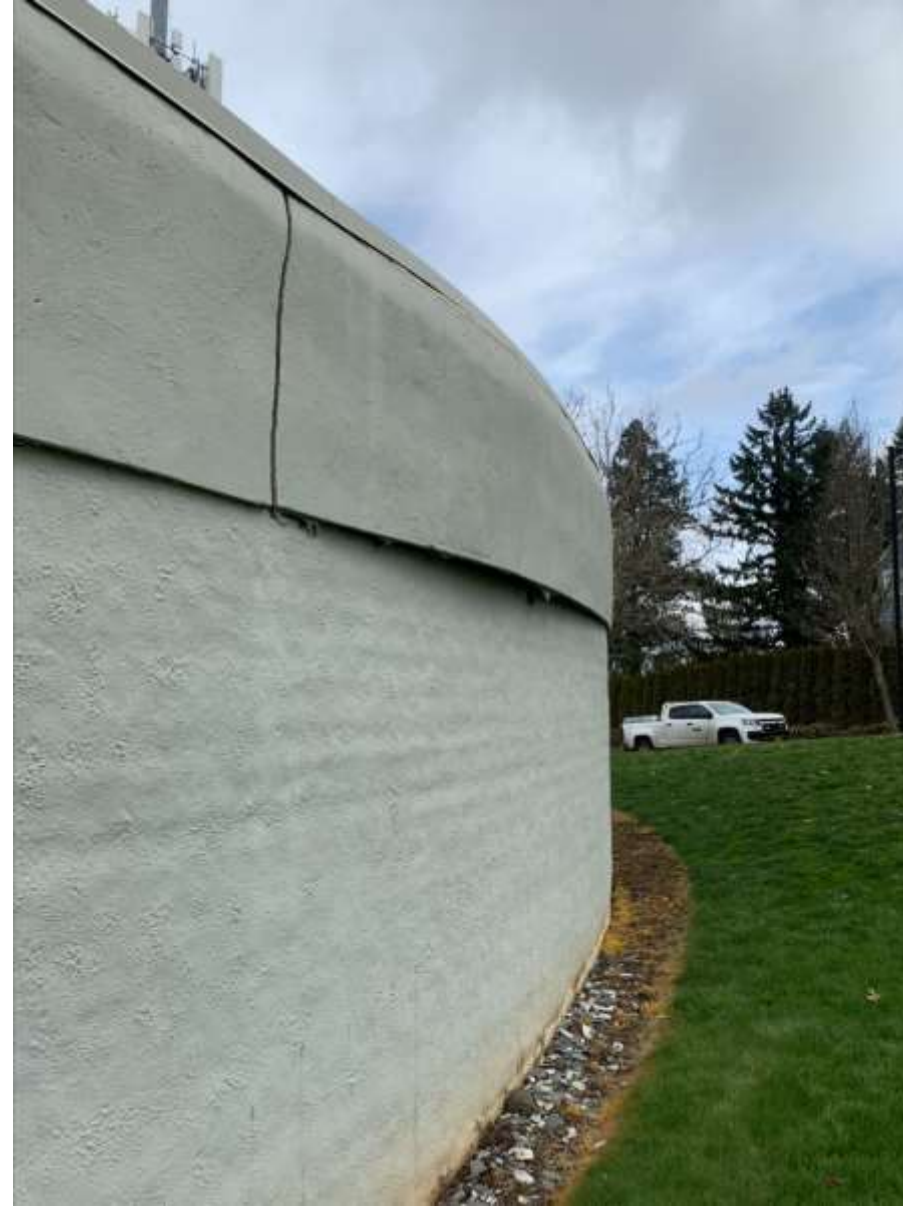
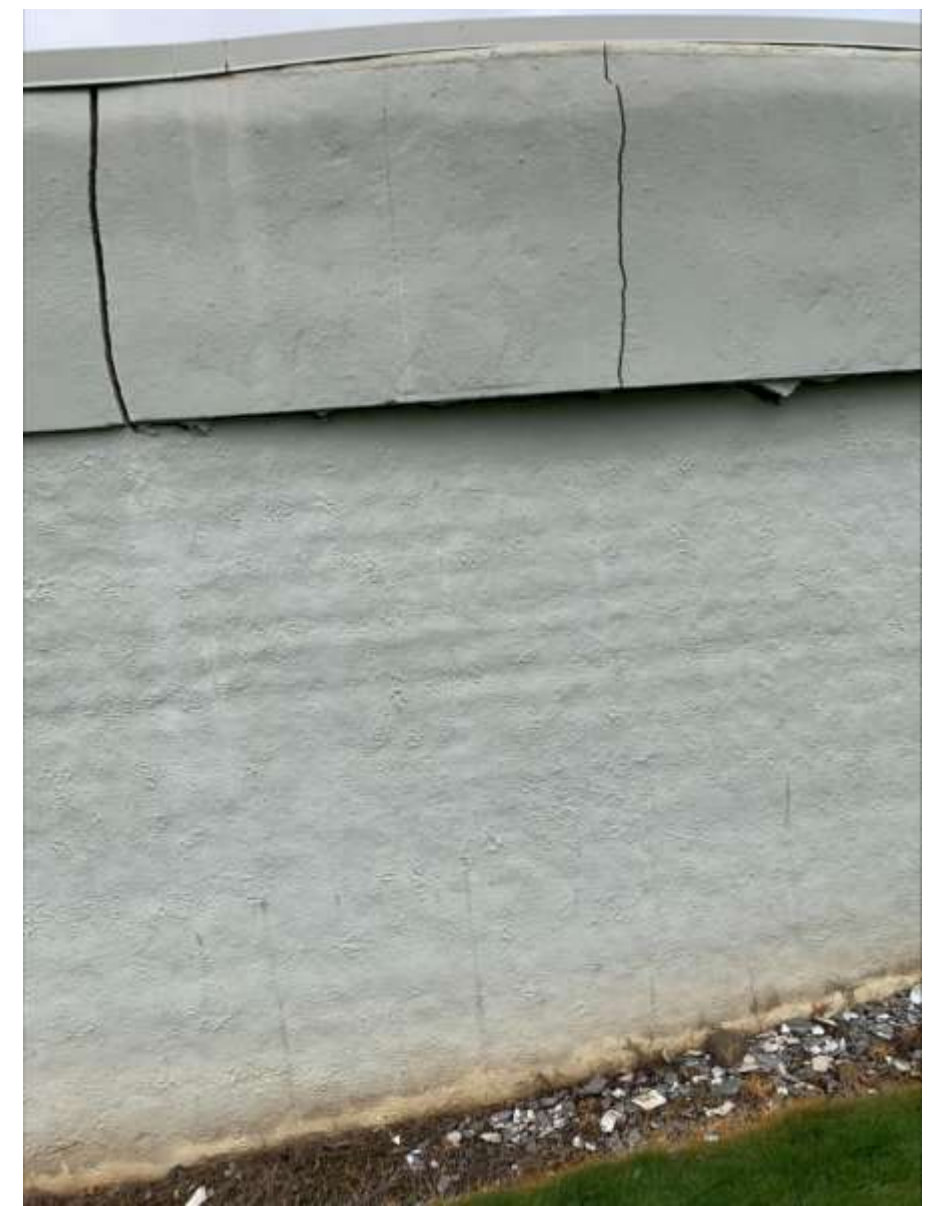
March 5, 2023, Site Visit

# What Happened?!!!!

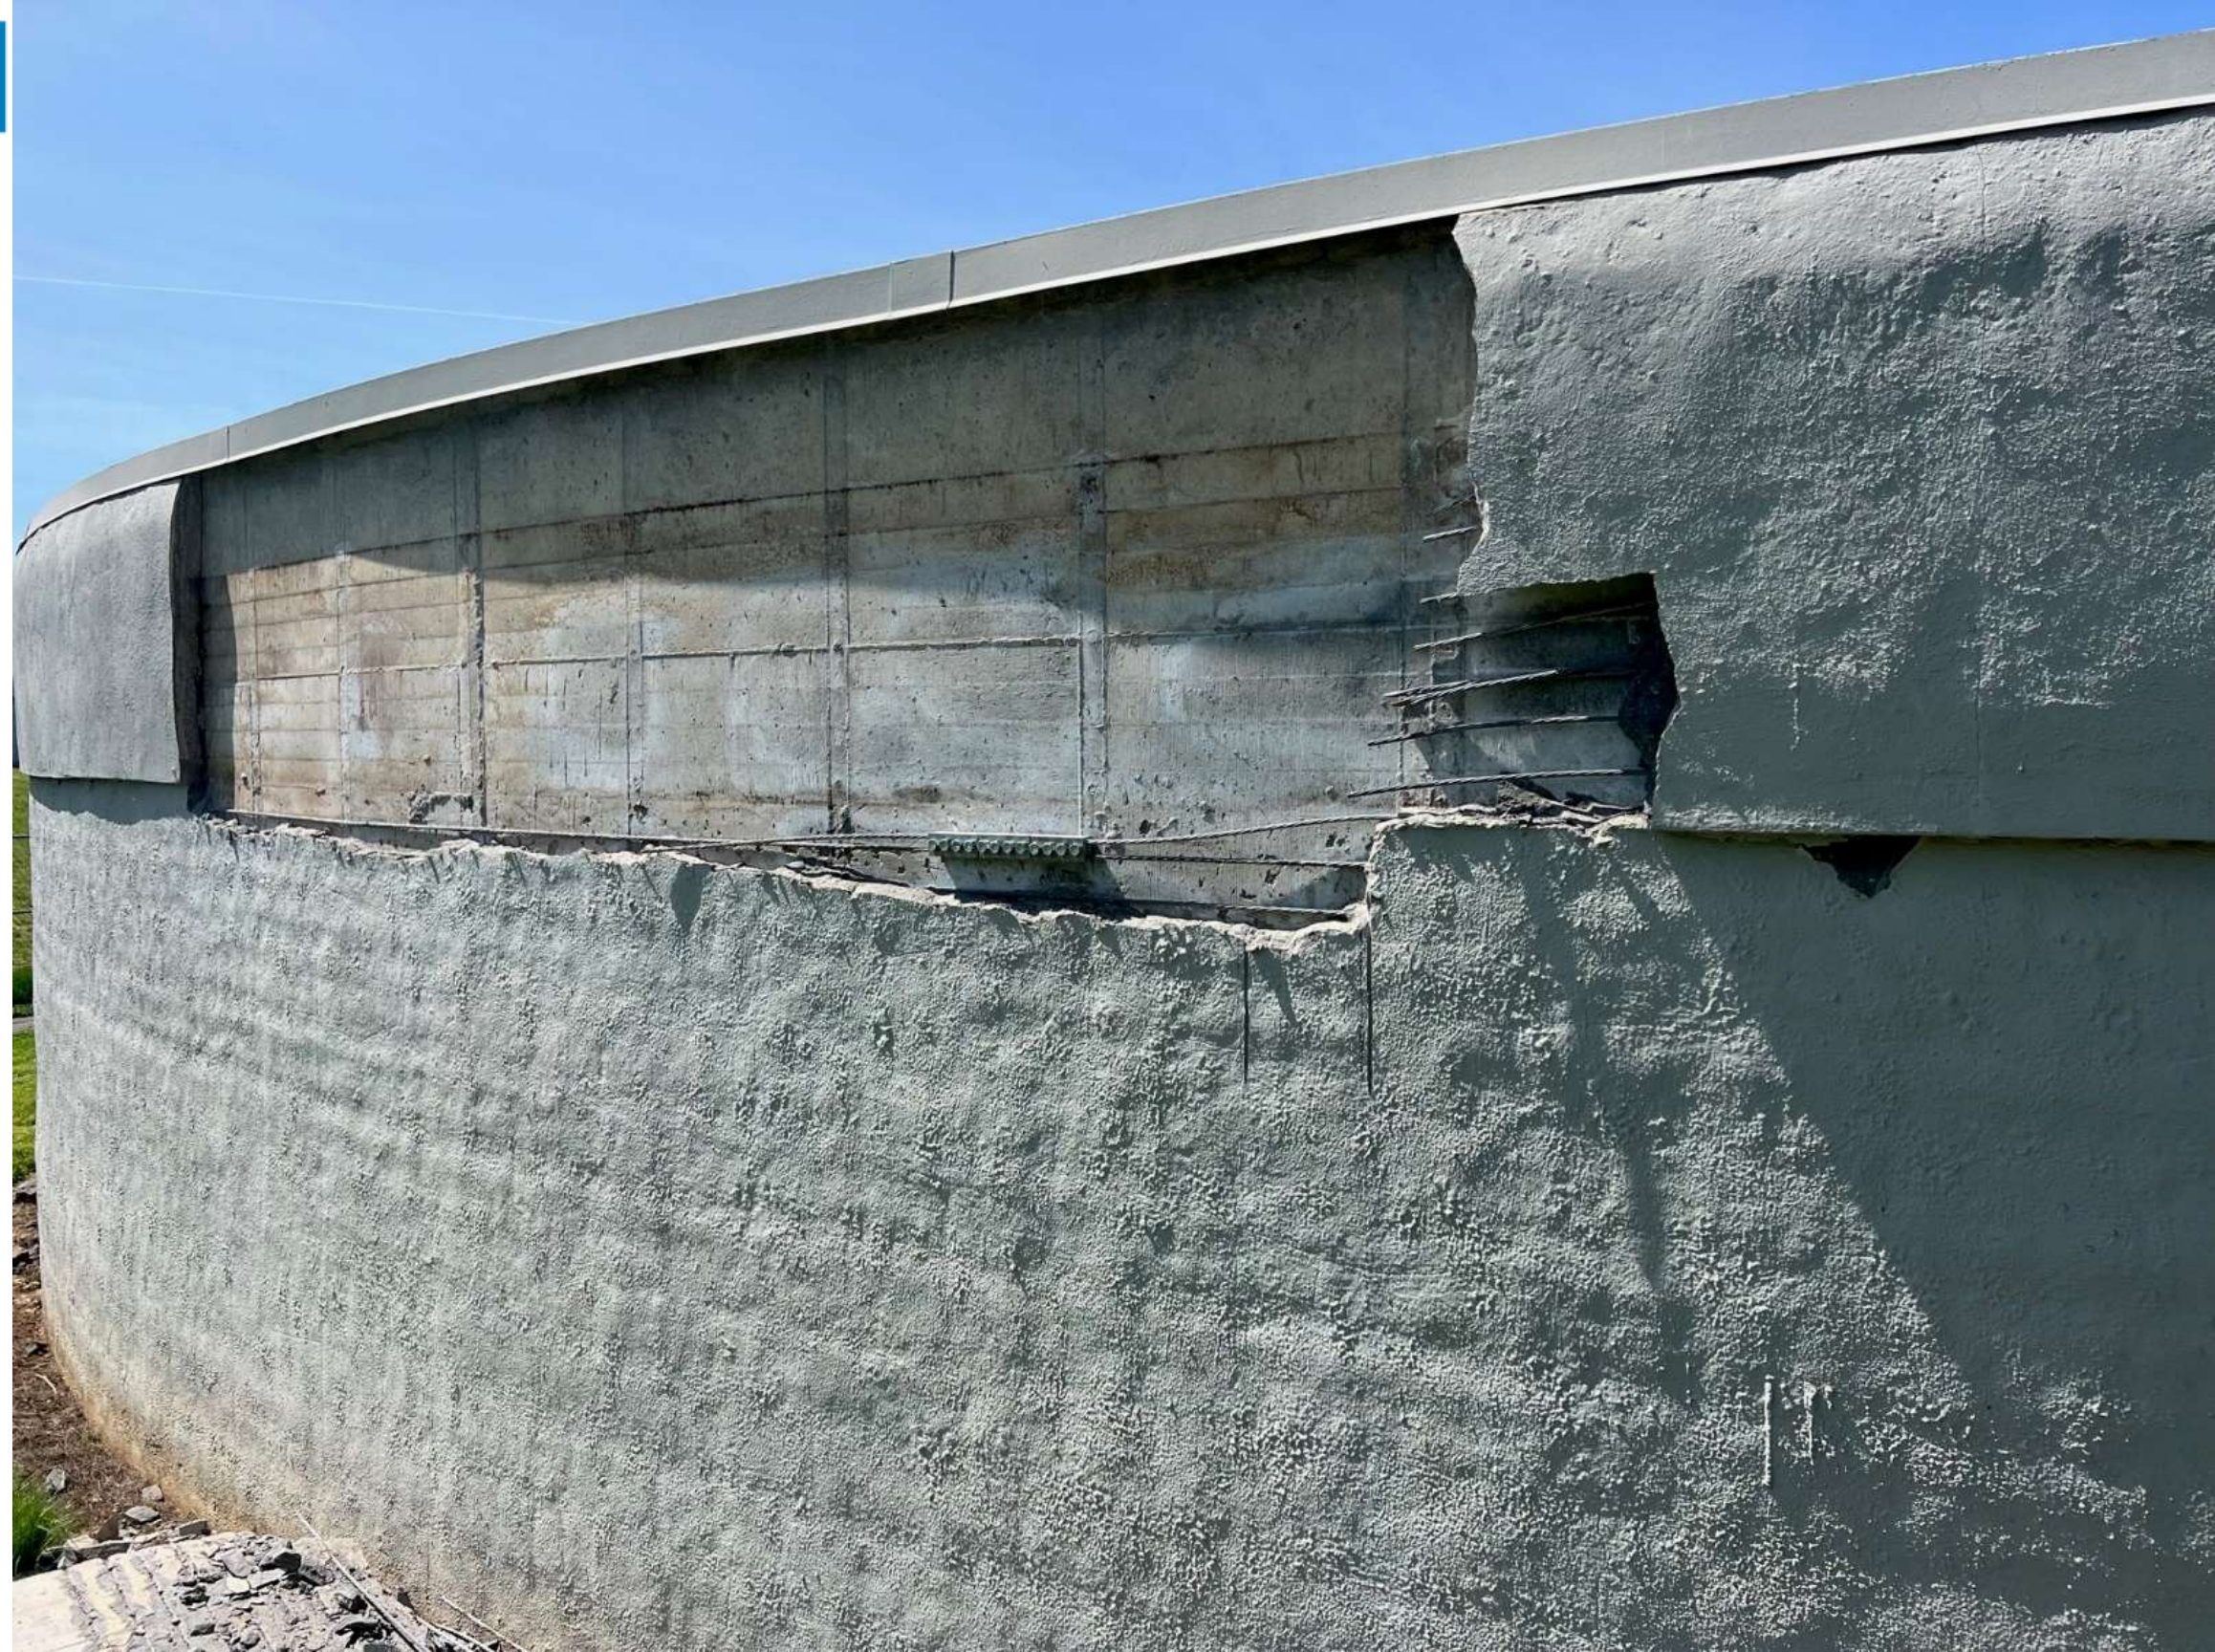
- Corroded Strands
- Isolated to this area?

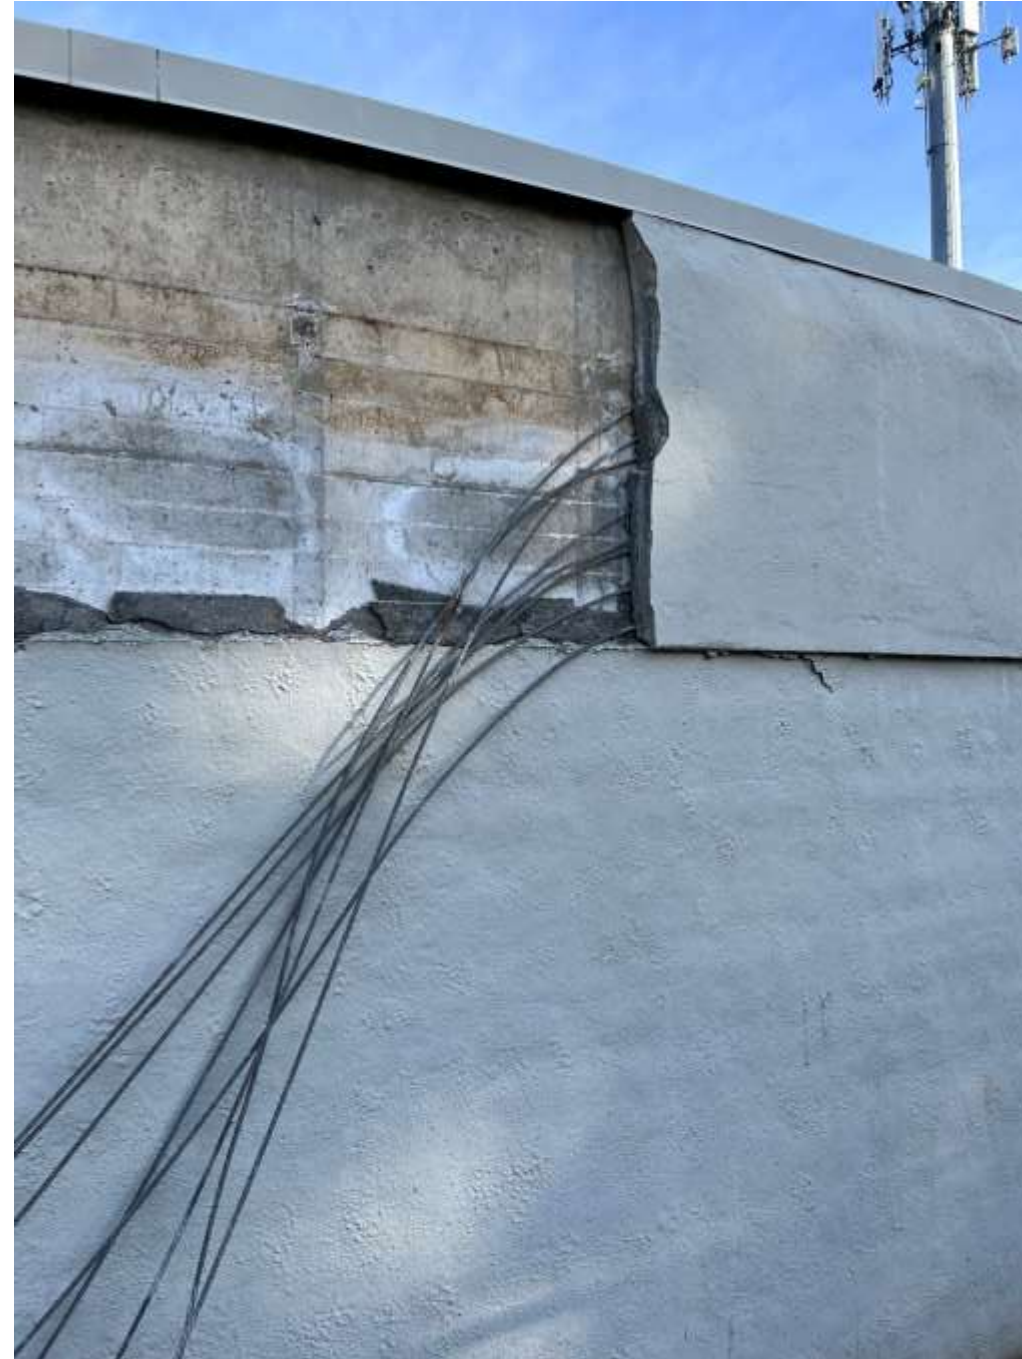
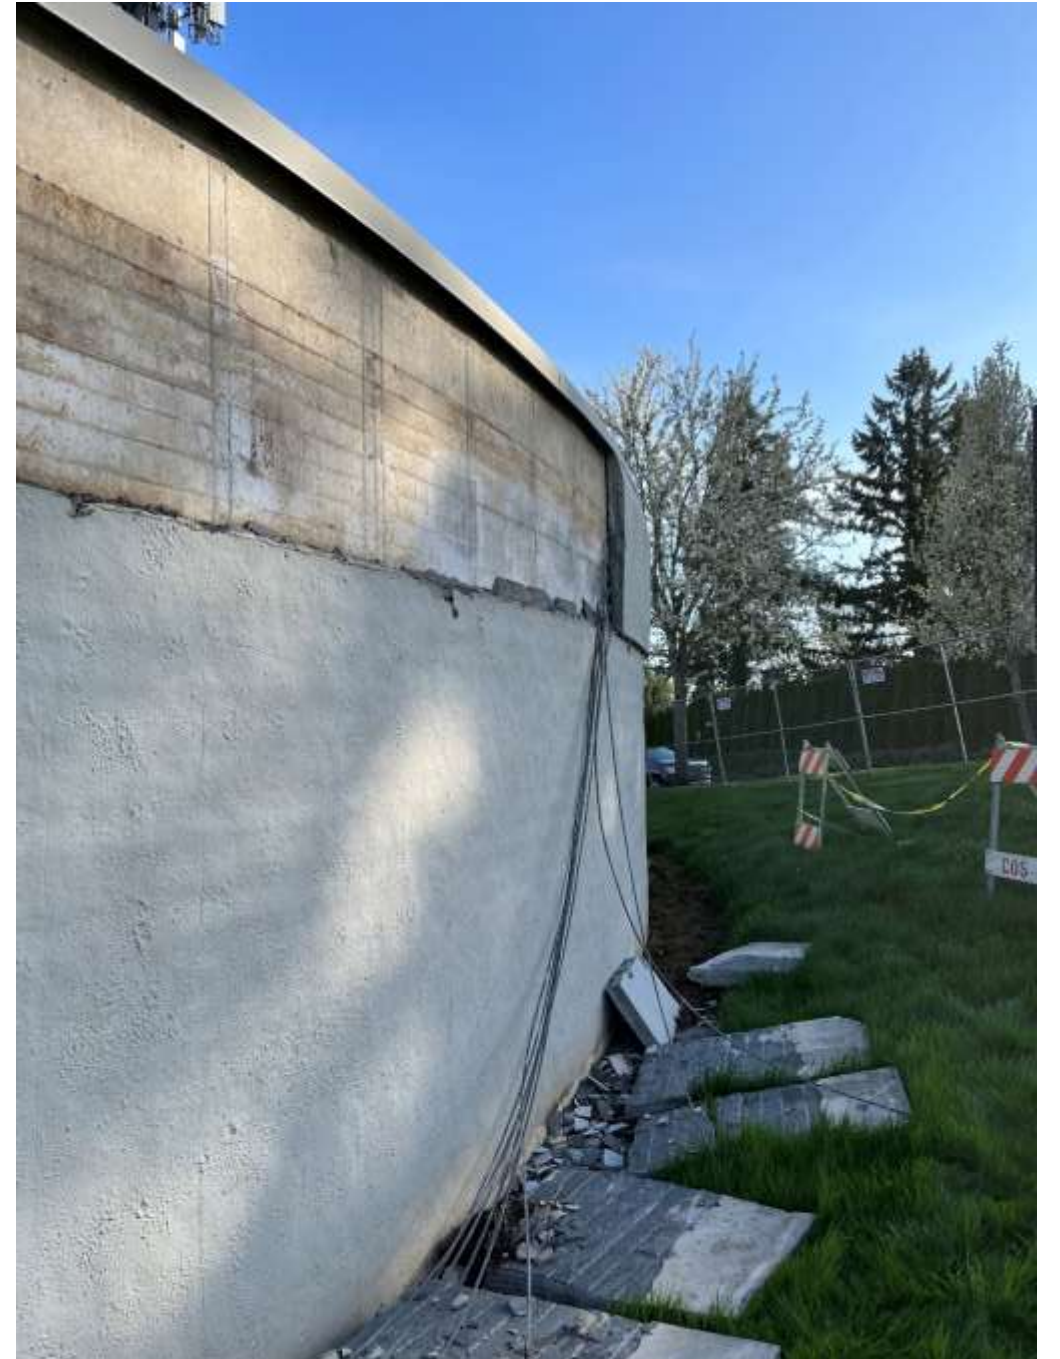
- Removed Additional Shotcrete
- Issue with stands appeared to be isolated to the one area

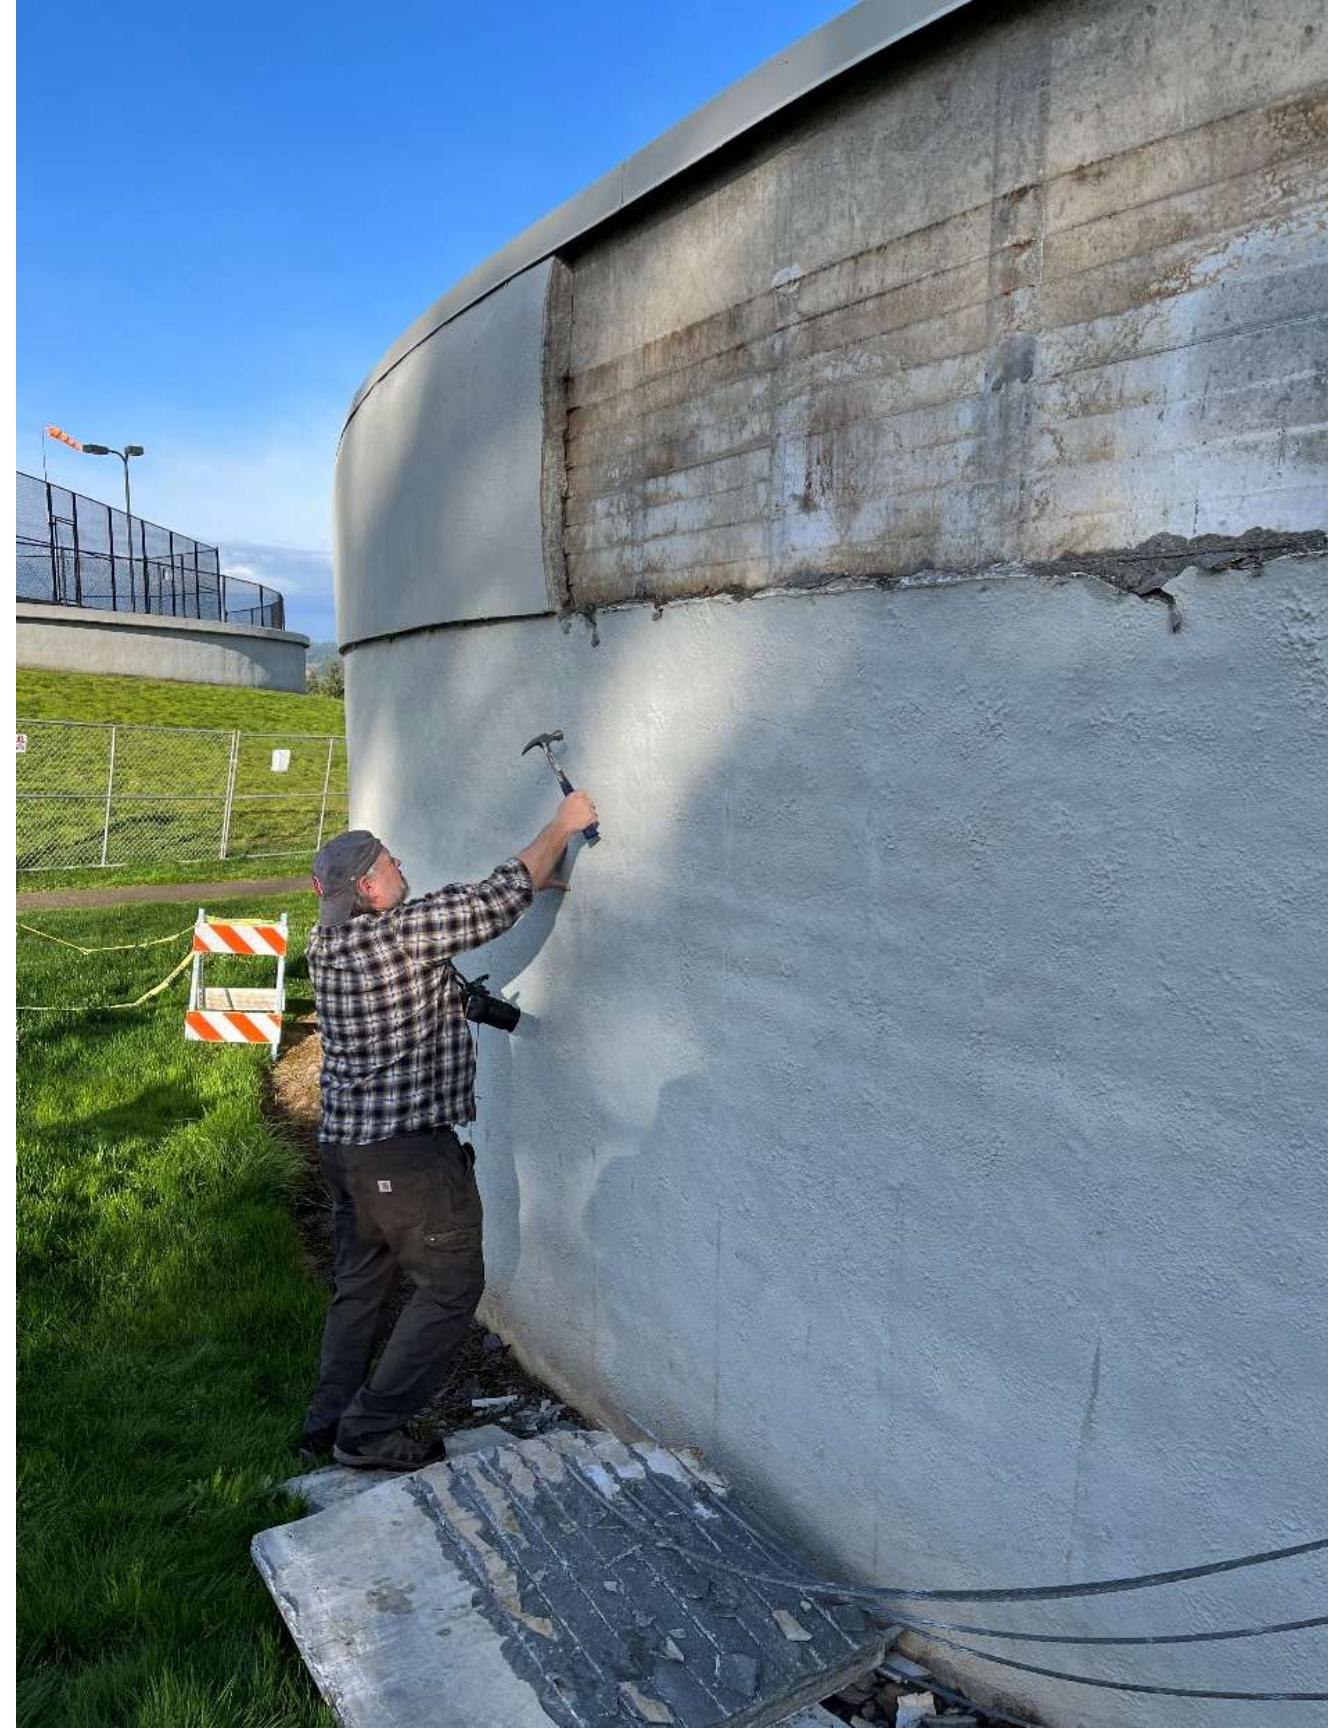
- Issues only in the architectural relief band
- Assessed the rest of the shotcrete
- Rest of shotcrete appeared to be in good shape

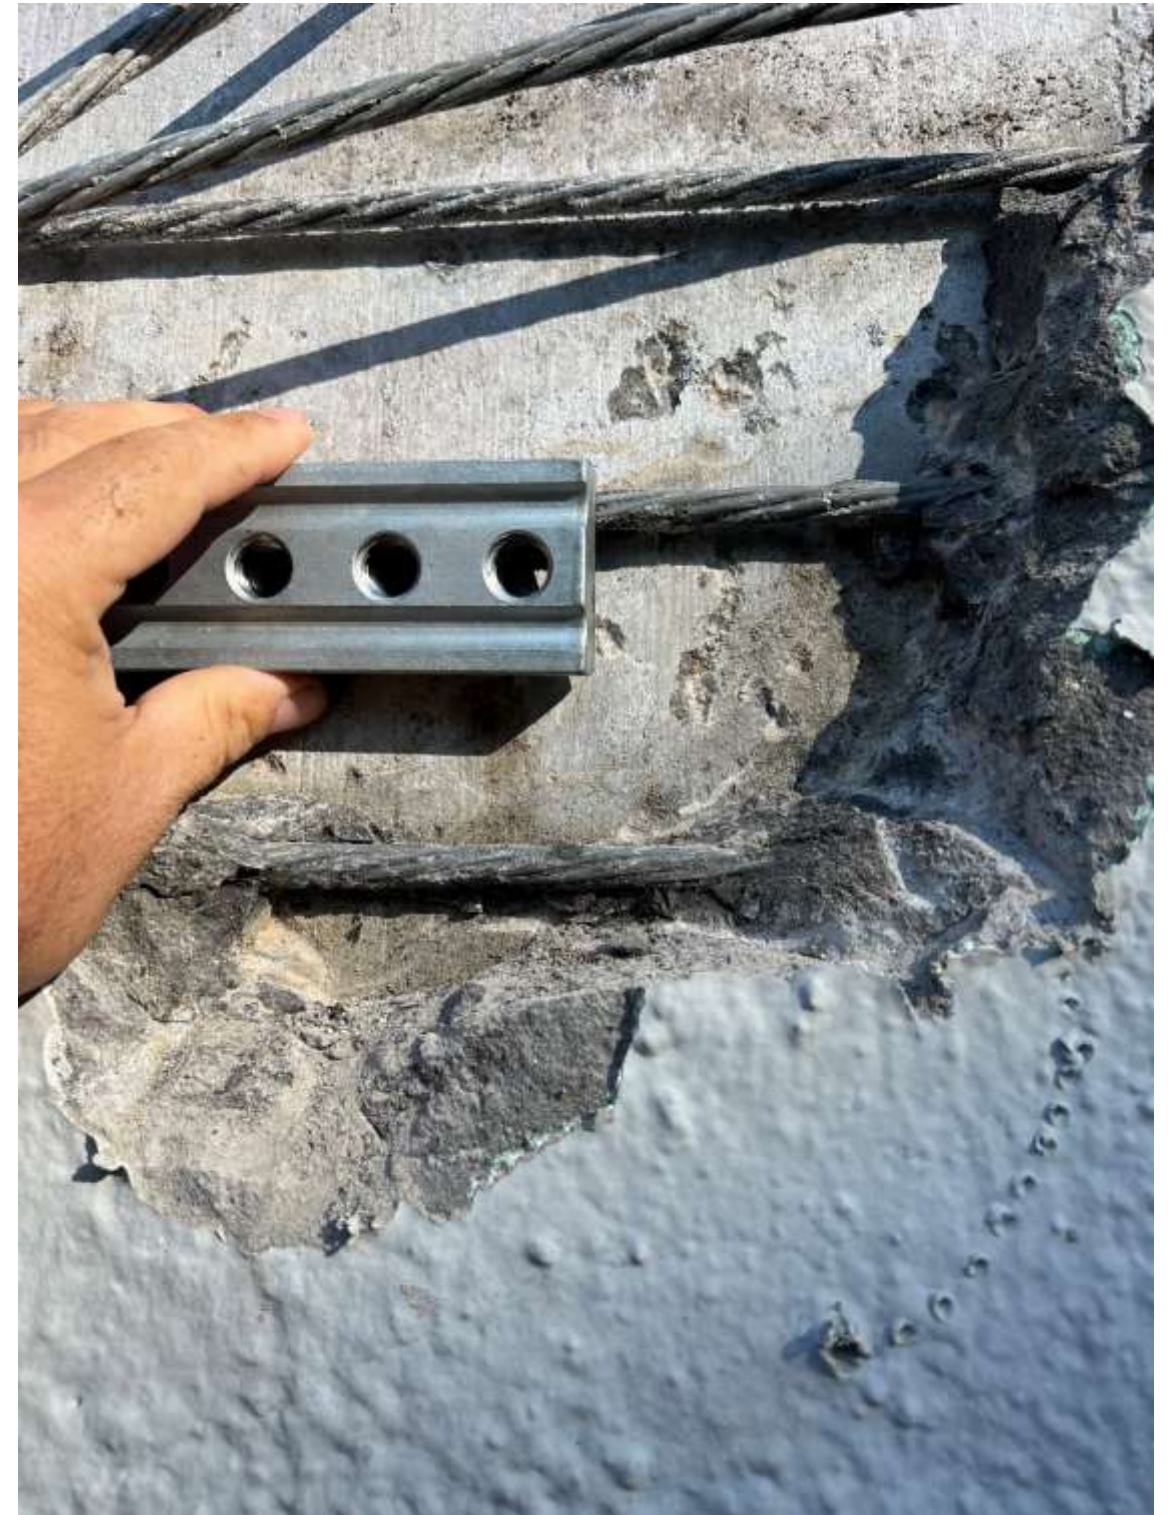
- In mid-March we Contacted DN tanks to discuss concepts and detailing for the repairs
- City contracted with DN in late April and they assisted with the assessment
- As part of the analysis DN checked condition of strands in lower shotcrete section – early May
- Chipped windows in shotcrete at 4 locations
- Strands and shotcrete were in good condition

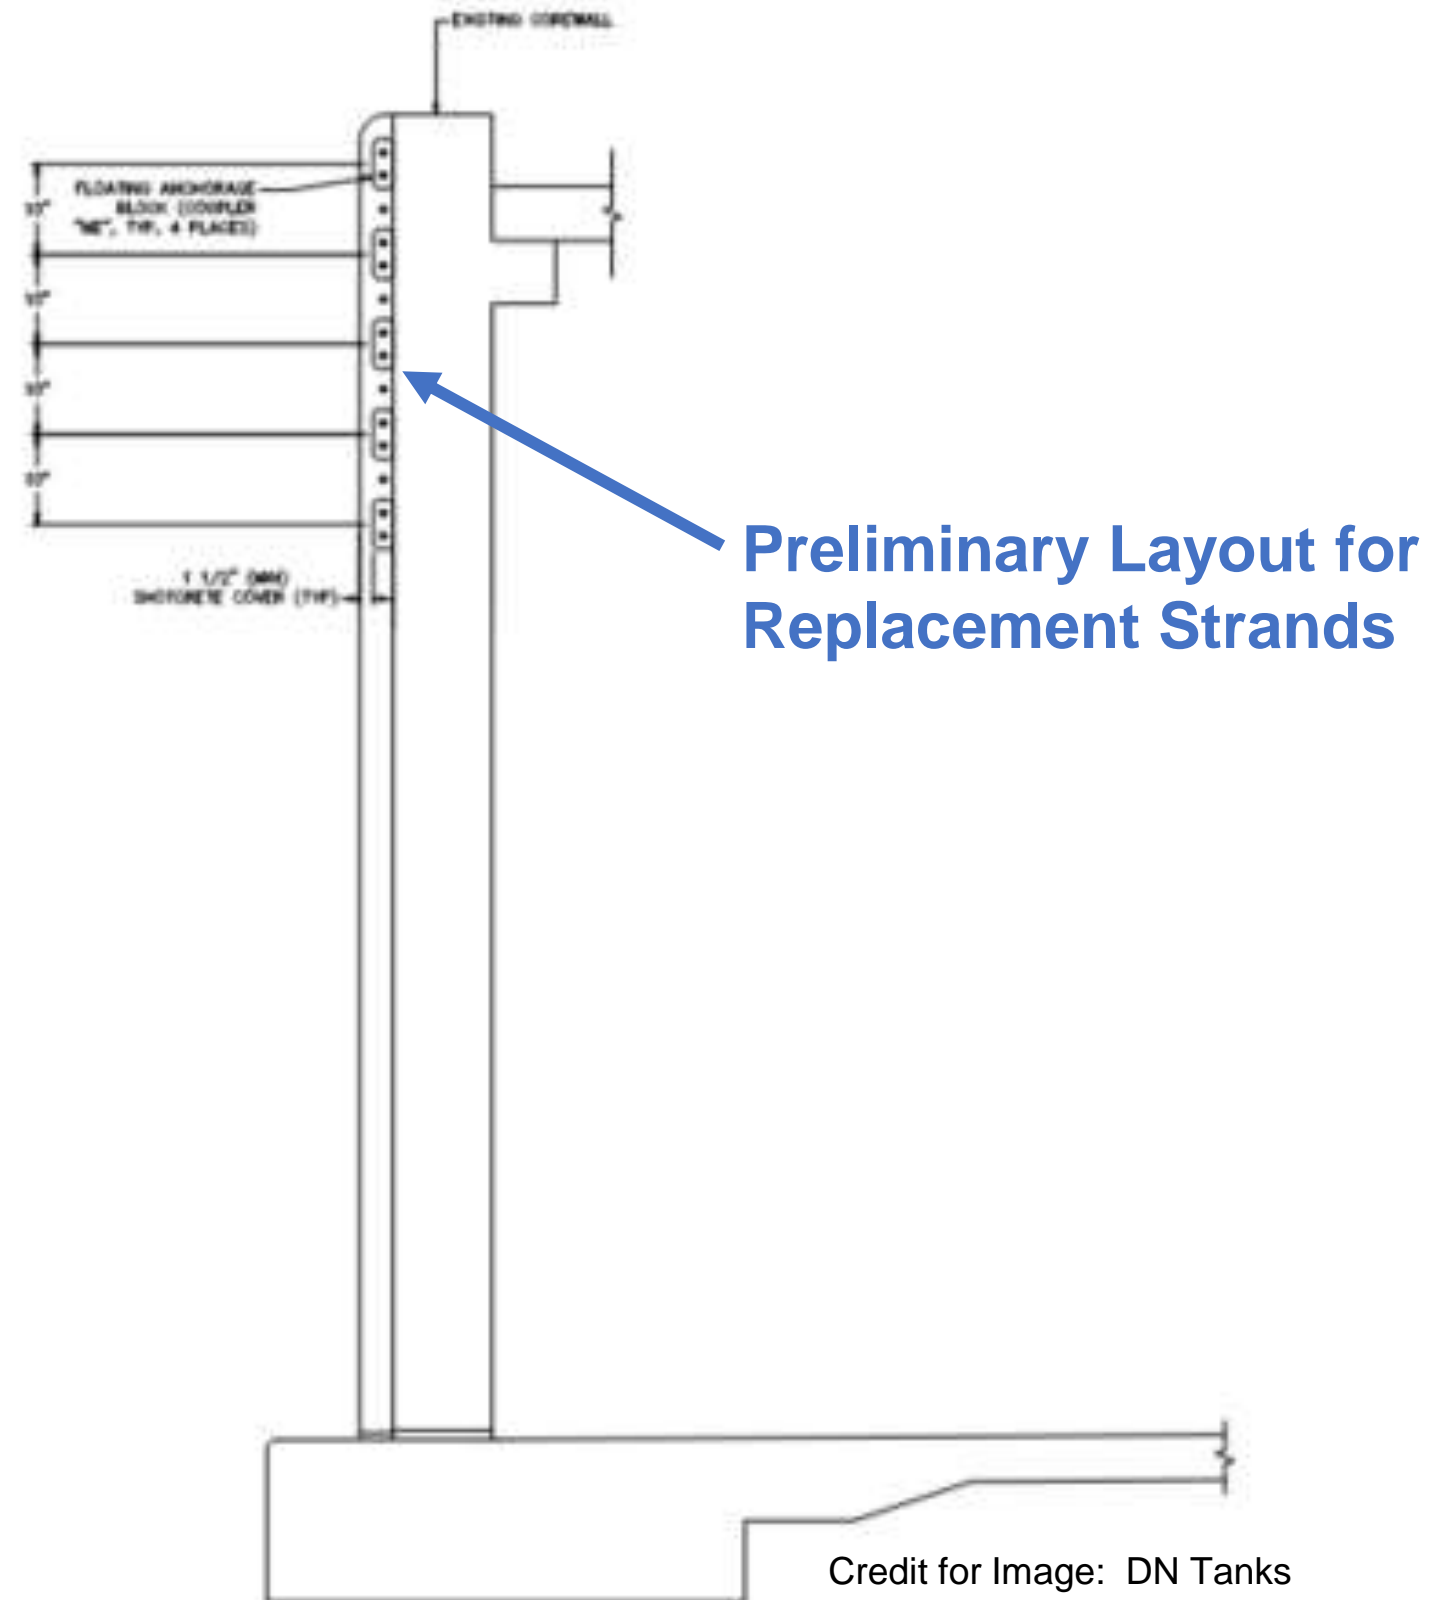
- Conducted analysis of the tank without the top strands
- ASCE 7 AND ACI 350.3R Standards
- Found it was still structurally sound
- Water level needed to be dropped
- Allowed the City to keep the reservoir in operation
