Drinking Water Pipeline Condition Assessment: Part 2

*PNWS-AWWA Conference – Spokane, WA
May 10, 2013*

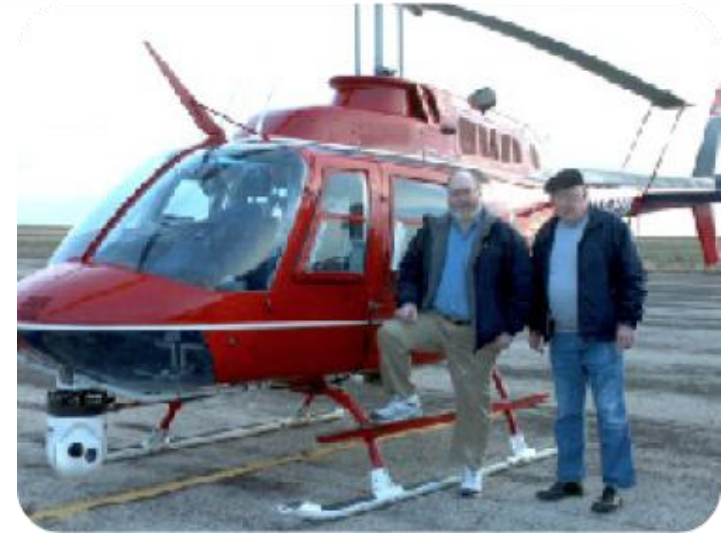
Infrared Thermal

- Thermographic Imaging
 - Provides heat signature images which may indicate leaks in wastewater lines or wastewater effluent discharges
 - Survey level technology
 - No excavation/special access needed

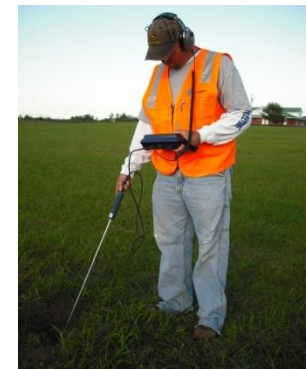
Acoustic Methods: Leak Detection

■ Acoustic Correlator (Echologics)

- Locates leaks along the pipe
- Pipe remains in service
- Works on all pipe sizes/materials

- Does not quantify leak rate

■ Acoustic Microphones

- Does not quantify leak rate
- Background noise can interfere

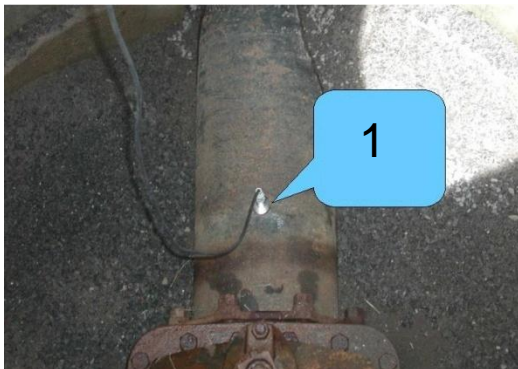
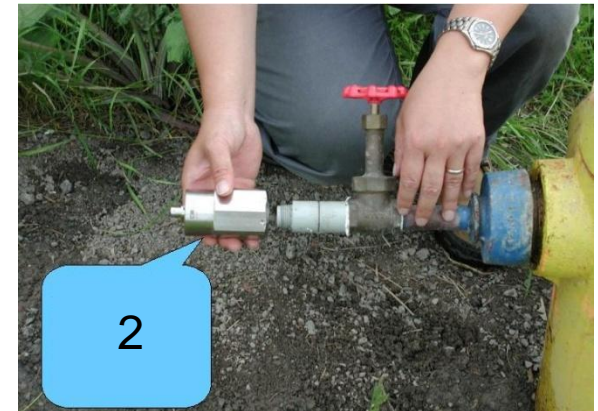
Acoustic Methods: Wall Thickness

■ Acoustic Correlator (Echologics)

- Measures average wall thickness between nodes (stiffness in non-metallic pipes)
- Pipe remains in service
- Works on all pipe sizes/materials

- Does not identify discrete defects
- Minimum amount of measurements for accurate statistical analysis may vary

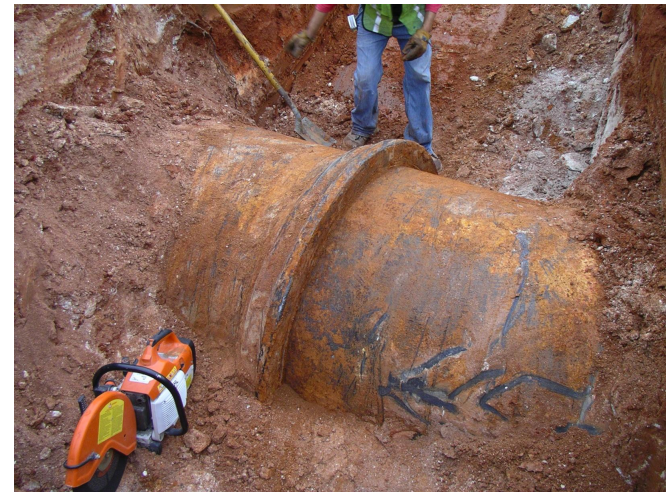
Ultrasonic / Pit Depth Measurement

- Exposure of pipe exterior required
- Difficult to determine localized metal loss inside pipe with ultrasonic
- Most commonly used on metallic pipes

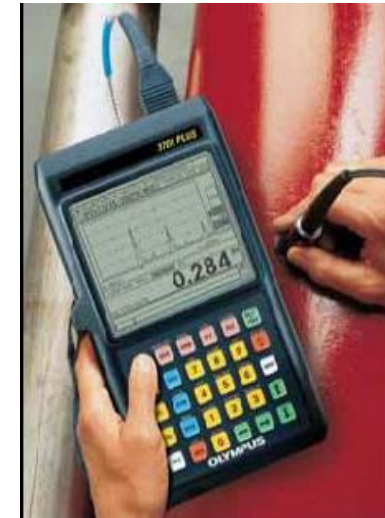
Guided Wave

- Screening of long lengths of pipe
- 100% of pipe wall is inspected
- Detects corrosion in insulated and buried pipes

- Variable Range: 1"-60" and 60-1,000LF
- Exposure of pipe exterior required
- Applies to metallic pipes only

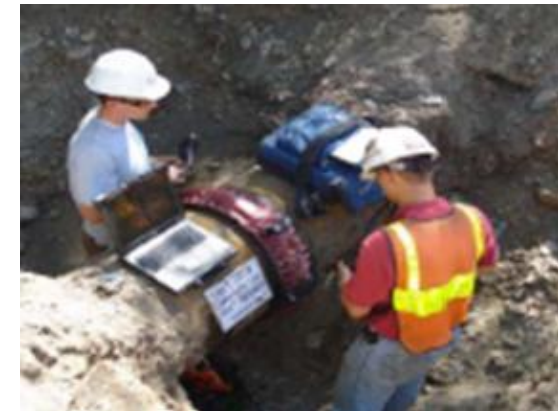
Ultrasonic Transit-time

- Average flow rate
- Frequently used for treated water applications

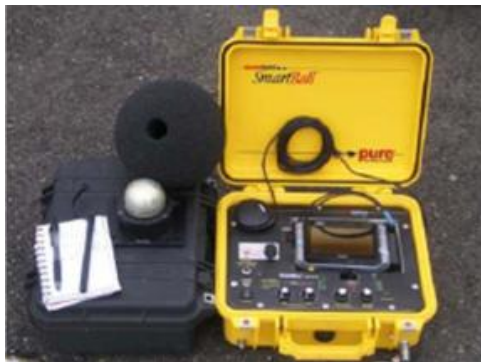
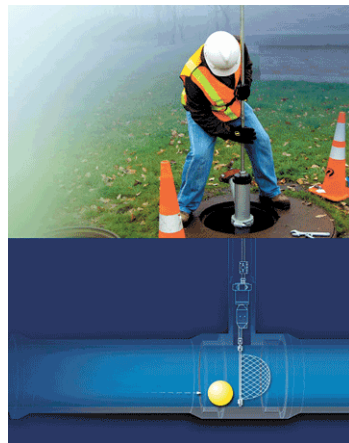
Free-Swimming Internal Hydrophones

■ Pure “SmartBall”

- Locates leaks and gas pockets
- Pipe remains in service
- Works on all pipe sizes/materials +6” (4” access)

- Defect location is approximate
- No pipe wall assessment data

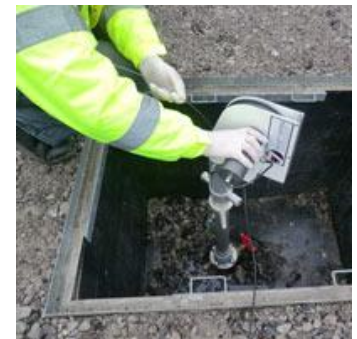
■ JD7 “Bullet”

- Locates leaks
- Pipe remains in service
- Works on all pipe sizes/materials
- Records visual images

- Defect location is approximate
- No pipe wall assessment data
- Tethered system for retrieval

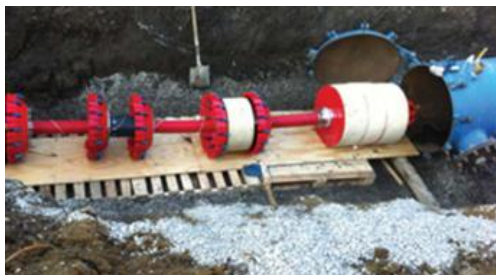
Free-Swimming Electromagnetic

■ PICA SeeSnake (RFT)

- Measures localized wall thickness
- Measures through linings
- Free swimming or tethered

- No leak/gas pocket detection
- Large insertion assemblies required for +24" sizes
- Extensive cleaning required
- Metallic pipe only

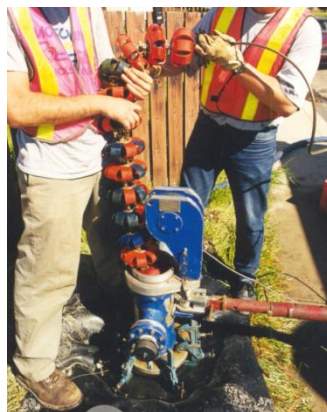
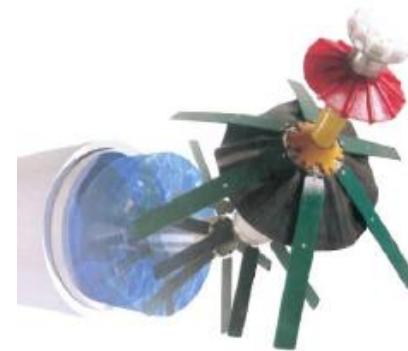
■ Pure PipeDiver

- Locates broken prestressed wires
- Pipe remains in service
- PCCP pipe only, +24"

- Site specific access requirements
- No leak detection *yet*

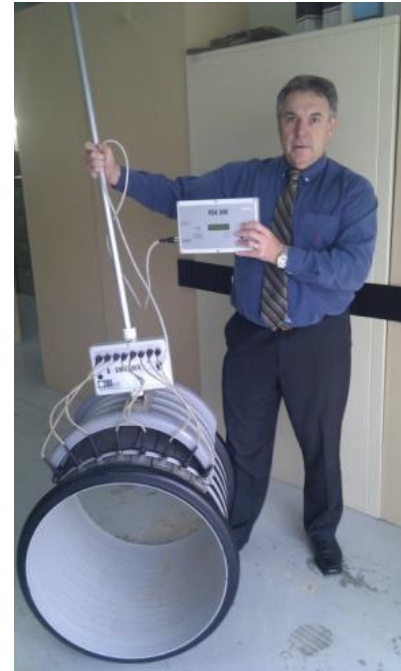
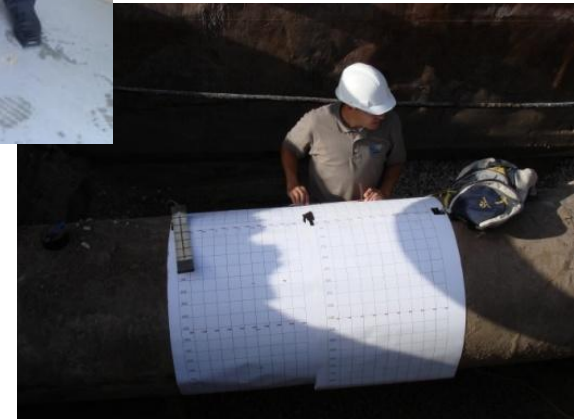
Broadband Electromagnetic

■ External Method

- Measures localized wall thickness
- Pipe may remain in service
- Measures through linings/corrosion

- Ferrous pipe only
- Must expose pipe

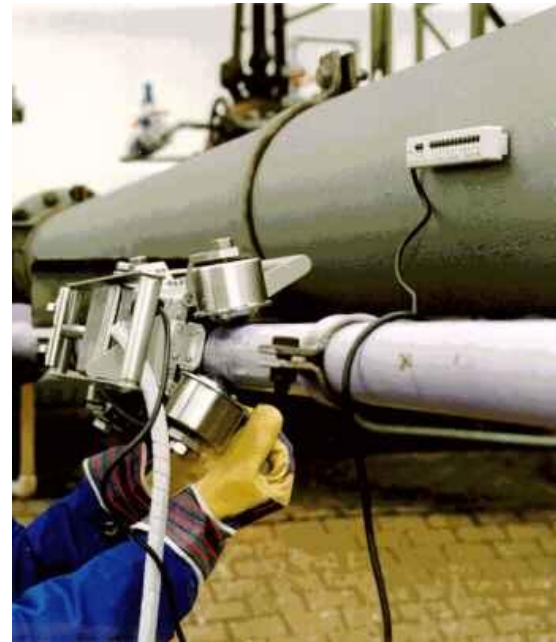
Magnetic Flux Leakage (External)

- Tools available for small and large diameter pipes
- Identifies remaining wall thickness
- Identifies size and location of defects (including pits)

- Excavation of buried pipes and replacement of coating or insulation are required
- Still emerging as technology for water pipelines

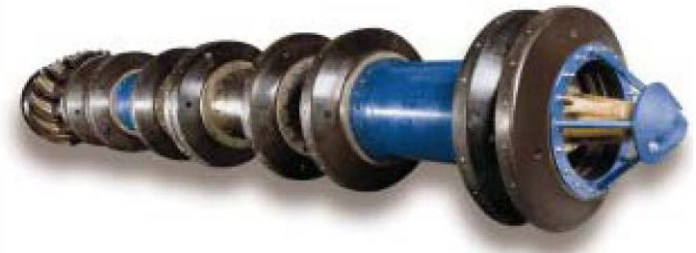
Ultrasonic Pig

- Benefits
 - Measures localized wall thickness
 - Free swimming or tethered
- Limitations
 - No leak/gas pocket detection
 - Cannot measure through linings
 - Large insertion assemblies required
 - Extensive cleaning required
 - Ferrous pipe only

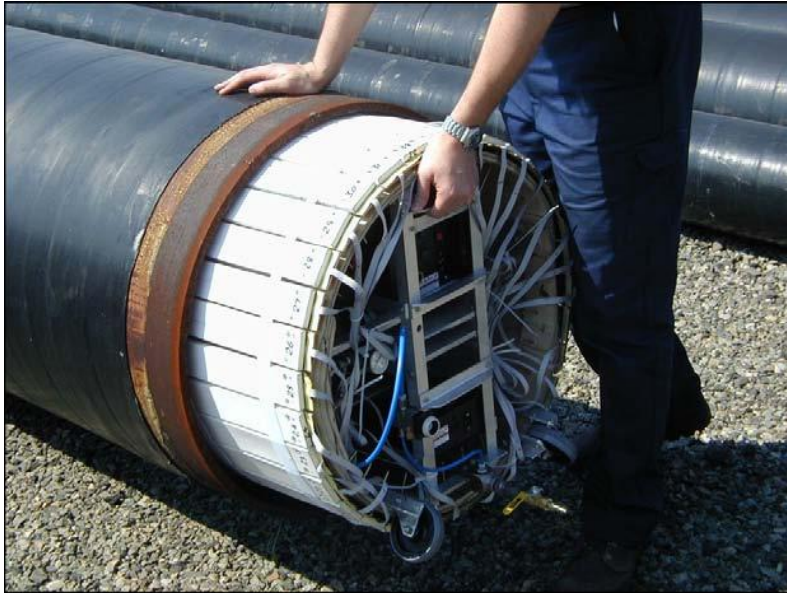
Broadband Electromagnetic

- Measures localized wall thickness
- Measures through linings/corrosion

- Inspect ferrous pipes as well as metallic components of composite pipes
- Detect broken wires
- Measure corrosion pits
- Direct contact with pipe wall not required

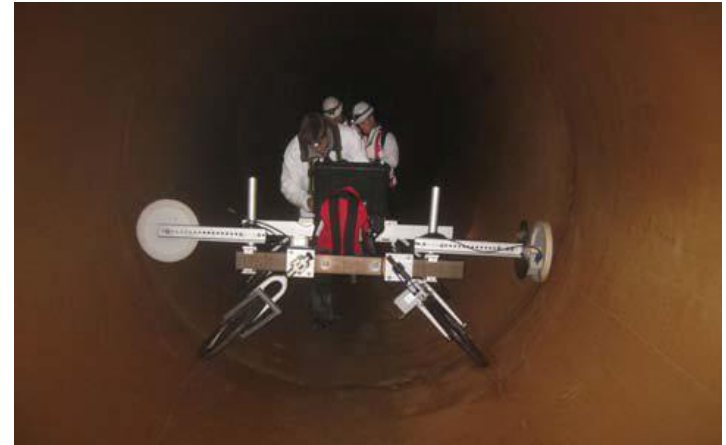
Remote Field Eddy Current

- Data interpretation needs experience and skill
- Some tools require pipe cleaning and/or dewatering before inspection

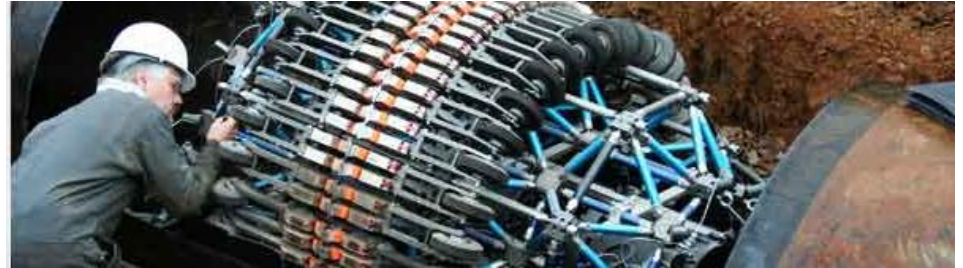
Magnetic Flux Leakage

- Precise comprehensive inspection
- Identifies remaining wall thickness
- Identifies size and location of defects (including pits)

- Pipe must be dewatered, and cleaned (some exceptions)
- Still emerging as technology for water pipelines
- Ferrous pipes only
- High cost

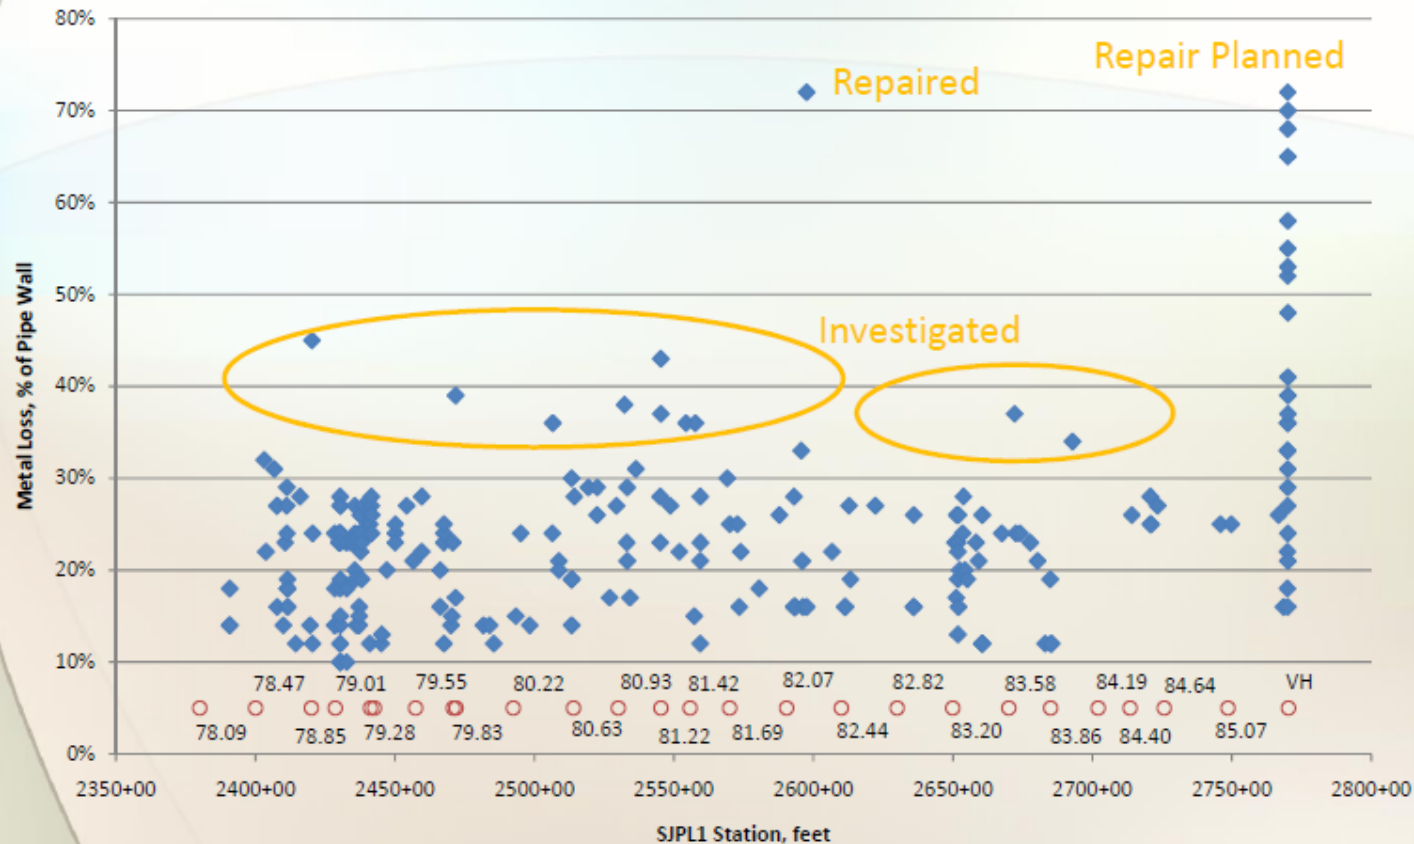
Magnetic Flux Leakage INI Hetch Hetchy Case Study Accuracy

Actions at Locations of Metal Loss

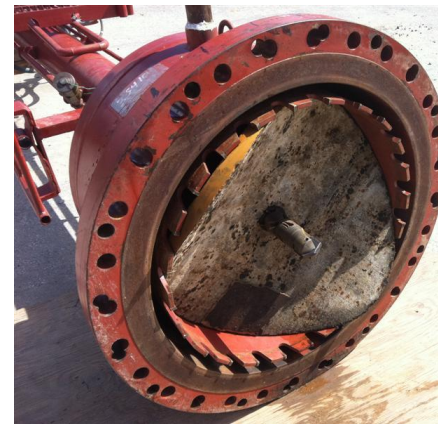
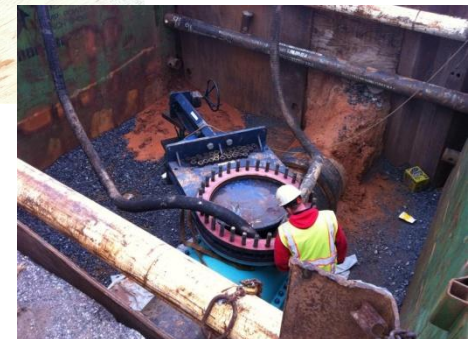
Echologics – Case Study Accuracy

- 60” Cast Iron Fire Water Pipeline
 - Combination of acoustic PIT and sample measurements increased statistical confidence

Data Set	Number of Samples	Average Wall Thickness	Confidence Interval	Upper Limit	Lower Limit
Echologics	14	1.44”	0.161”	1.60”	1.28”
Coupons and Corrosion Pits	31	1.36”	0.056”	1.42”	1.31”
Combined Data	45	1.39”	0.063”	1.45”	1.32”

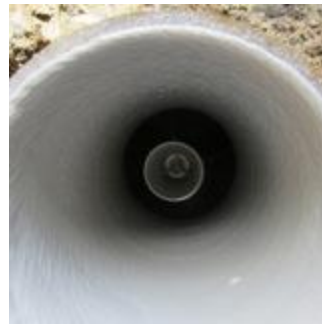
Spray Applied Liners

Principal Advantages	Principal Disadvantages	Features
<ul style="list-style-type: none">• Semi-structural.• No large scale disruption compared to PE slip lining.• Excellent abrasion resistance.• Long-term corrosion protection material.• Usually bypass service is not required.	<ul style="list-style-type: none">• Semi-structural• Easier leakage detection on metal pipes.• Recommended for pipes prone to local damage and well suited for local host pipe damage.	<p>Materials:</p> <ul style="list-style-type: none">• Polyurethane• Polyurea• Epoxy• Polymeric <p>Specifications:</p> <p>NSF/ANSI Standard 6 AWWA M28 Class 3 Rehabilitation technology</p>

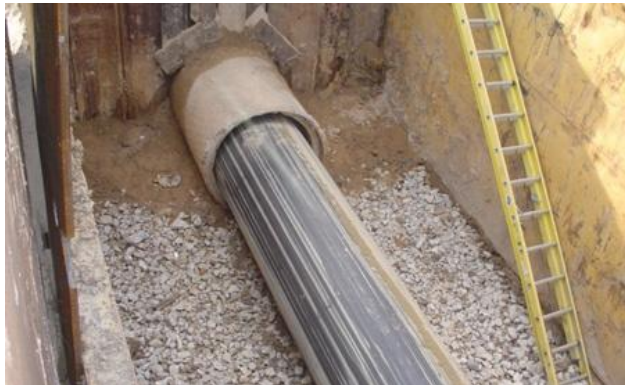
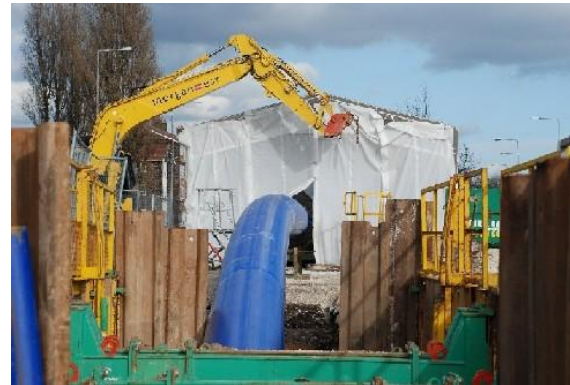
Sliplining

Principal Advantages	Principal Disadvantages	Features
<ul style="list-style-type: none">• Less excavation than open-cut• Designed for full structural pipe• Extensive history of successful installations	<ul style="list-style-type: none">• Limitation for grade changes and curved alignments• Requires robust excavation pit• Removal of structural obstructions and heavy debris• Reduction of effective inside pipe diameter• Quality control of grout operation	<p><u>Materials:</u></p> <ul style="list-style-type: none">• HDPE• PVC• GRP <p><u>Specifications:</u></p> <p>ASTM D3262; D4161; F1803; D1784; D3212; F477</p> <p>AWWA M45</p>

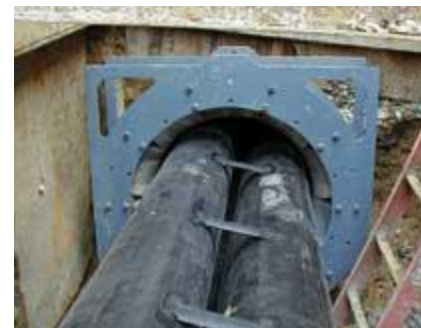
Fold & Form

Principal Advantages	Principal Disadvantages	Features
<ul style="list-style-type: none"> • Rapid installation • Continuous pipes • Maximizes capacity • No excavation • Grouting not required • Internal lateral re-connection 	<ul style="list-style-type: none"> • Plastic alloy – not full composite pipe • HDPE version has thermal expansion considerations • Does not correct lateral defects or sags • Point repairs required prior to inst • Relies on existing pipe for installation support • Lateral locations must be located exactly • Cannot be used high flow temperatures 	<p>Materials</p> <p>PVC</p> <p>HDPE</p> <p>Standards:</p> <p>ASTM F1216; F1504; F1867; F1871</p>

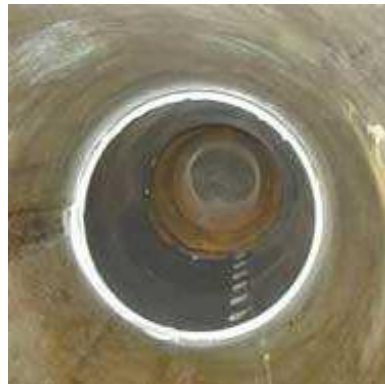
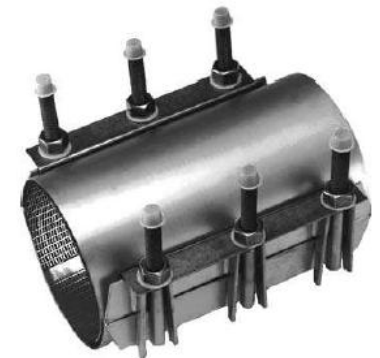
Spot Repairs

Principal Advantages	Principal Disadvantages	Features
<ul style="list-style-type: none">• Focused on isolated problems• Internal and external solutions are available• Minimizes surface disruptions• Optimizes rehabilitation construction costs• Structural and hydraulic repairs	<ul style="list-style-type: none">• May require limited excavation for certain types/locations of defects• Costly• Does not fix entire pipe	<p>Materials: All pipe materials</p> <p>Specifications: ASTM Various AWWA M11</p>

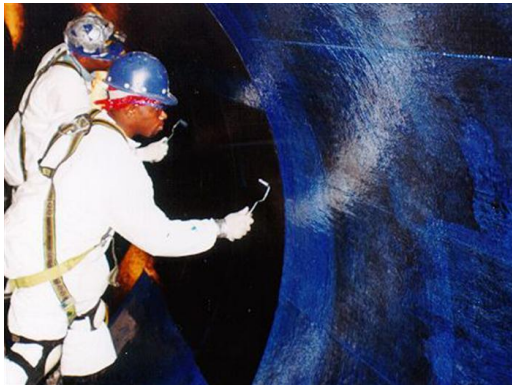
Carbon Fiber Wrap

Principal Advantages	Principal Disadvantages	Features
<ul style="list-style-type: none">•Structural rehabilitation•Can increase pipeline strength above original design•Corrosion protection•Minimal loss of flow capacity	<ul style="list-style-type: none">•Limited to sectional repairs as cost can be high•Requires highly trained and experienced technicians•Extensive surface preparation•Best suitable for pipe sections with no fittings.•30 through 201 inches and above•50 psi to 350 psi	<p><u>Materials:</u> Layers of carbon fibers and glass fibers, epoxy</p> <p><u>Specifications:</u> ANSI/NSF 61 certified, but no standardized design guides yet</p>

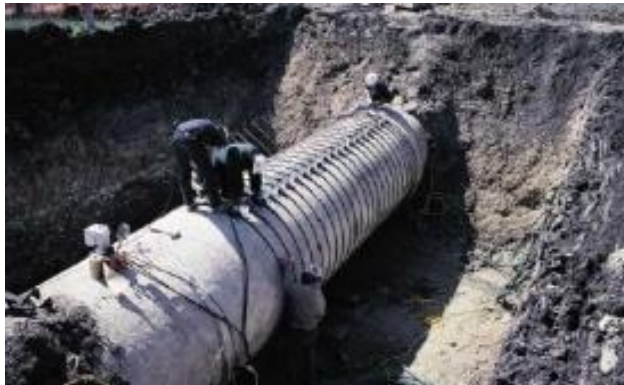
External Reinforcing

Principal Advantages	Principal Disadvantages	Features
<ul style="list-style-type: none">• Pipe can remain in service• Structural repair• Straightforward installation technique• Long track record	<ul style="list-style-type: none">• Damaged pipe segment must be exposed• Does not address defects in steel cylinder (leaks)• Requires additional corrosion protection• Isolated repair only	<p><u>Materials:</u> PCCP</p>

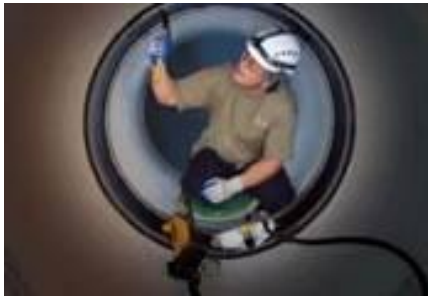
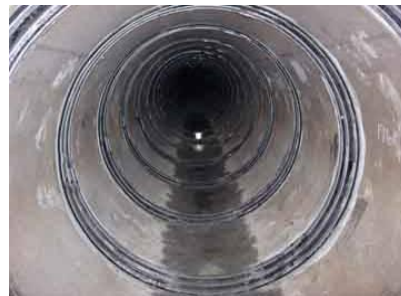
Joint Sealing

Principal Advantages	Principal Disadvantages	Features
<ul style="list-style-type: none">• Seals leaking joints and minor cracks or holes• Prevents soil loss• Low cost due to minimal disruption• Can use with all pipe materials• Hydraulic only	<ul style="list-style-type: none">• Some materials easily damaged during installation• Plastic pipe requires annular space grouting• Does not correct sags• Joint problems on curved pipes• May require person entry• External lateral connection – trenching• Point repairs required prior to some installation	<p>Materials: RCP; VCP; PCCP</p> <p>Specifications: ASTM: Various</p>

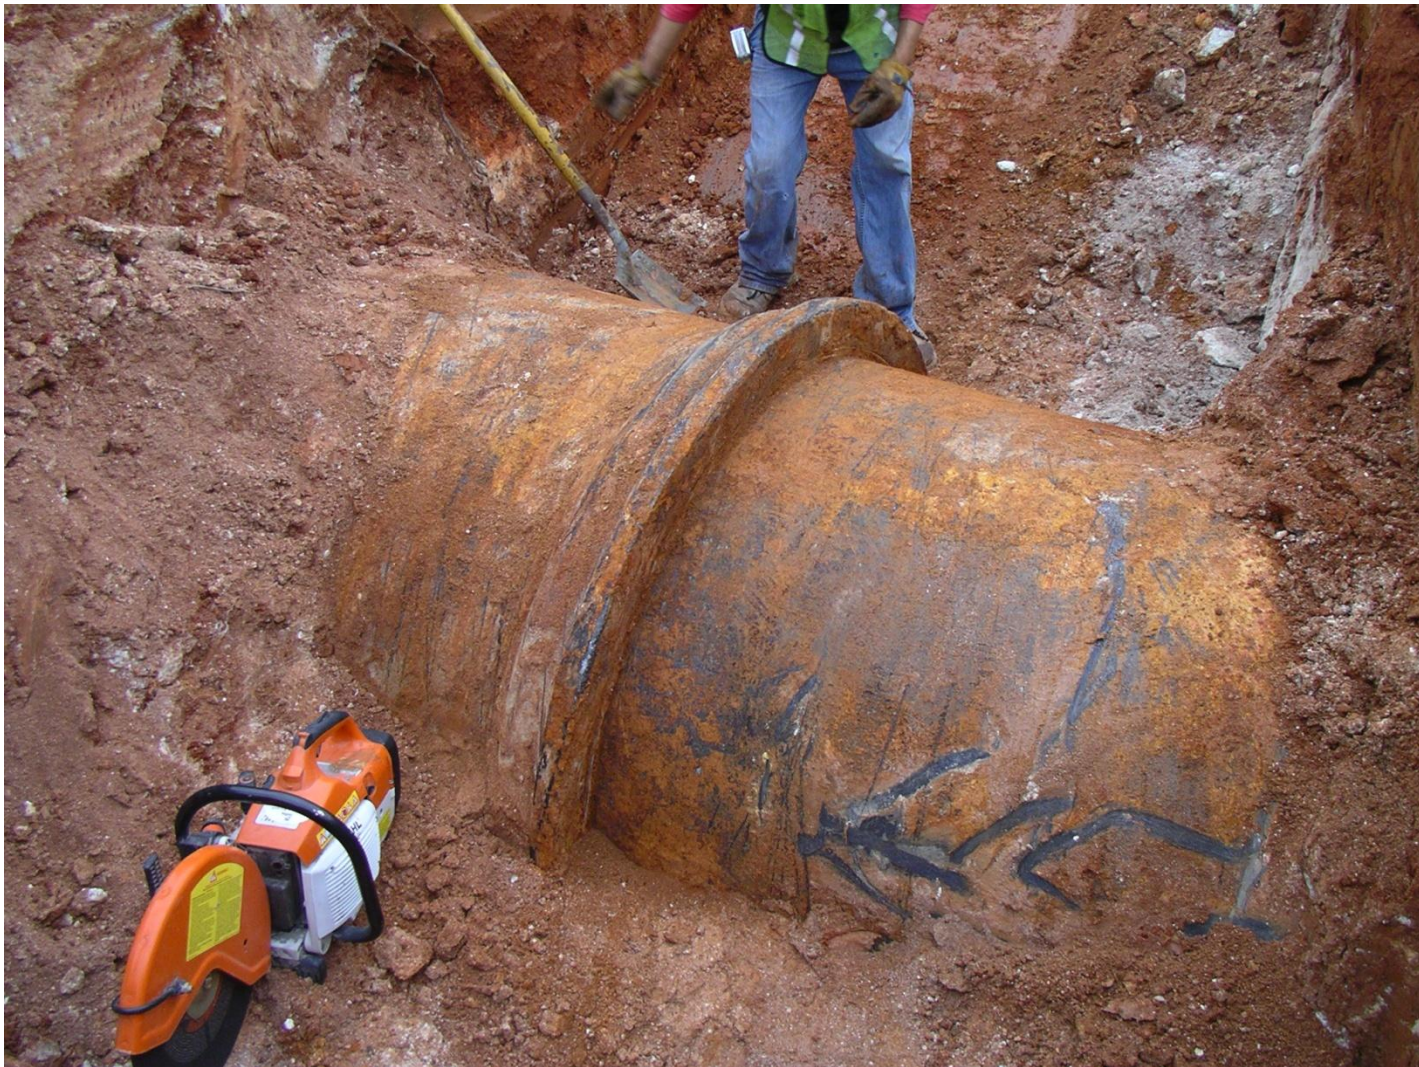
Smart Ball – Case Study Accuracy

- Rock-Tenn 42” RCP Force Main
 - PURE reports leak location to +/- 5 feet, but no leaks found on this force main
 - Smart Ball was inserted, traversed 7,900 LF and was recovered
 - Detected no leakage or trapped gas in pipeline
 - A robot mounted electromagnetic tool did, however, find defective wires in the dewatered RCP during a plant shutdown

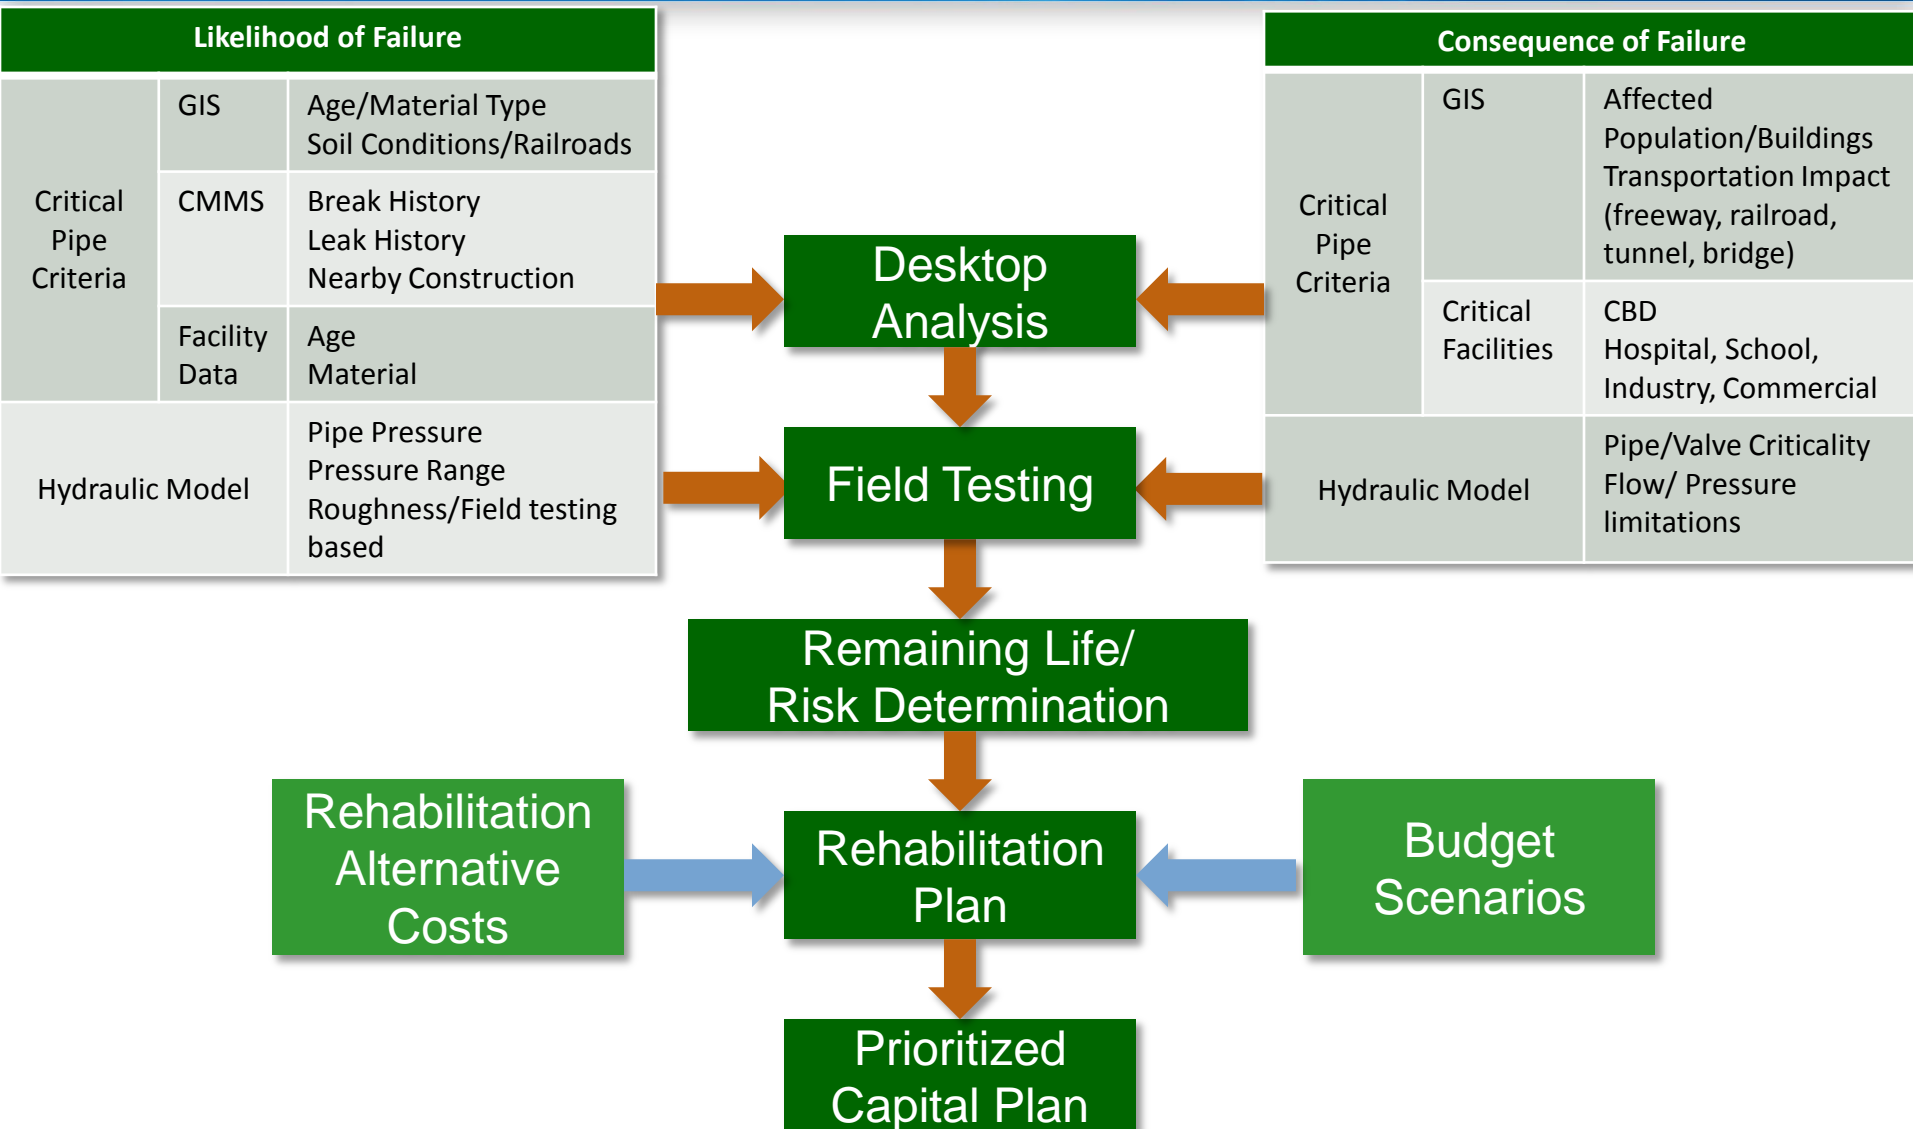
Phased approach provides step-wise process to make the best decisions about rehabilitation
