Algae Monitoring in the Clackamas River Watershed

From monitoring to response.

Clackamas River Water

April 27, 2018

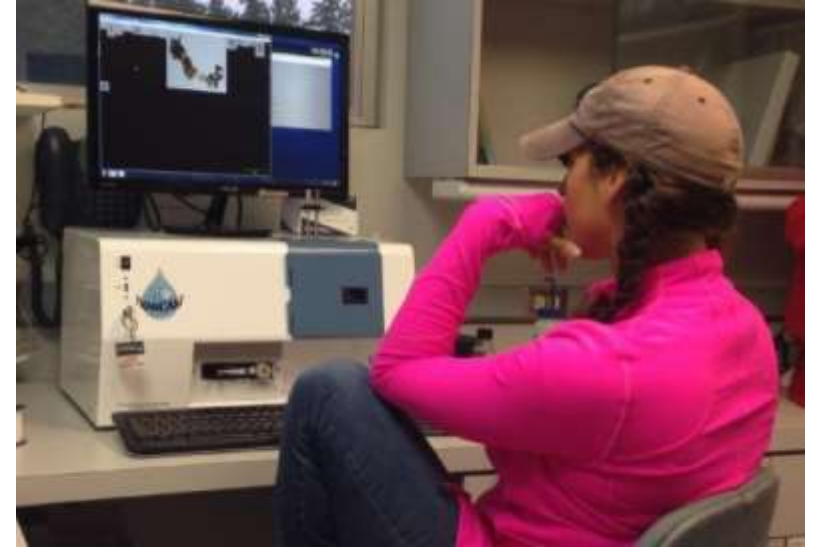
- The instruments CRW uses for algae monitoring allow for the rapid identification and quantification of algae and nutrients in the system.
- Samples are analyzed for dominant species with a Fluid Imaging Technologies FlowCAM (2014).
- Nutrient concentrations (ammonia, nitrate + nitrite, orthophosphate) with an Astoria-Pacific ChemWell-T AutoAnalyzer (2015).

FlowCAM operation at CRW

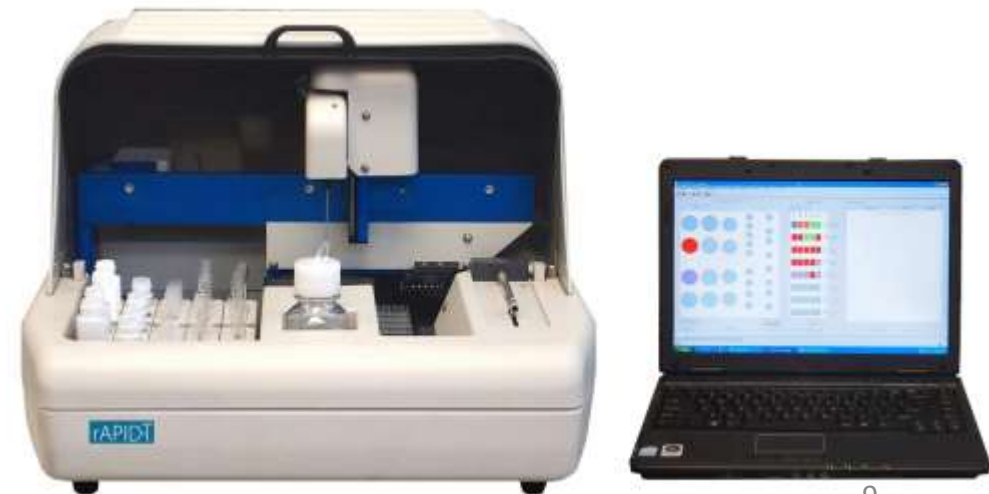
AutoAnalyzer

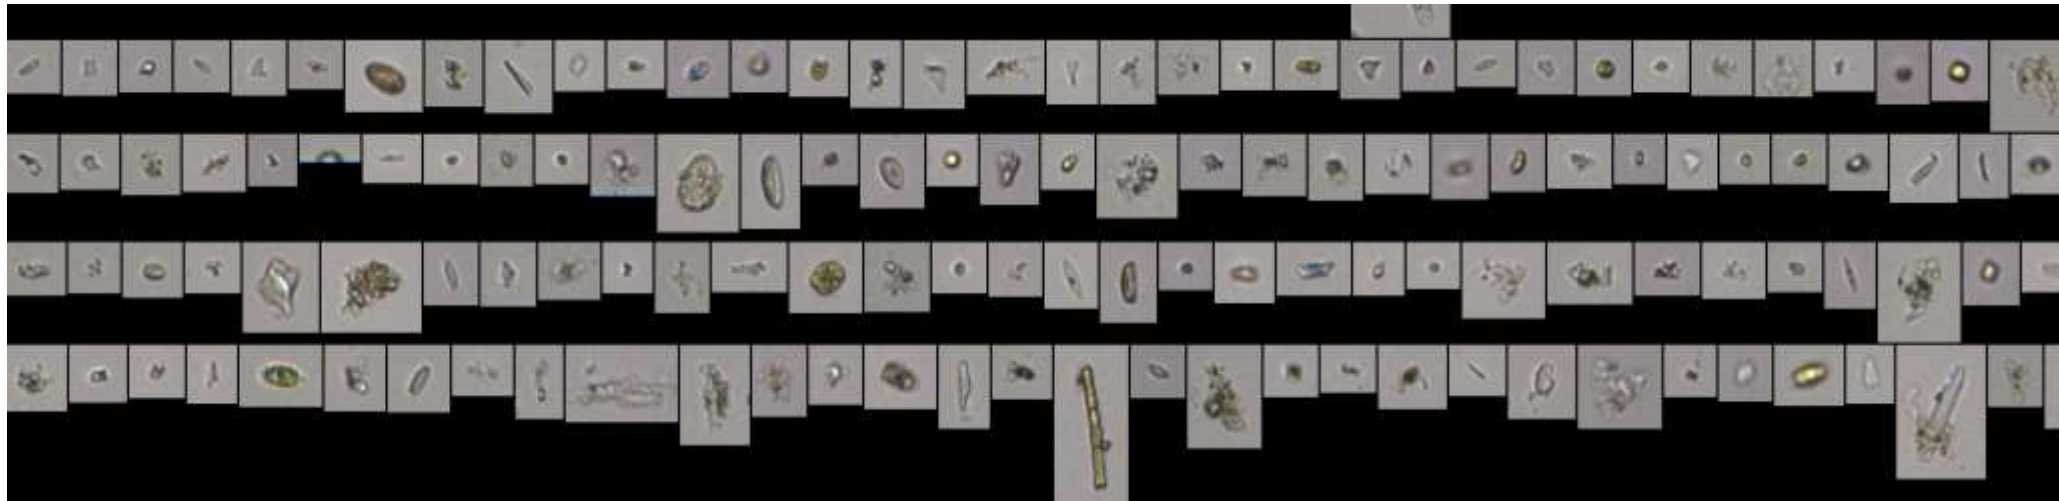
Drinking Water Impacts

- Taste and Odor issues were reported in finished drinking water.
- Were Dolichospermum detected at the drinking water intakes during the bloom period?

— **No.**

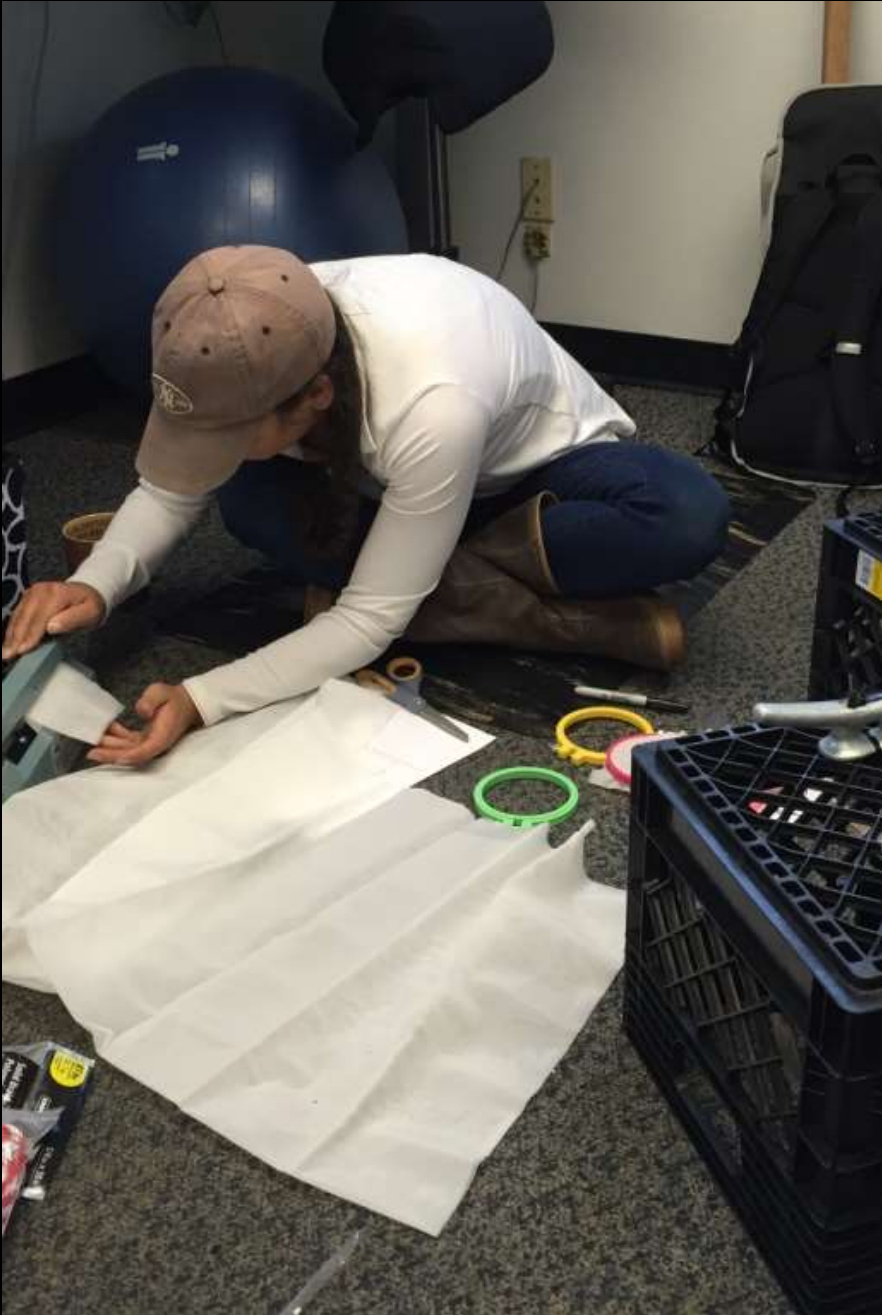
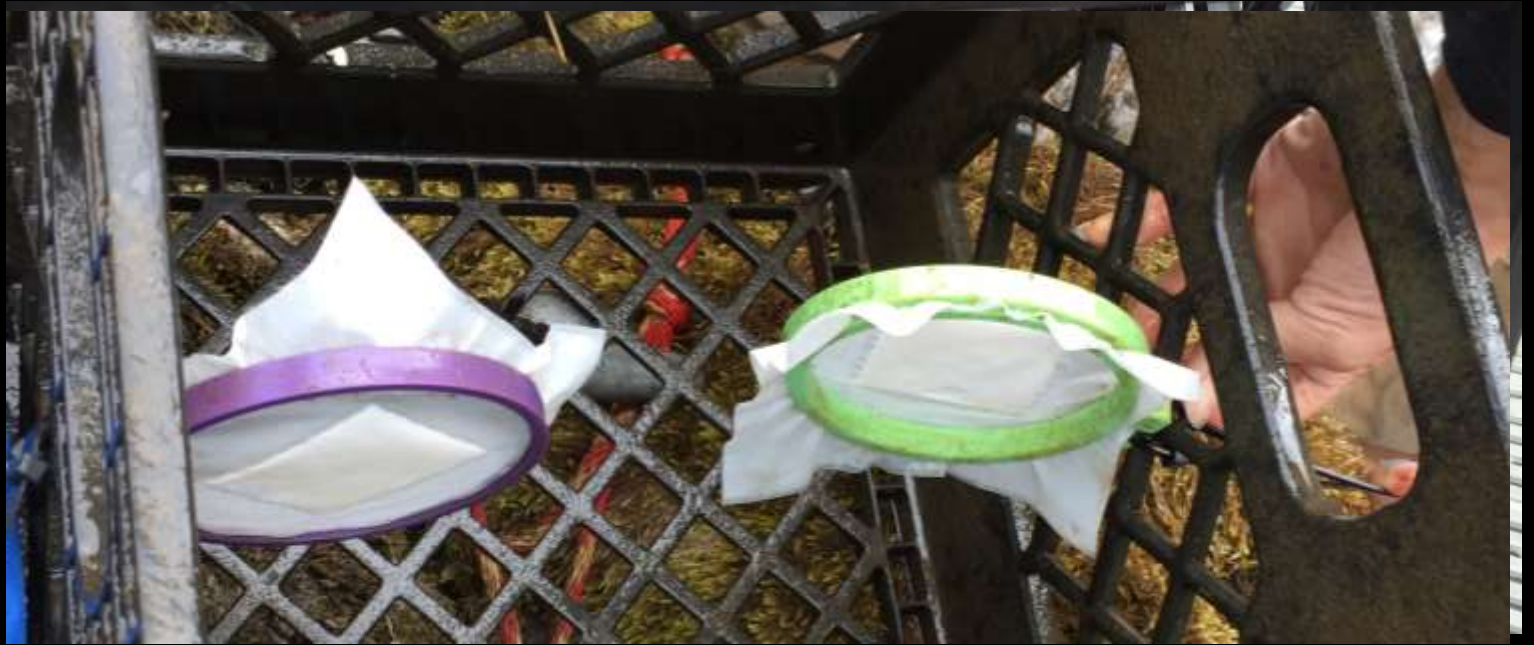
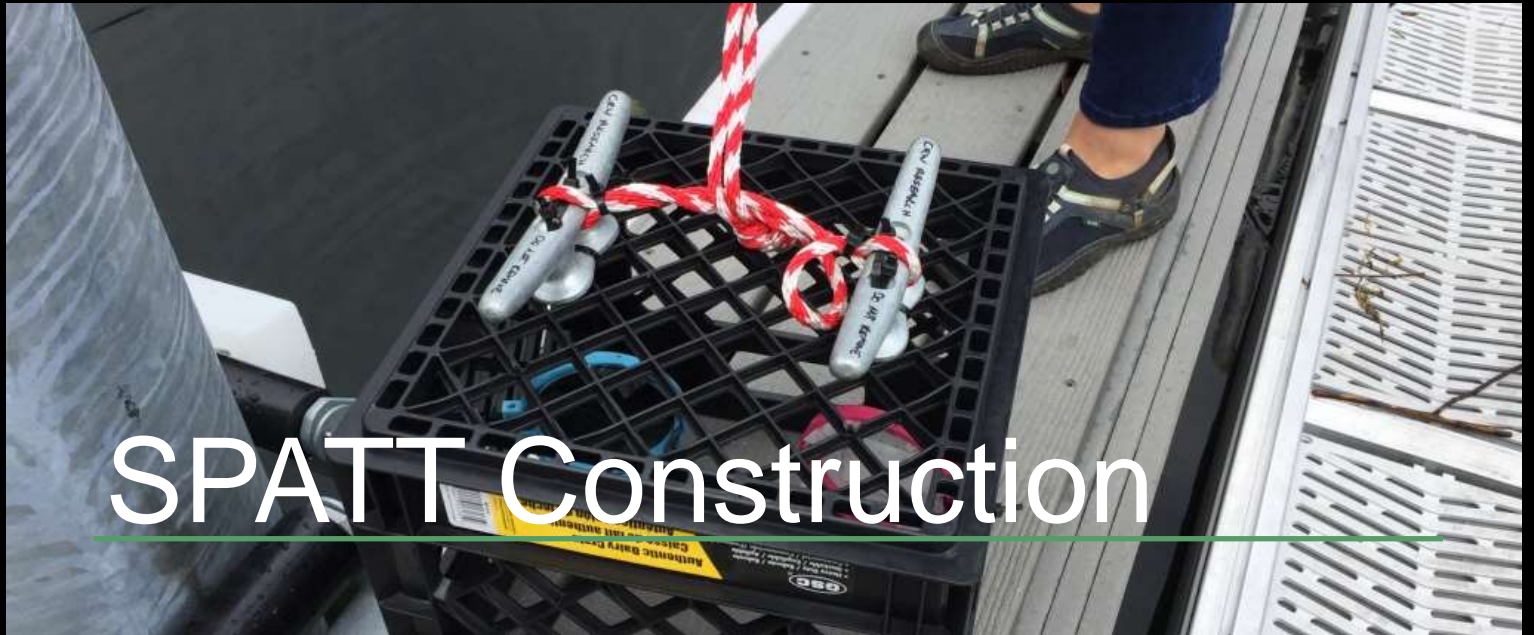
- A simple and sensitive in situ method for monitoring the occurrence of toxic algal blooms.
- Passive adsorption of cyanotoxins onto porous synthetic resin filled sachets (SPATT bags).
 - Qualitative sampling- presence/absence
 - Aggregate of all the toxins passing by over time.
- Followed by extraction with methanol and analysis.

SPATT Construction

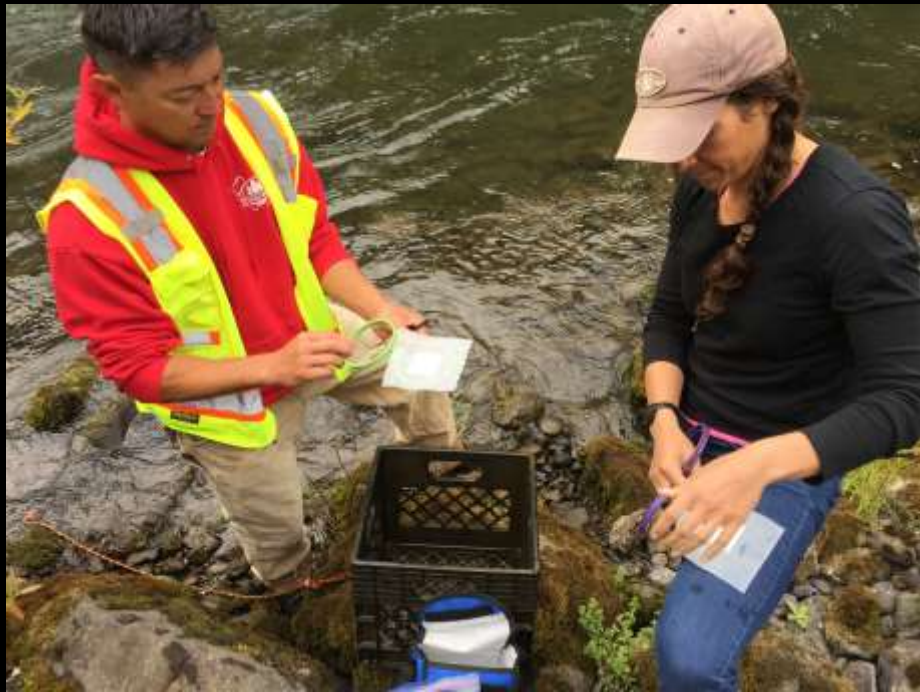
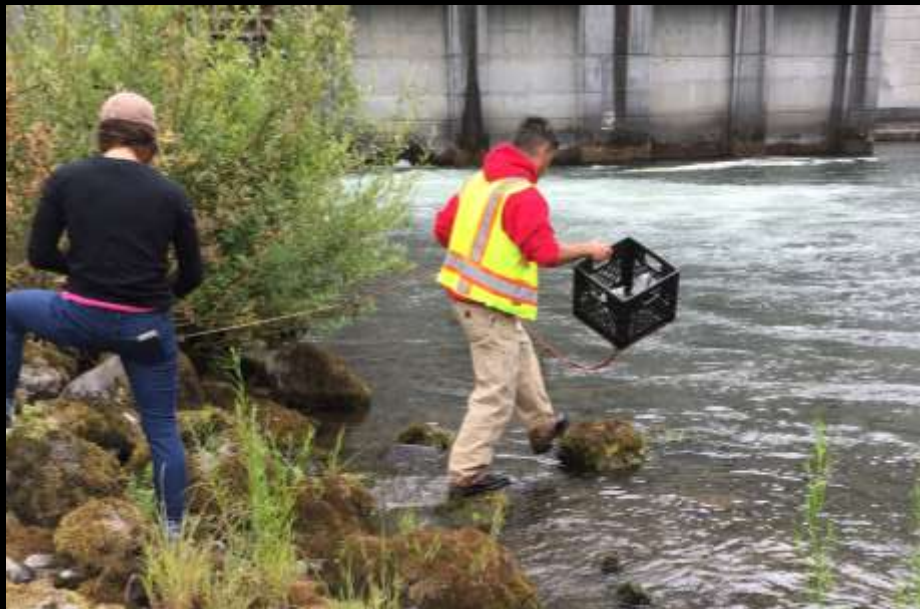
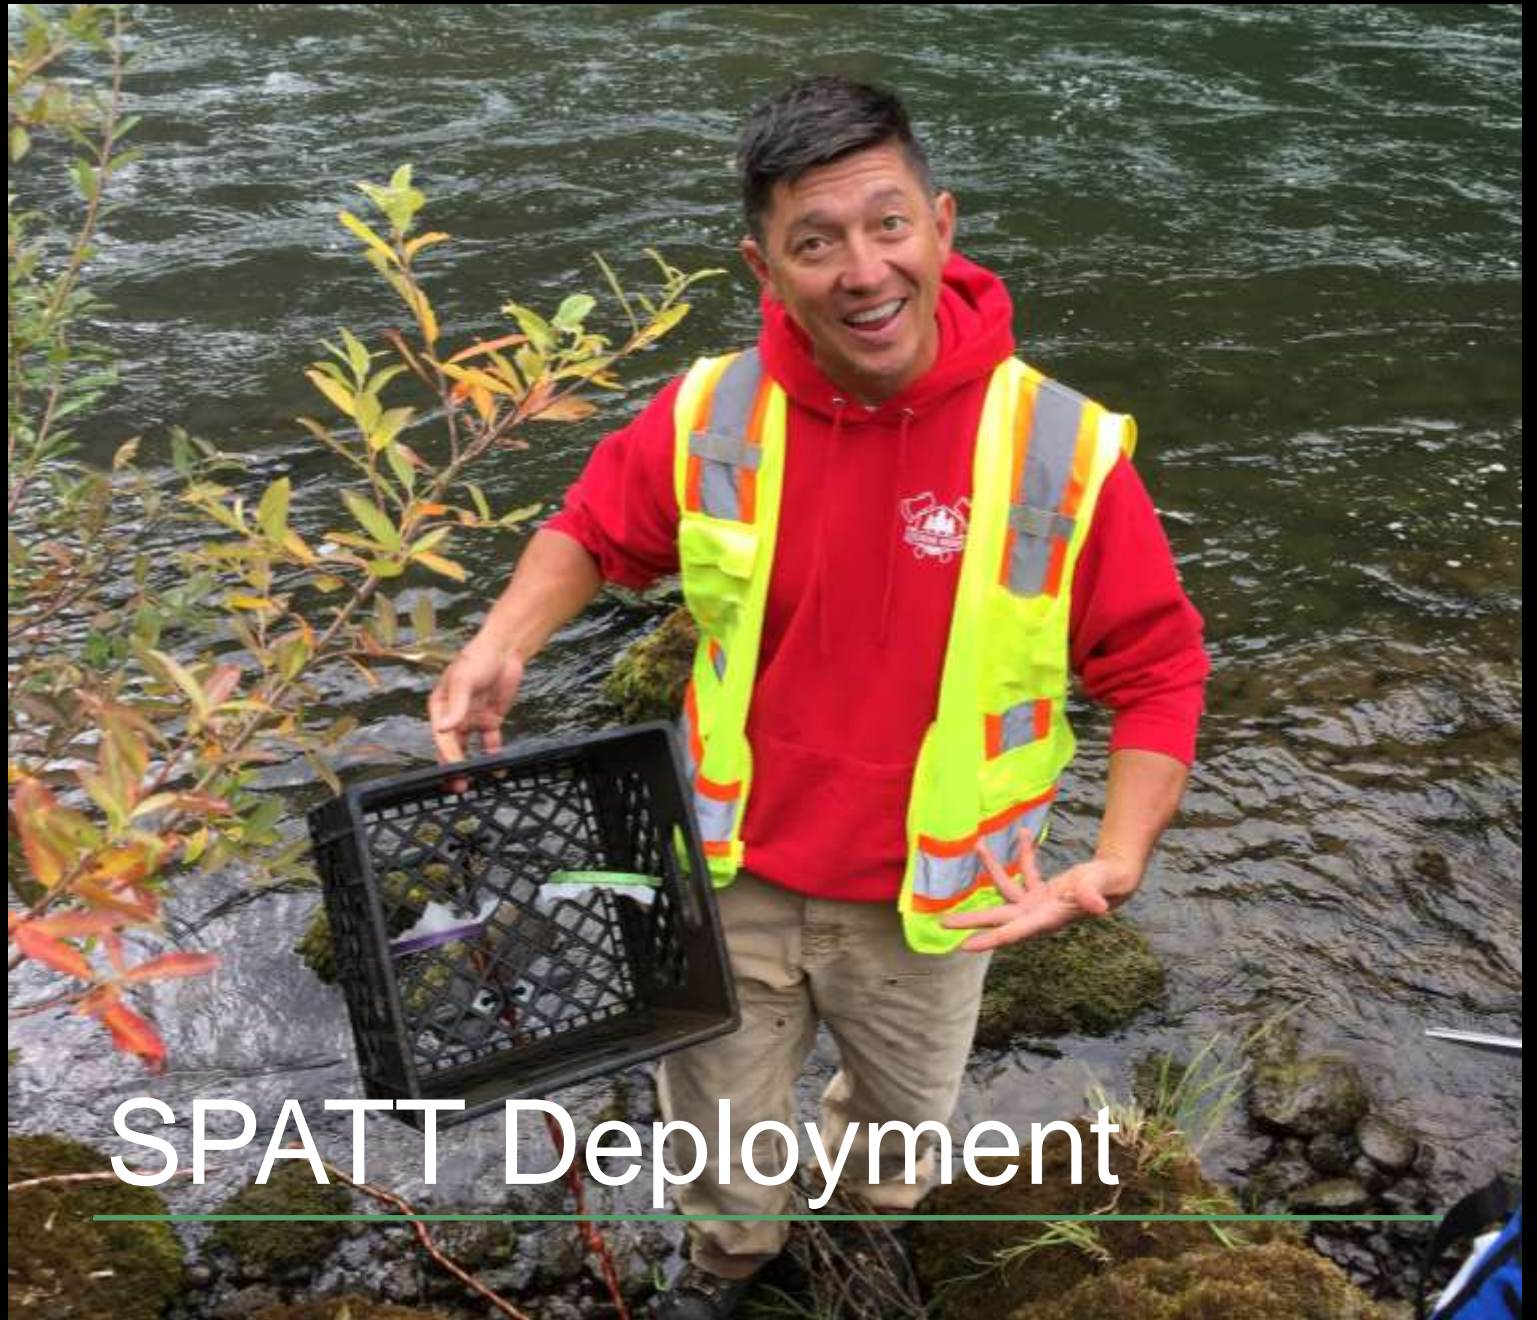
SPATT Deployment

- Low levels of microcystin were detected in SPATT extracts in July 2017 at CRW's intakes.
- No toxins were detected in ANY SPATT extracts in the North Fork Reservoir.
 - No reported blooms at the time.

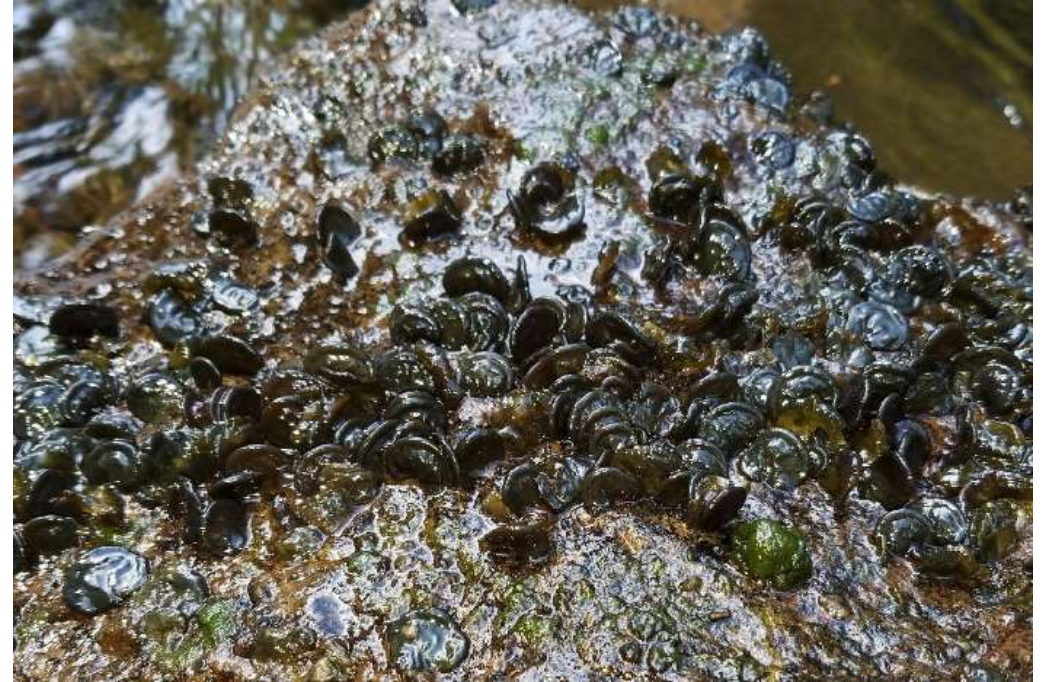
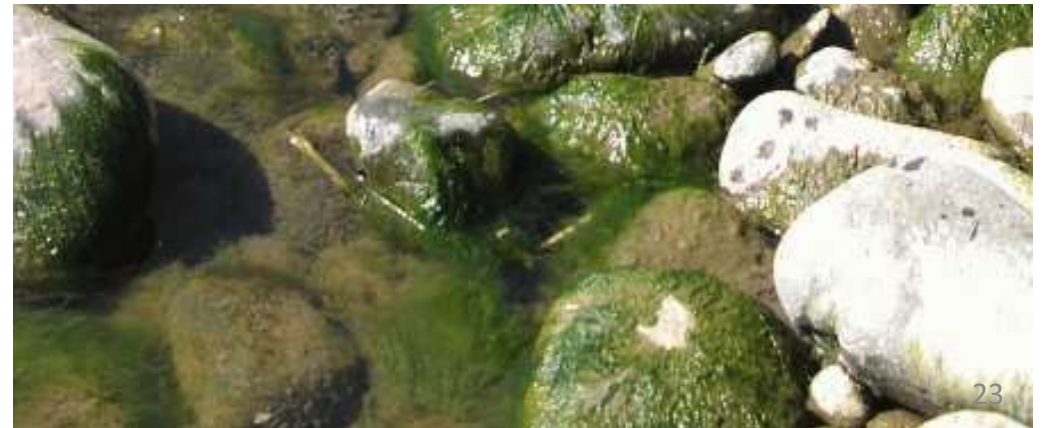
USGS Pilot Study- Benthic “Periphyton” Blooms

- Recent research suggests that periphyton (benthic algae) can produce toxins.
- A preliminary study conducted in 2016 in the Willamette Valley (including the Clackamas Basin) found that many benthic algae samples collected yielded detectable cyanotoxins.

- High percentage of cyanotoxins in benthic colonies.
- Frequent detection of cyanobacteria and cyanotoxins in plankton net tows (in transport).
- Microcystin and Anatoxin-a were detected in 53% of SPATT extracts by ELISA.
 - Microcystin detected in extracts from July 2017.

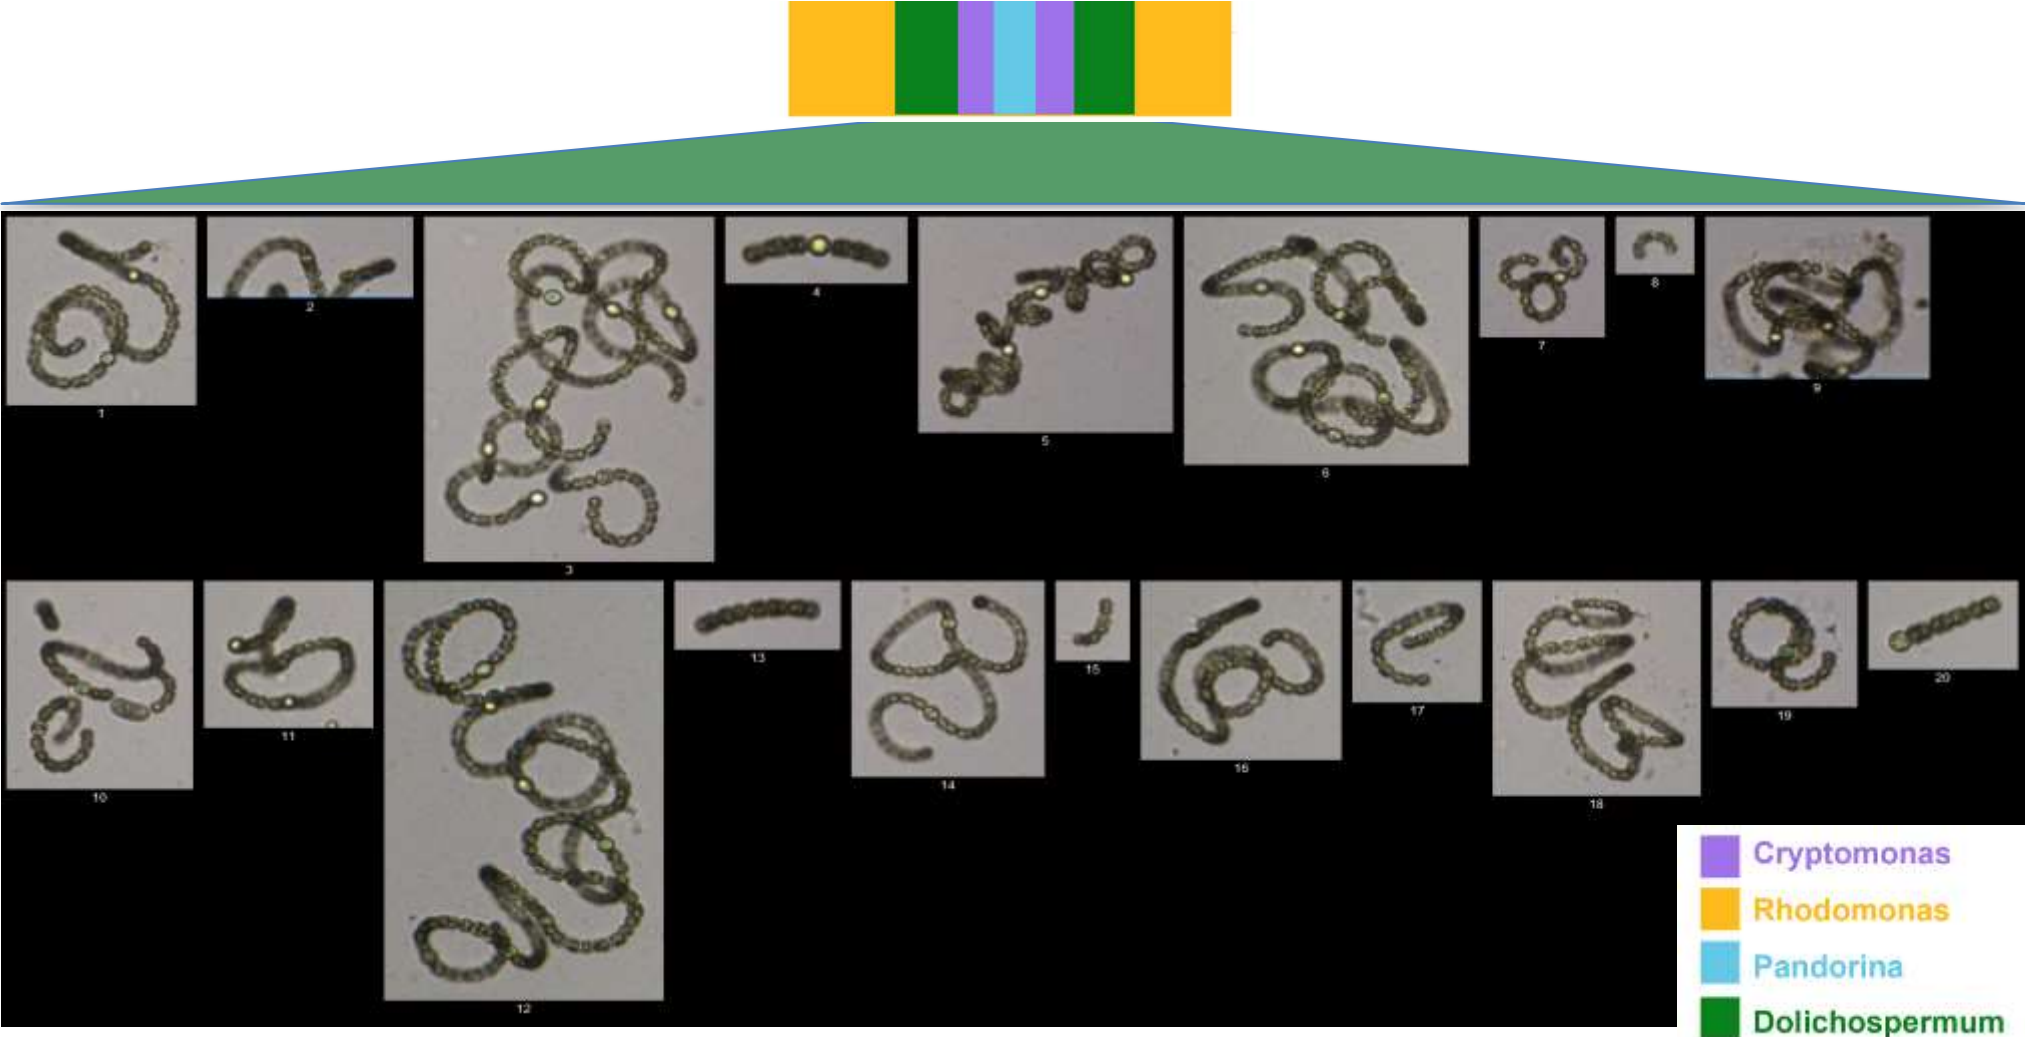
Jul 22

The Rise of Dolichospermum
