# Backflow Prevention at Wastewater Facilities

Jeffrey A. Lundt, P.E.

King County Wastewater Treatment Division

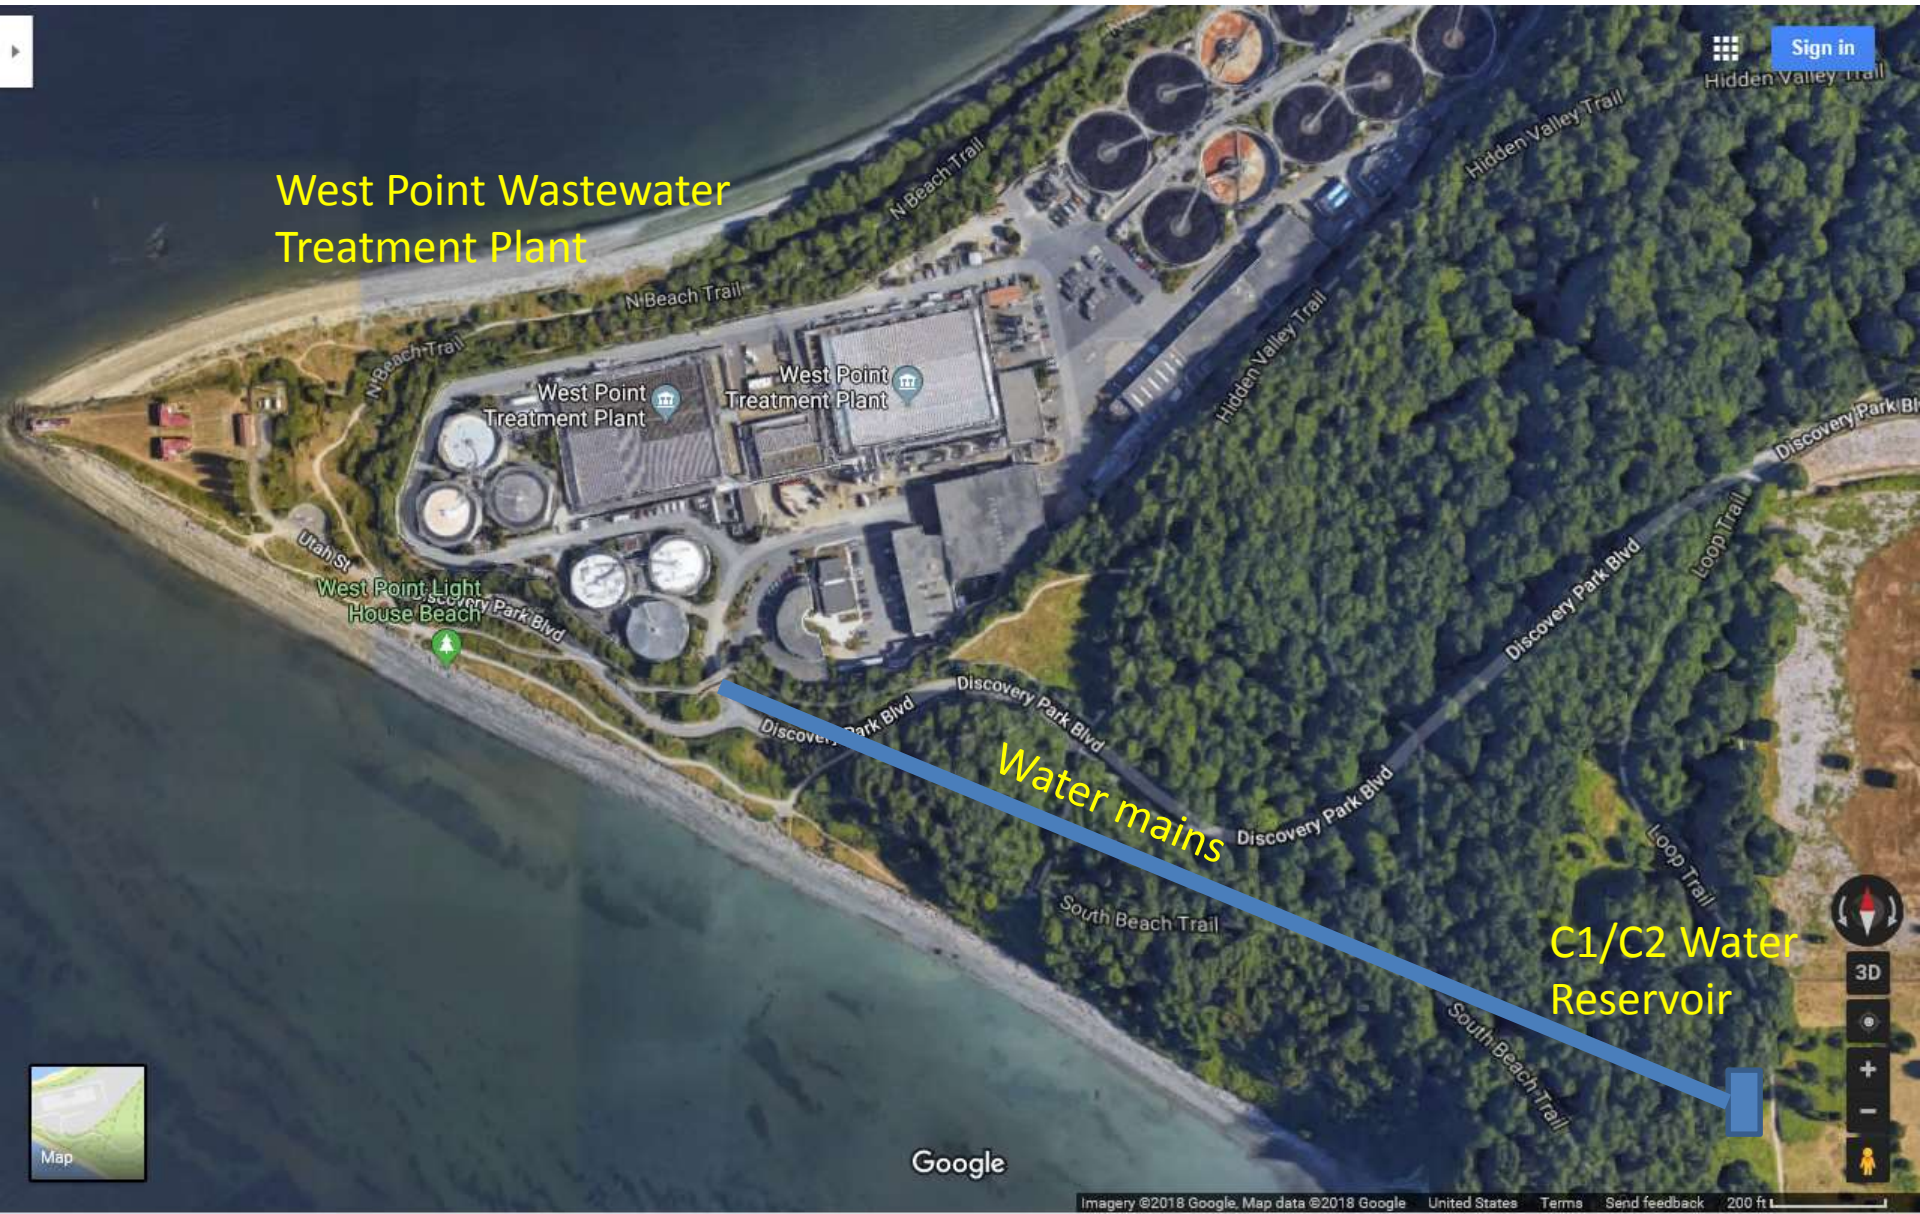
# West Point Existing Reservoir

West Point Wastewater Treatment Plant

Water mains

C1/C2 Water Reservoir

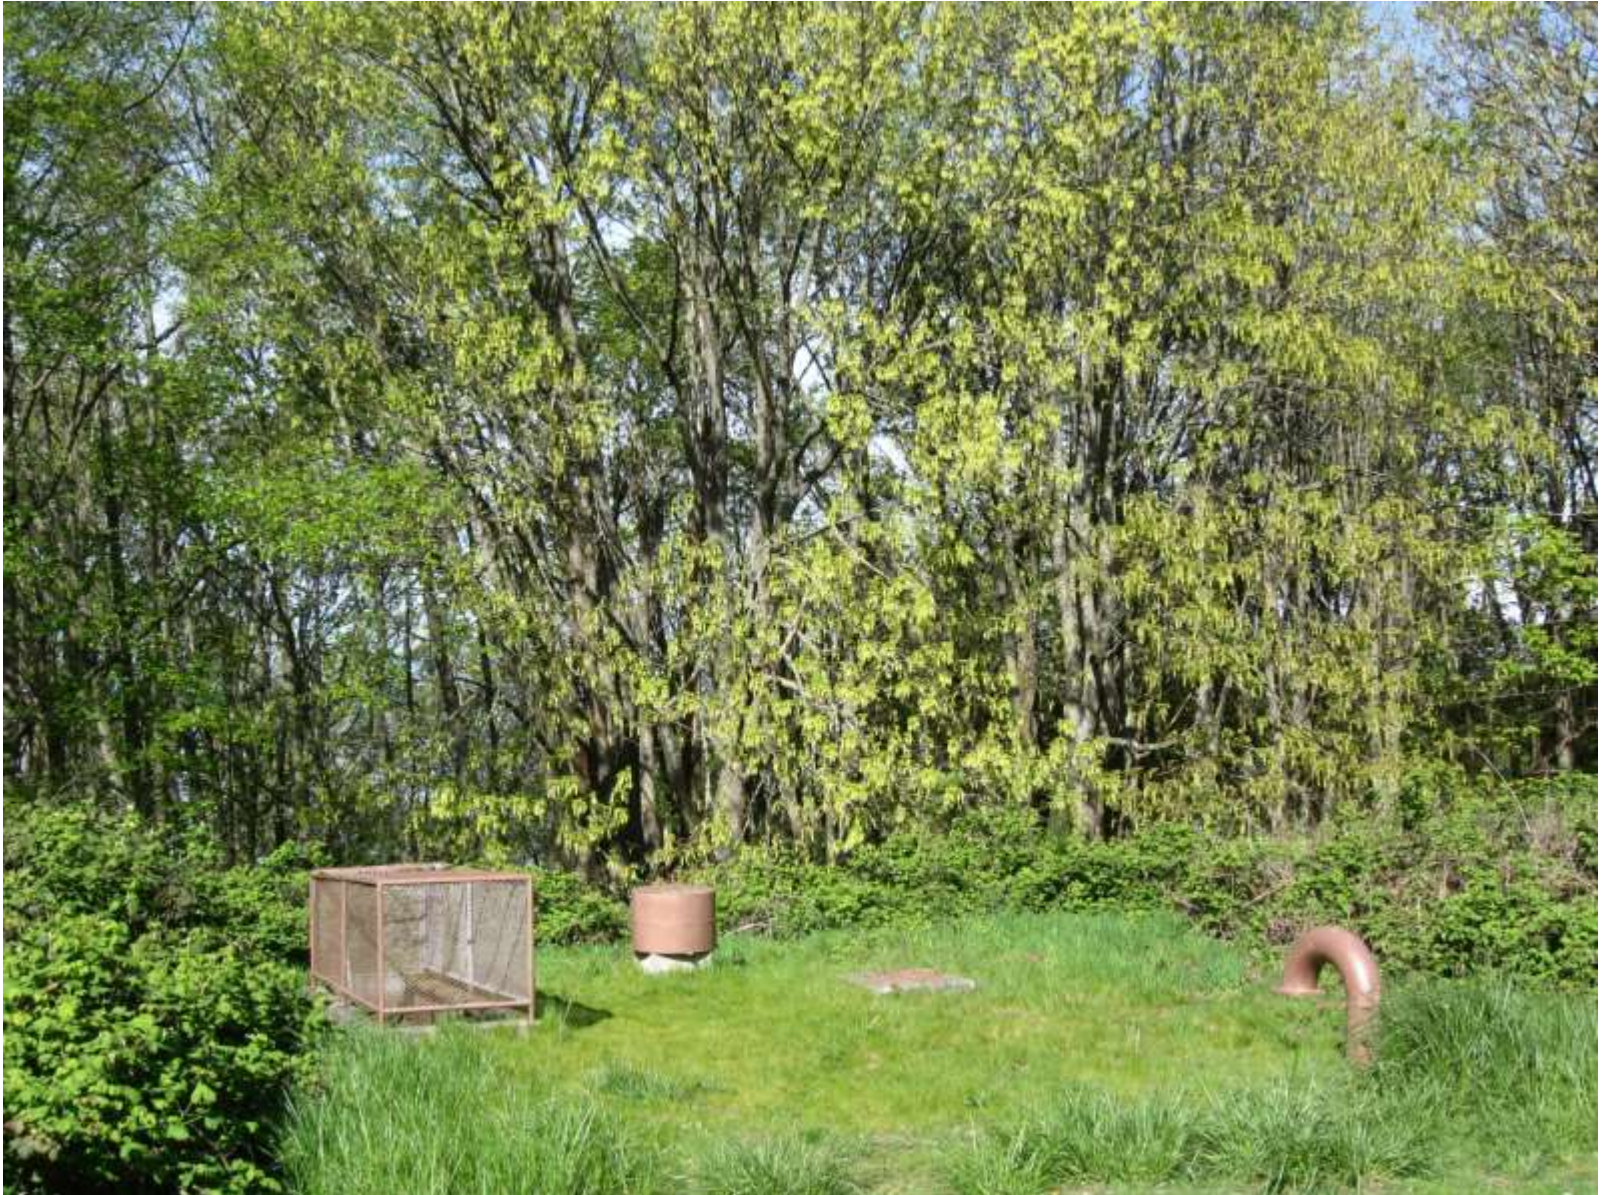
# West Point Existing Reservoir

- Buried reservoir
- Air gap  $< 2x$  inlet pipe diameter
- Inadequate drain – to the beach
- C2 reservoir can back up into C1
- Difficult entry to reservoirs and mechanical space
- Coordination with Seattle Parks
- Reservoir is in Park easement

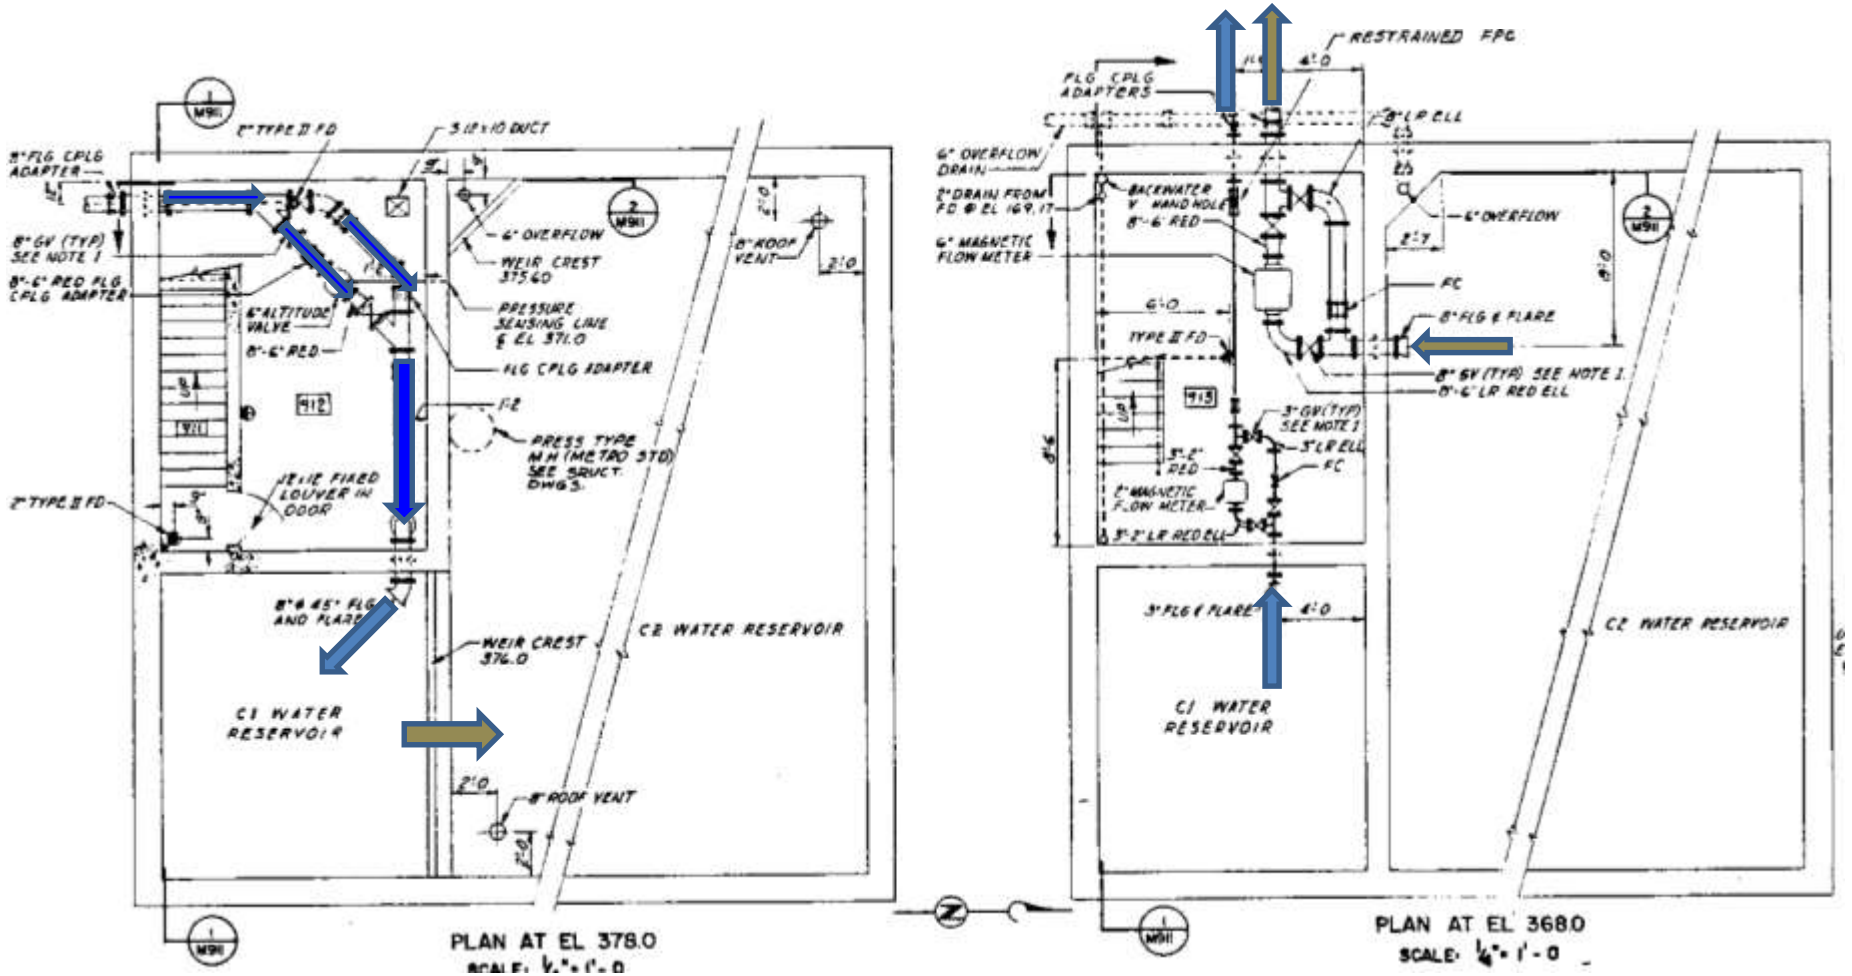
# West Point Existing Reservoir

C1 Capacity – 171,000 gallons, 32'w x 52'l x 13.75'd –  $Q_p = 1,100$  gpm  
 C2 Capacity – 18,400 gallons, 12.16'w x 14' l x 14.5'd -  $Q_p = 100$  gpm

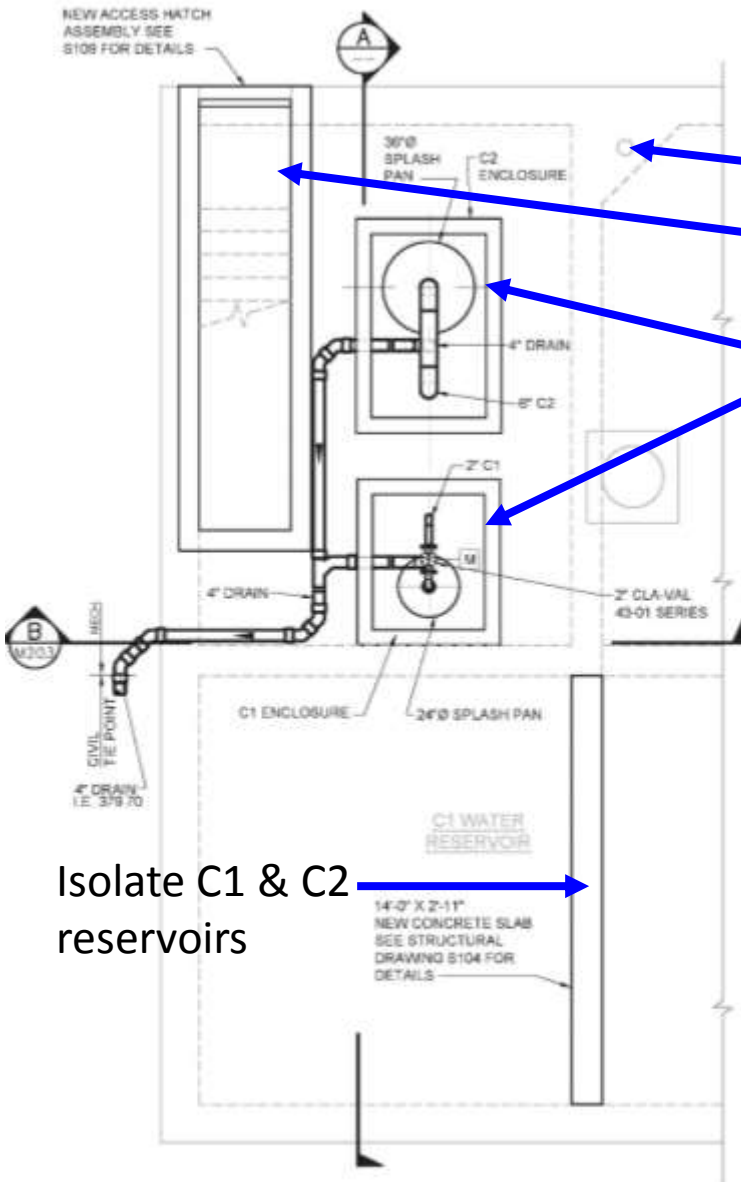
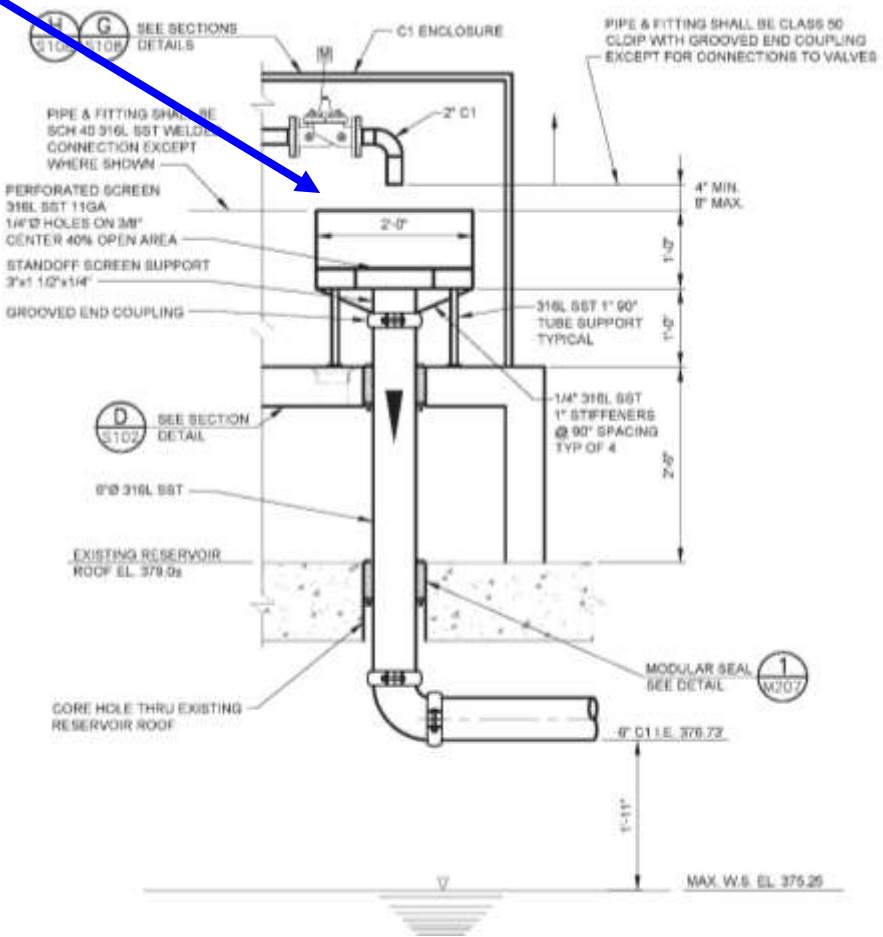
# Proposed improvements

Plug old overflow

Secure entry hatch

Separate air gaps

Isolate C1 & C2 reservoirs

- Separate above grade supply points
- Separate C1 & C2 reservoirs
- New overflow
- New separate gasketed access hatches
- New mechanical room hatch
- Structural modifications to roof
- New overflow

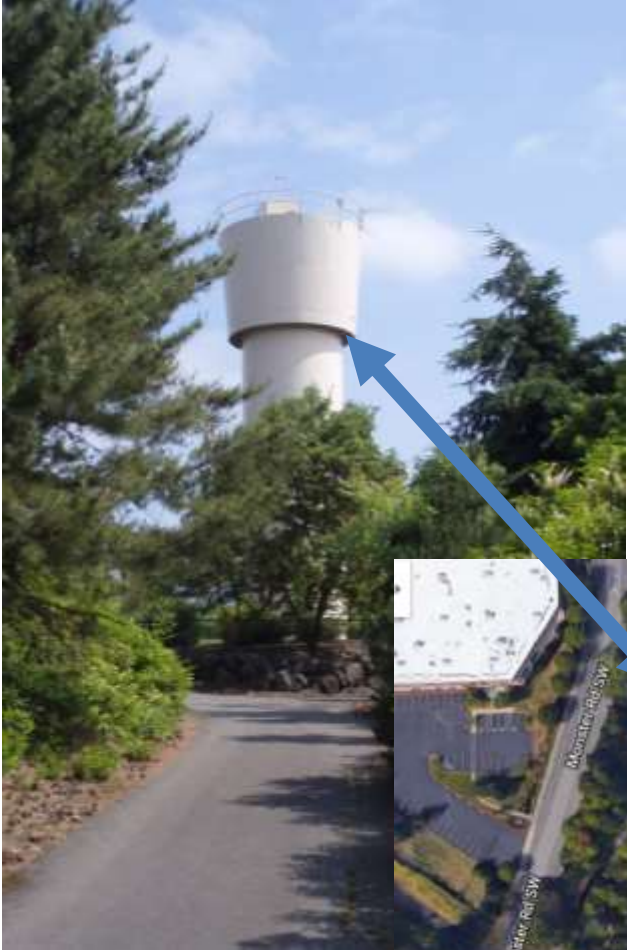
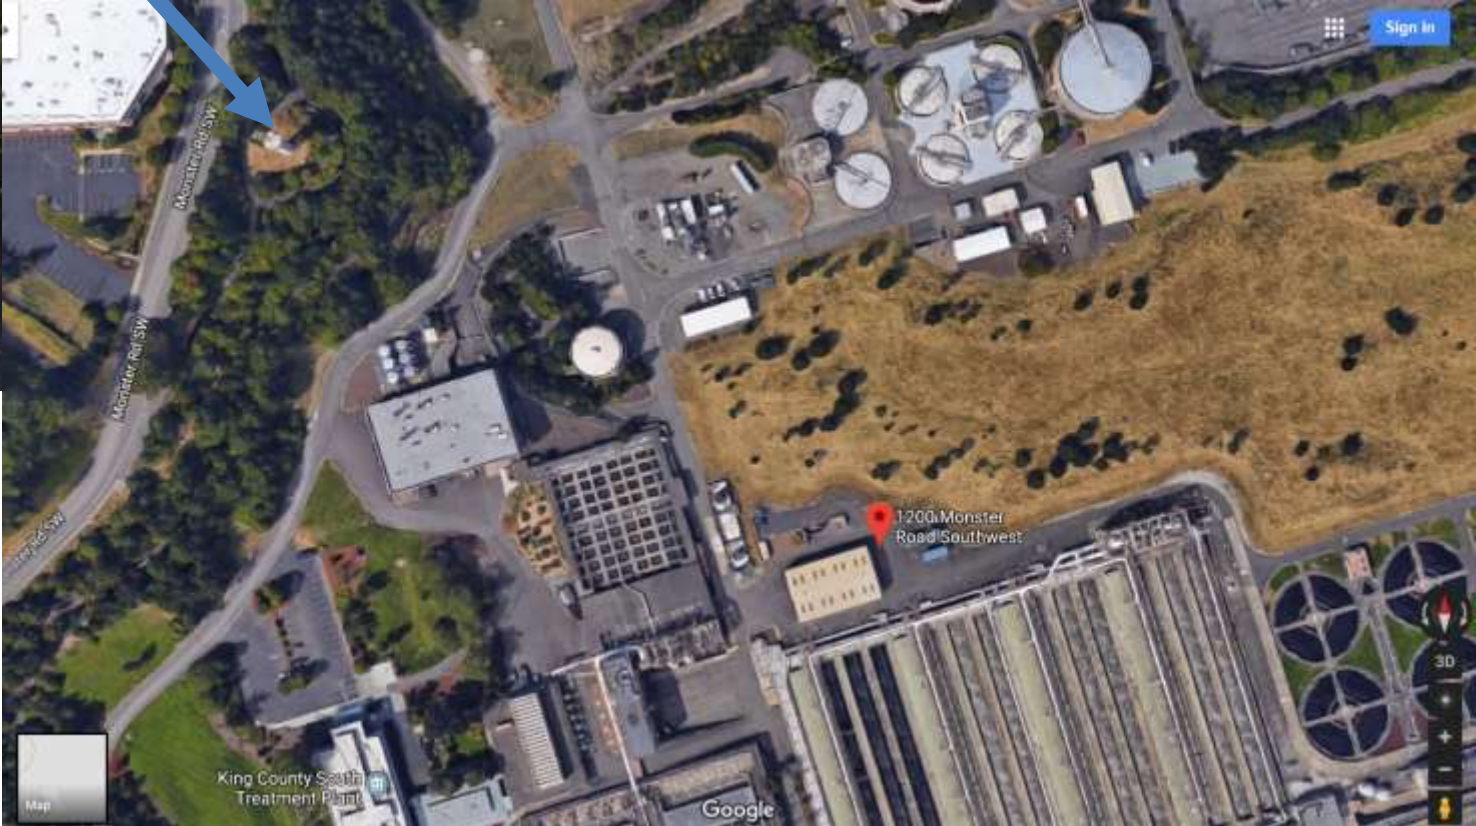
# South Plant Water Tank

- Also built in the mid-1960s
- Two compartment water tower on site
- Utility supply feeds plant potable tank
- Overflows to process water tank
- Similar multiple water systems on site
- Insufficient air gap

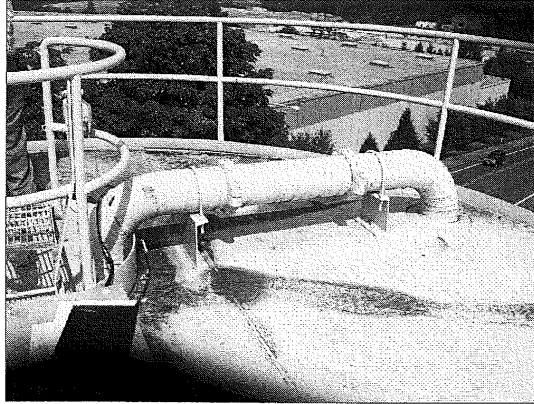
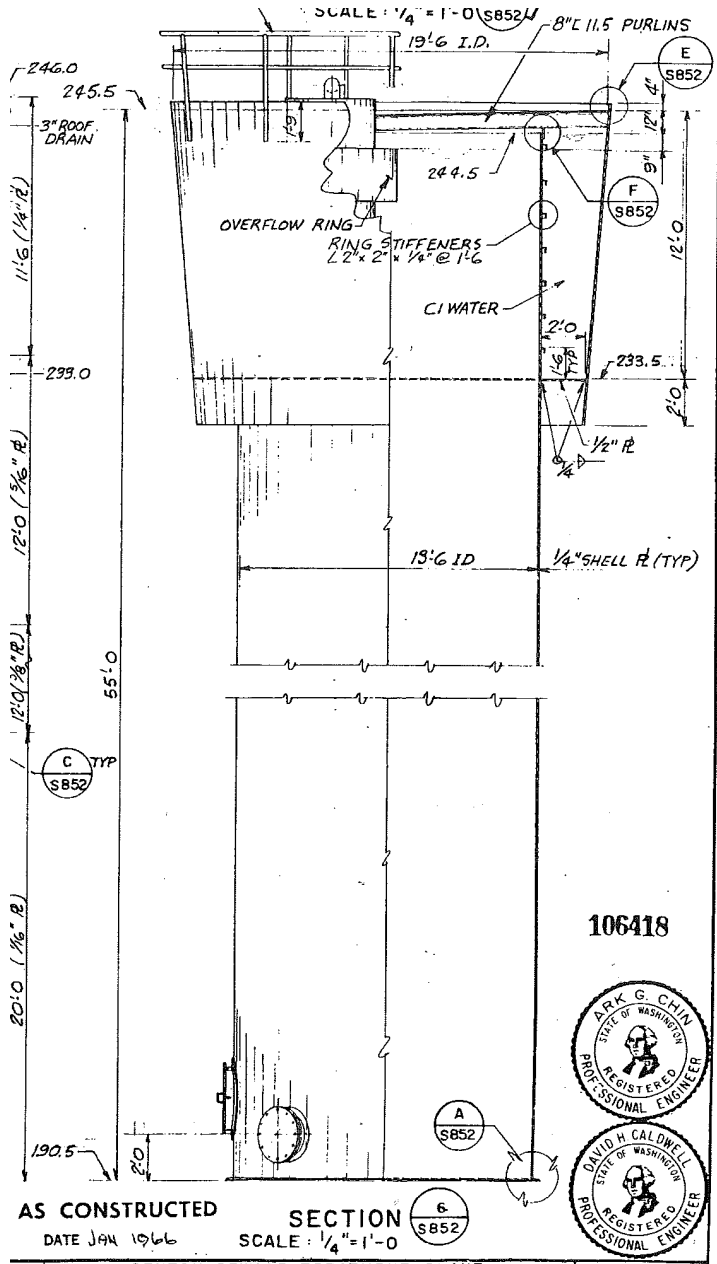
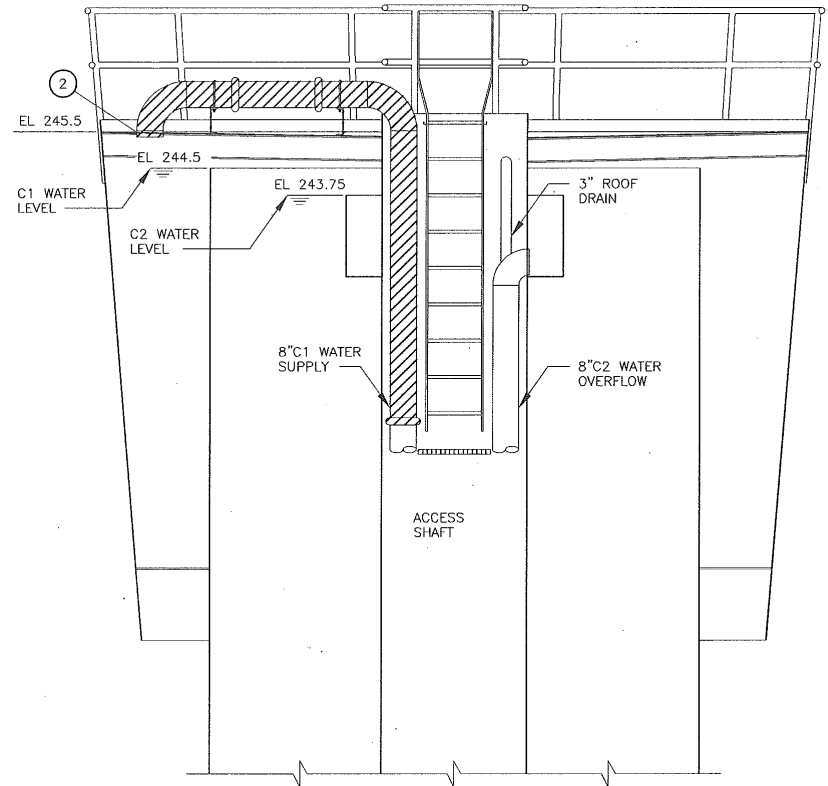
# Existing Tank

C1 Capacity – 31,000 gallons  
 C2 Capacity – 22,000 gallons

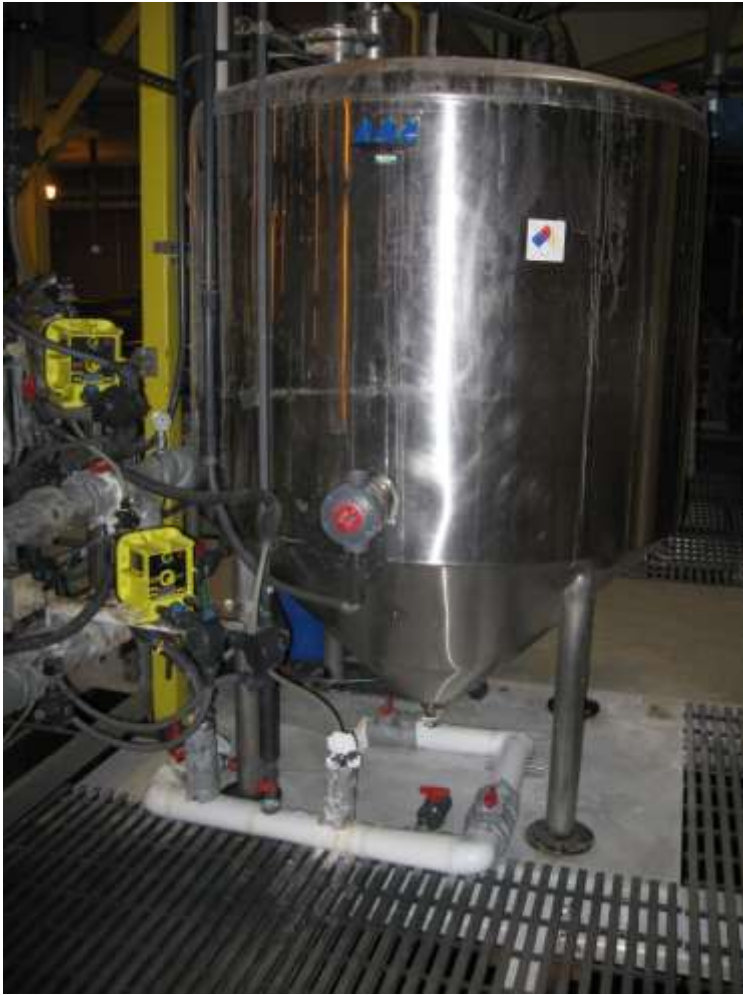
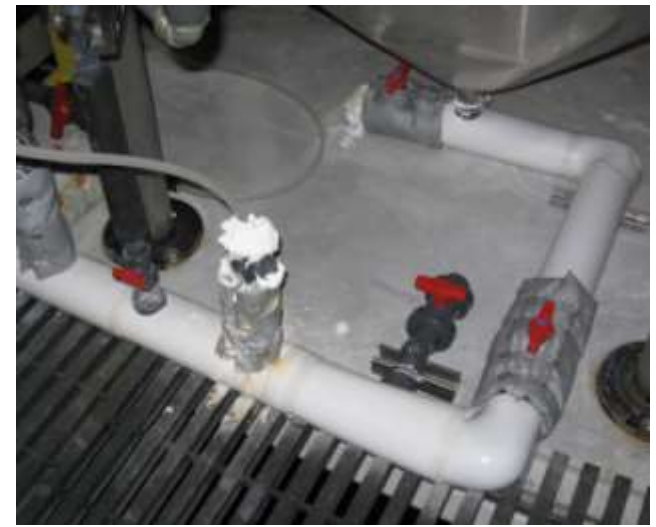
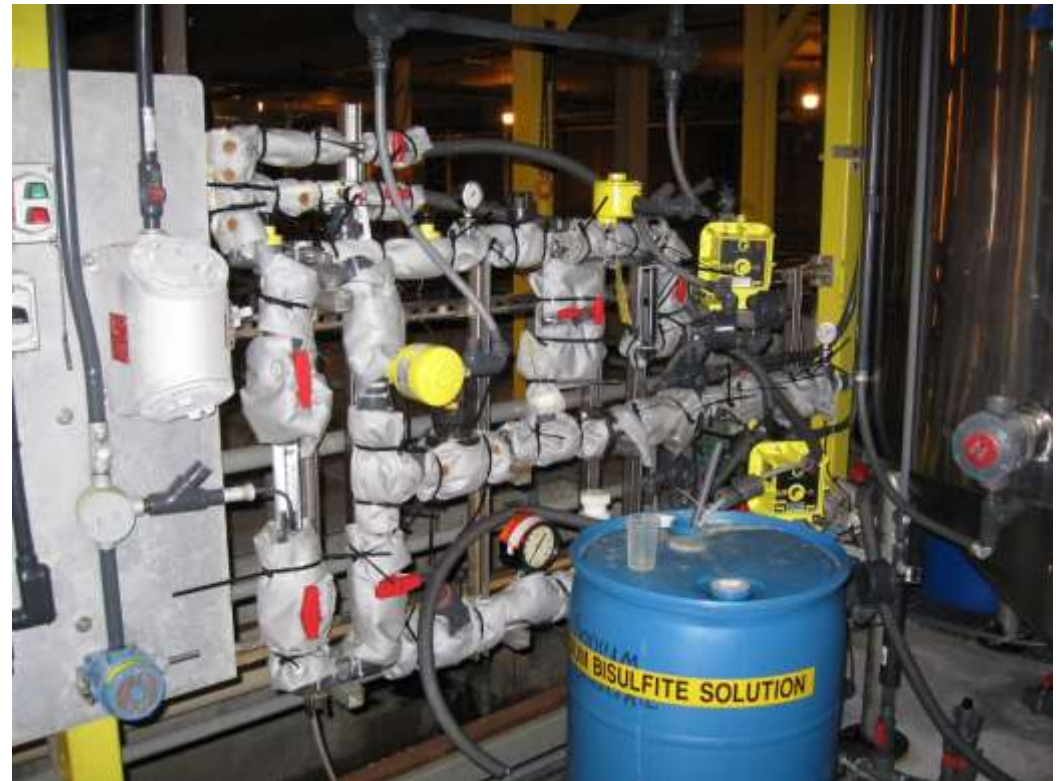
# Alki CSO – Old Chem System

- Previously a primary treatment plant
- Converted to CSO – intermittent use
- Dechlorination system had issues
- Built new dechlor system that needed carrier water for sodium bisulfite
- Potable water connection to the chemical room, turn into process water with air gap
- Package C2 system less expensive than extending C2 from clarifier building

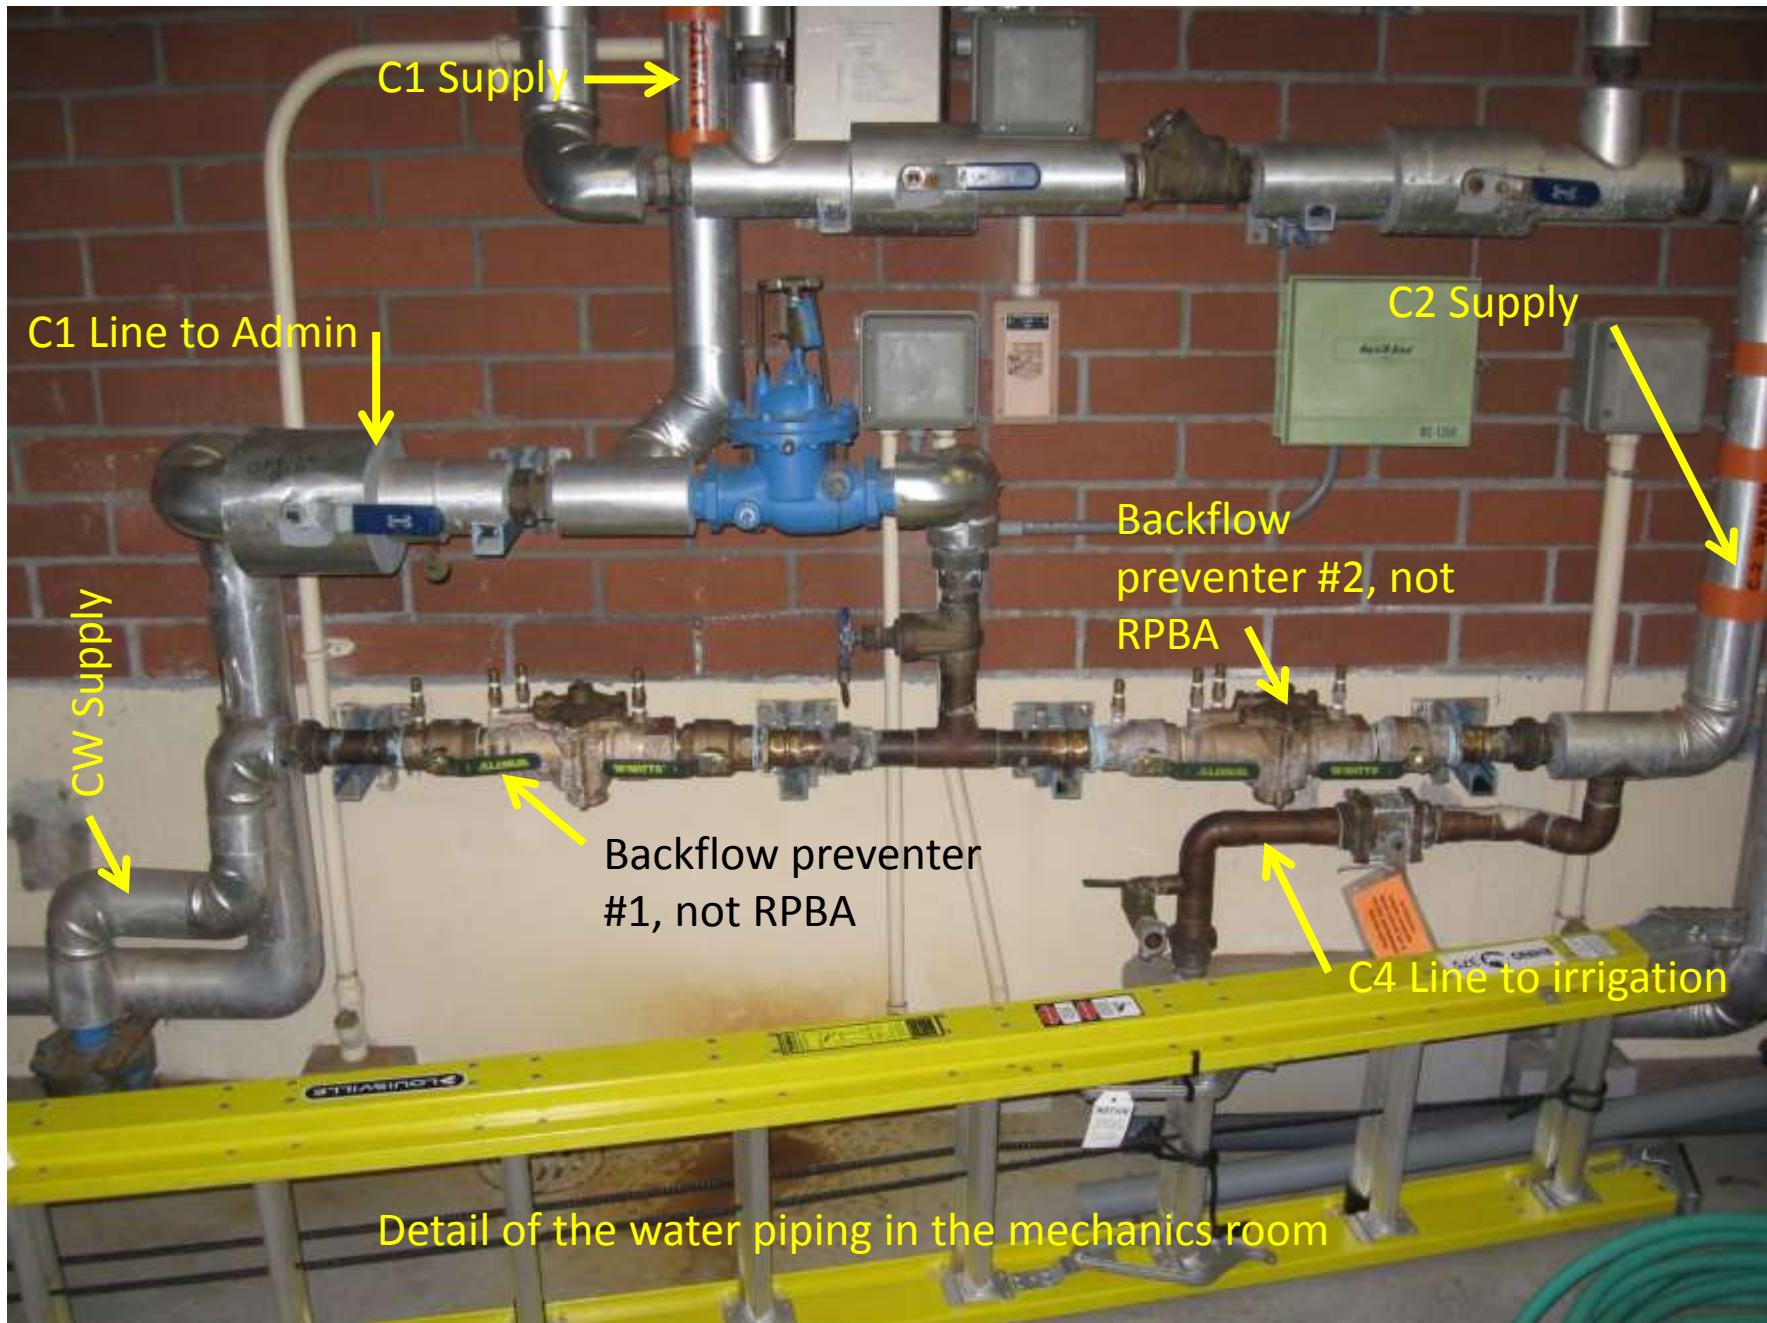
C1 Supply →

C1 Line to Admin ↓

CW Supply ↓

Backflow preventer #1, not RPBA

Backflow preventer #2, not RPBA ↓

C2 Supply ↓

C4 Line to irrigation ↓

Detail of the water piping in the mechanics room

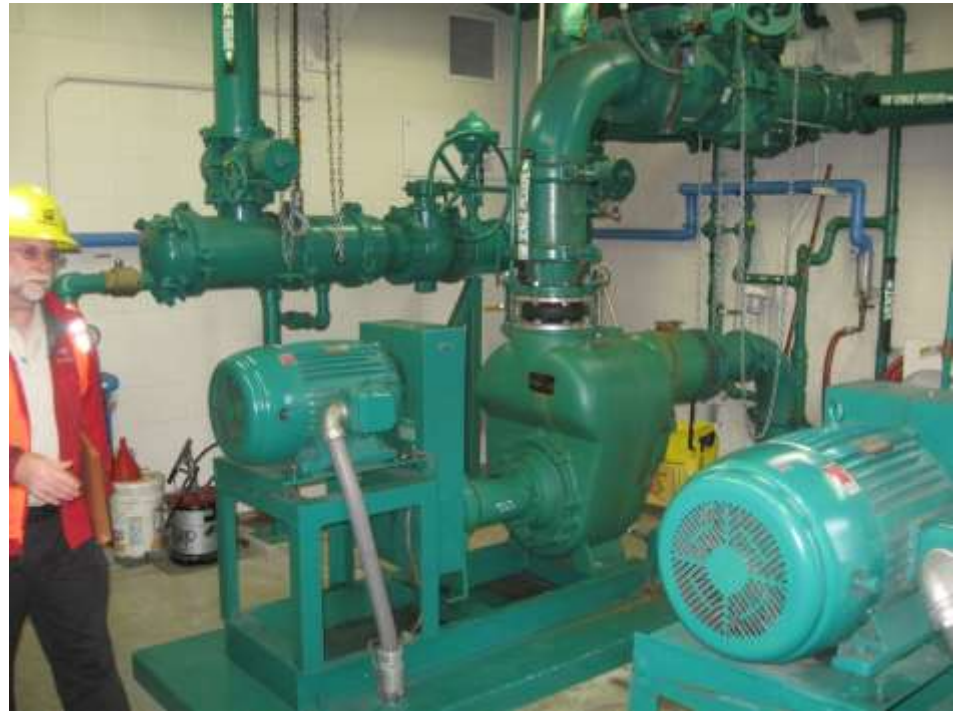
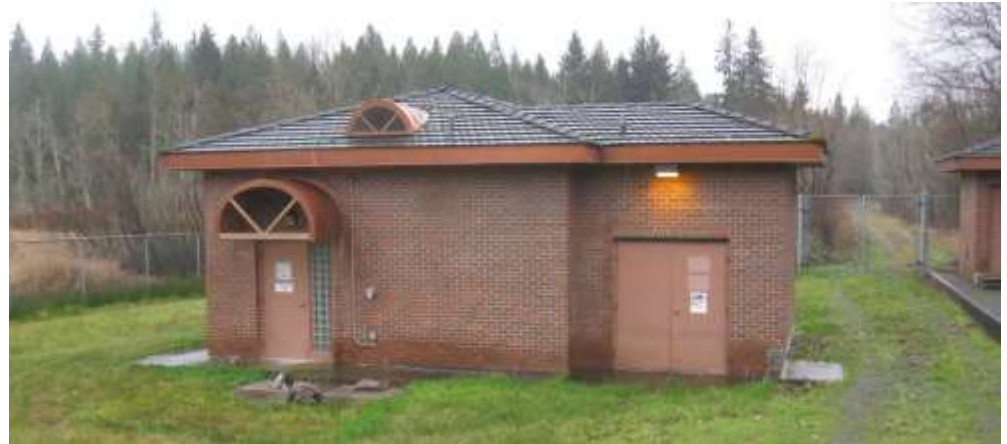
- WTD operates this pump station owned by the City
- Potable and process pressurized by same CW service
- Needed an air gap for process water (pump seal water & flushing)
- Limited space

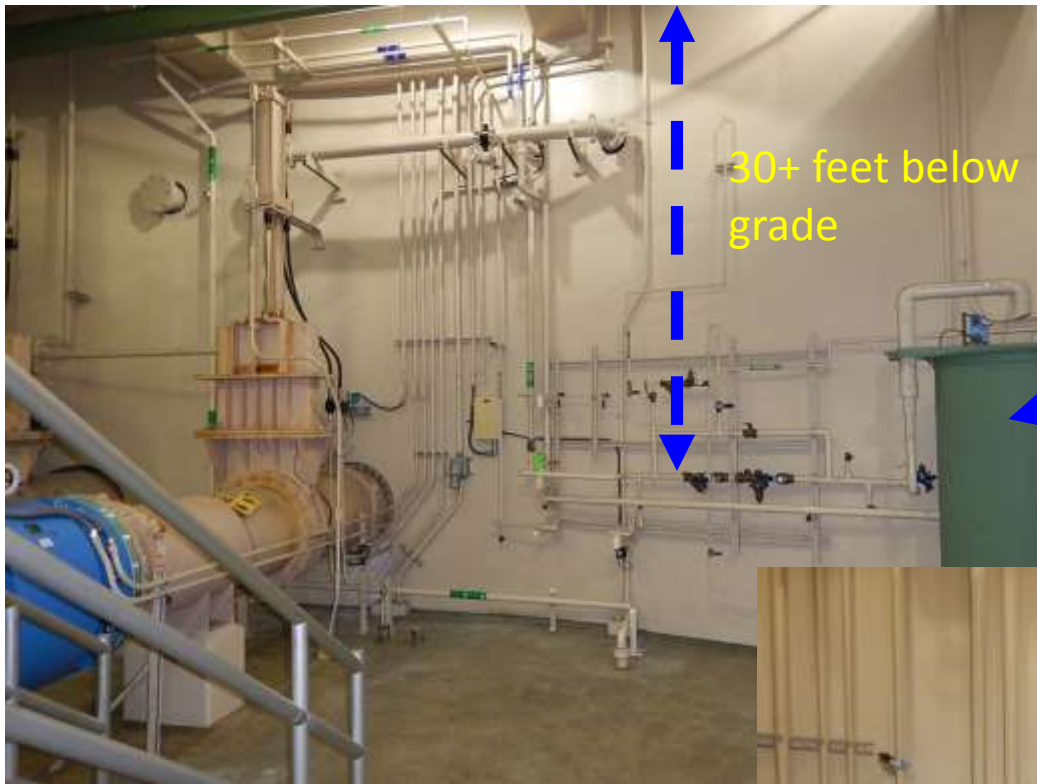
C2 air gap tank (pumps out of view to the right)

- Built in the 1980's
- BFPV & air break tank below grade
- City of Tukwila utility and inspector
- Requested BFPV outside near the water meter
- Several alternatives considered inside and outside the building

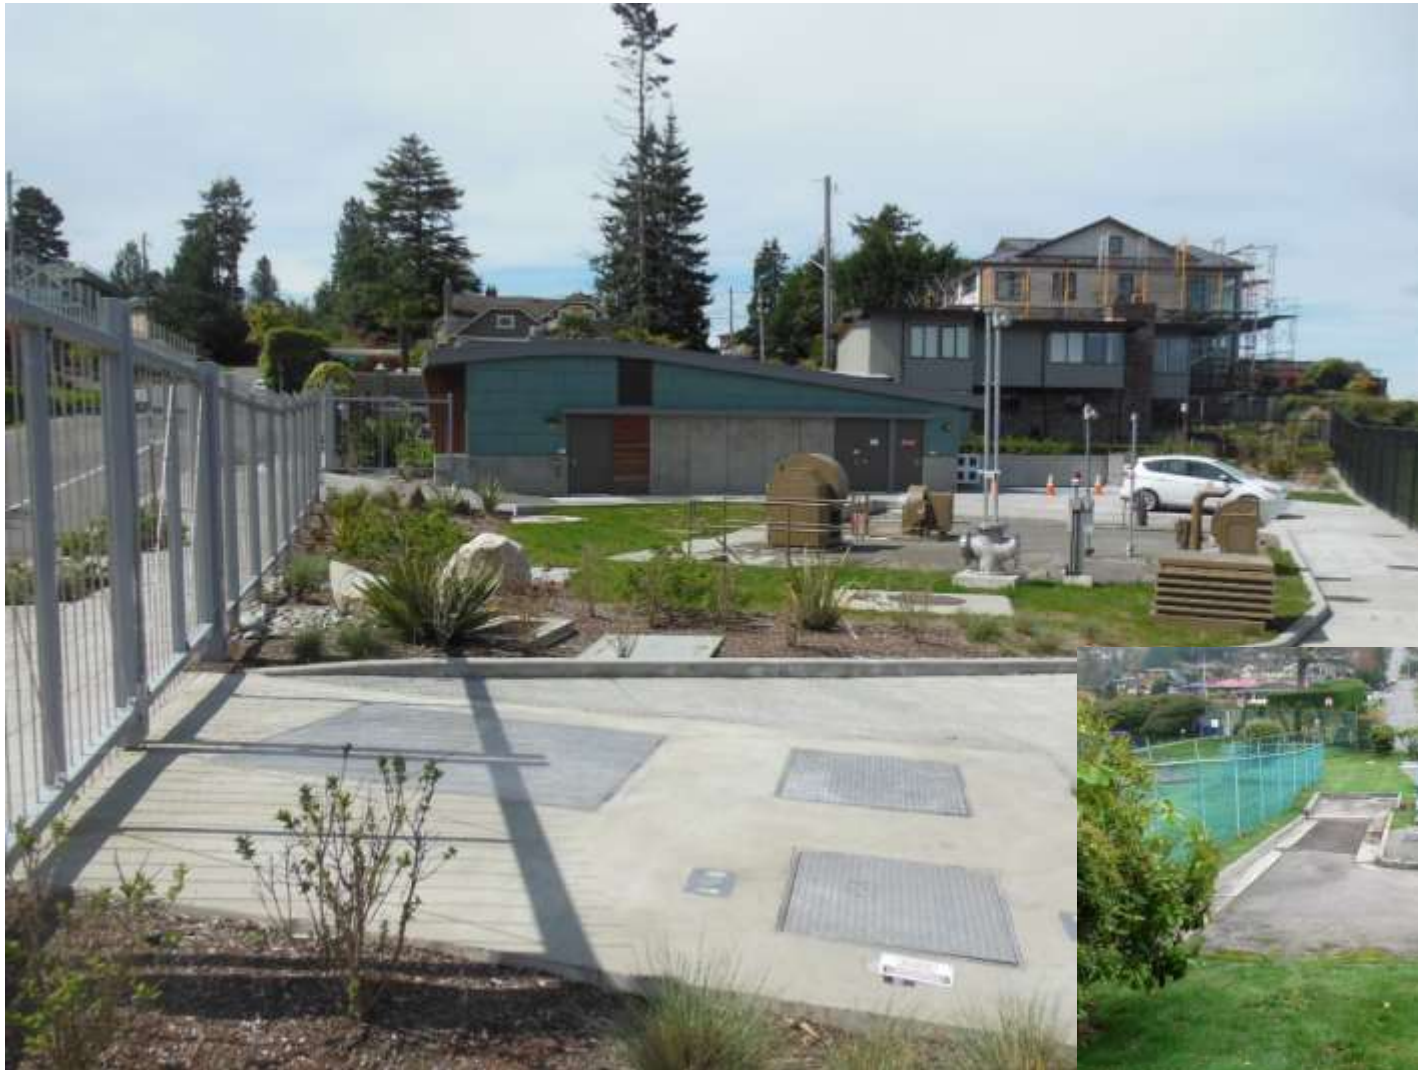
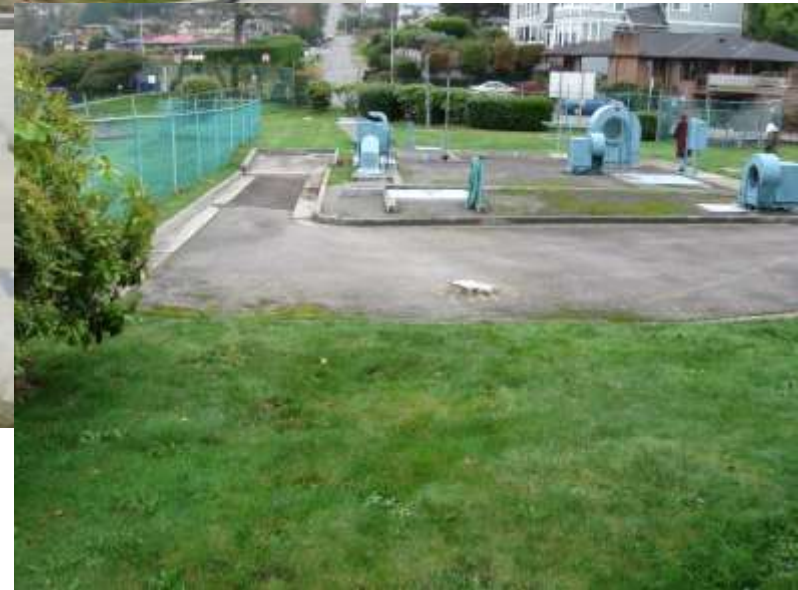
# NBPS Photos

- Originally a primary WWTP for a sewer district
- Built in the 1930's
- Metro/WTD took over in 1960's and turned the facility into a pump station flowing to Carkeek PS
- CSO storage facility construction lead to NBPS upgrade including utilities
- Previous air break underground

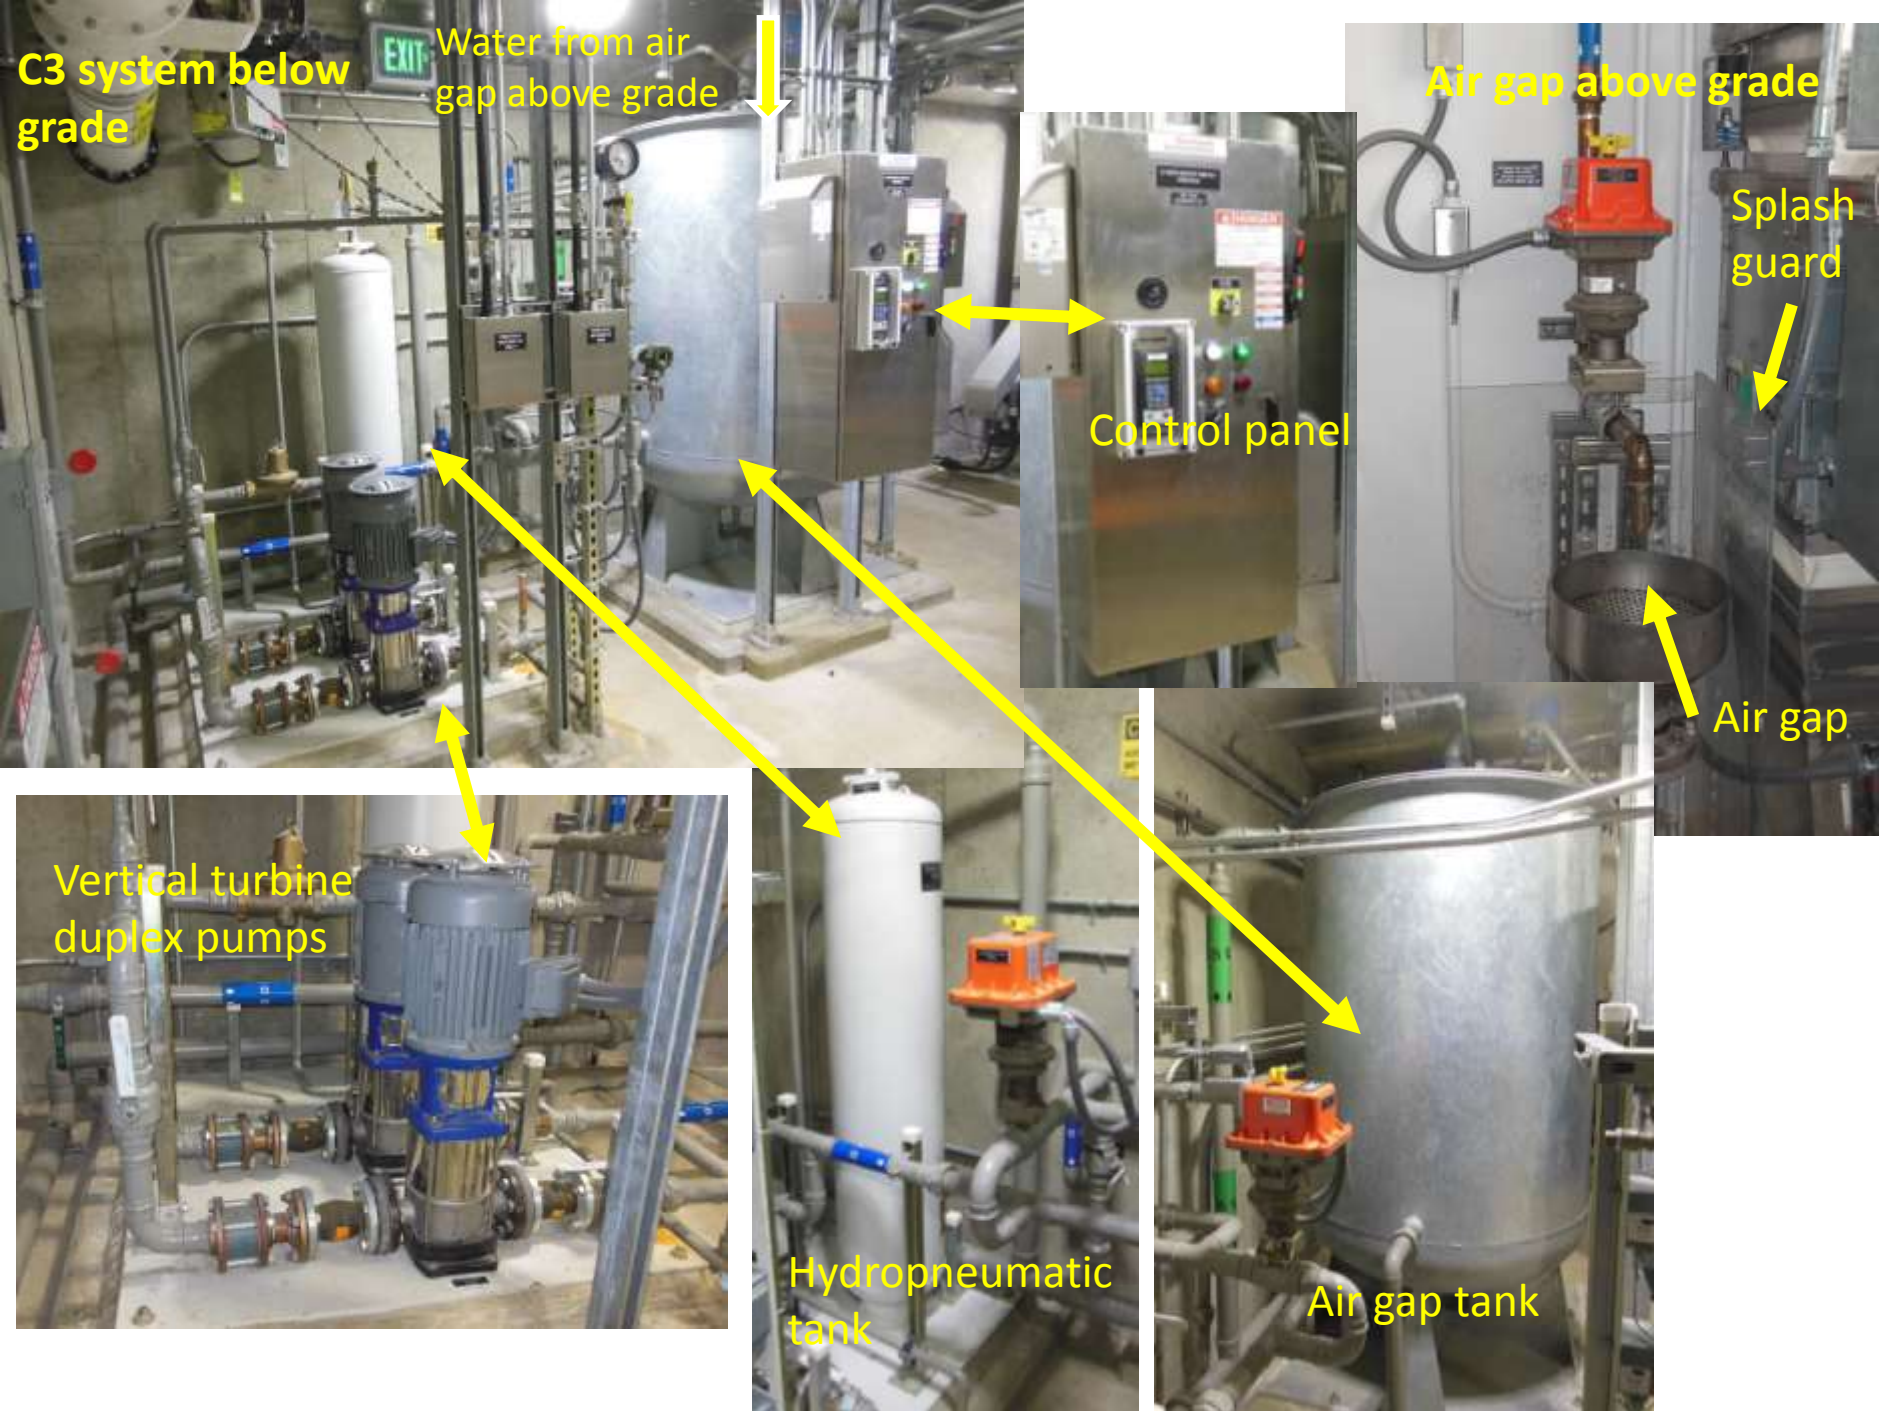
C3 system below grade

Water from air gap above grade

Air gap above grade

Control panel

Splash guard

Air gap

Vertical turbine duplex pumps

Hydropneumatic tank

Air gap tank
