# GETTING RID OF LEAD: REMOVING TACOMA WATER'S LAST LEAD GOOSENECKS

PNWS-AWWA SECTION CONFERENCE  
TACOMA, WA  
APRIL 27, 2018

## **Potential Lead Gooseneck Service Replacement Plan**

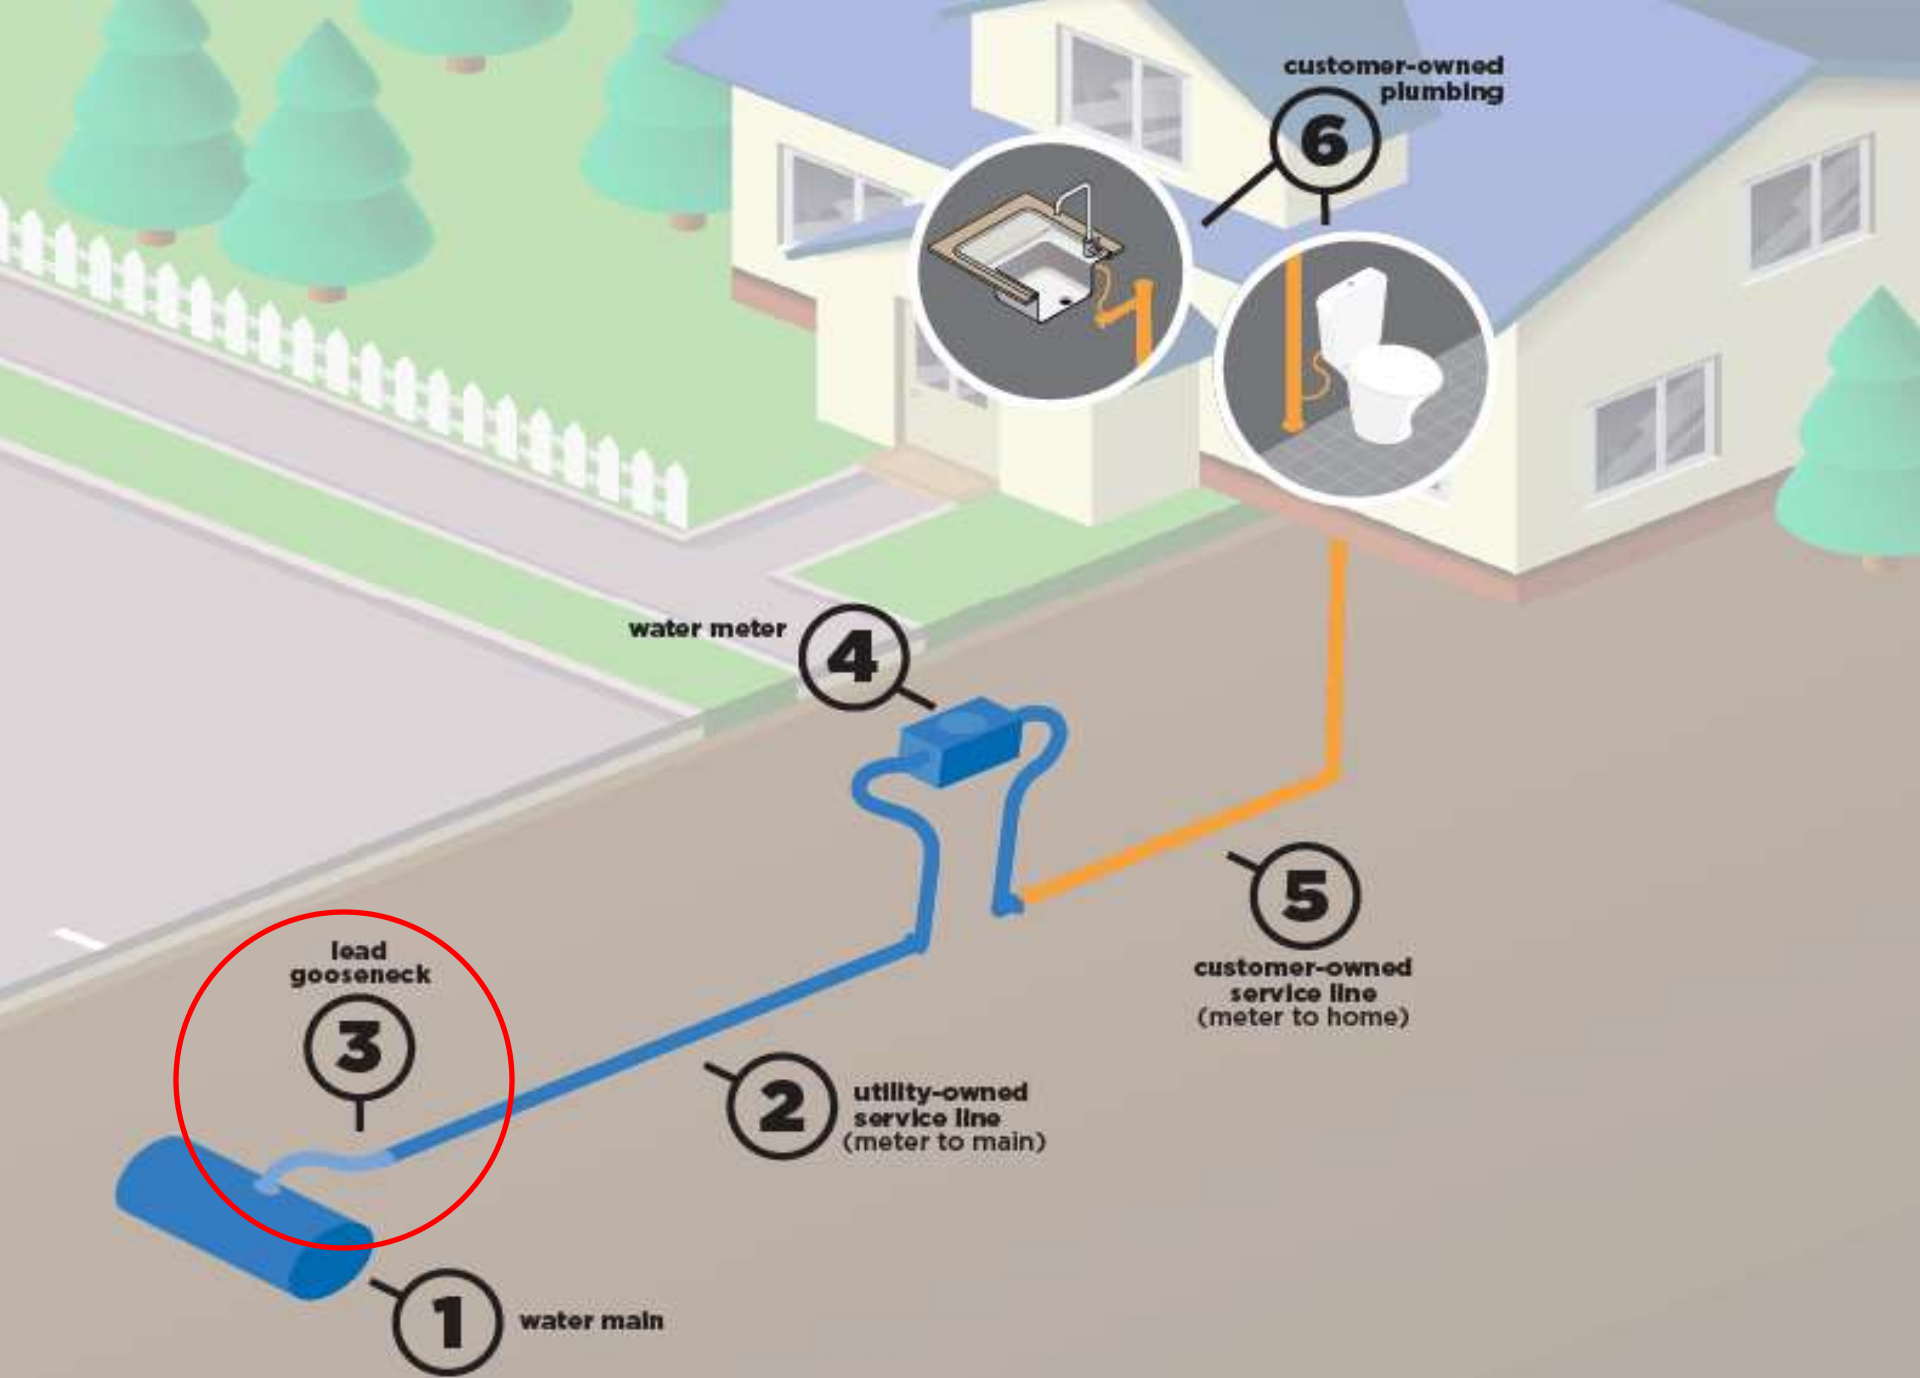
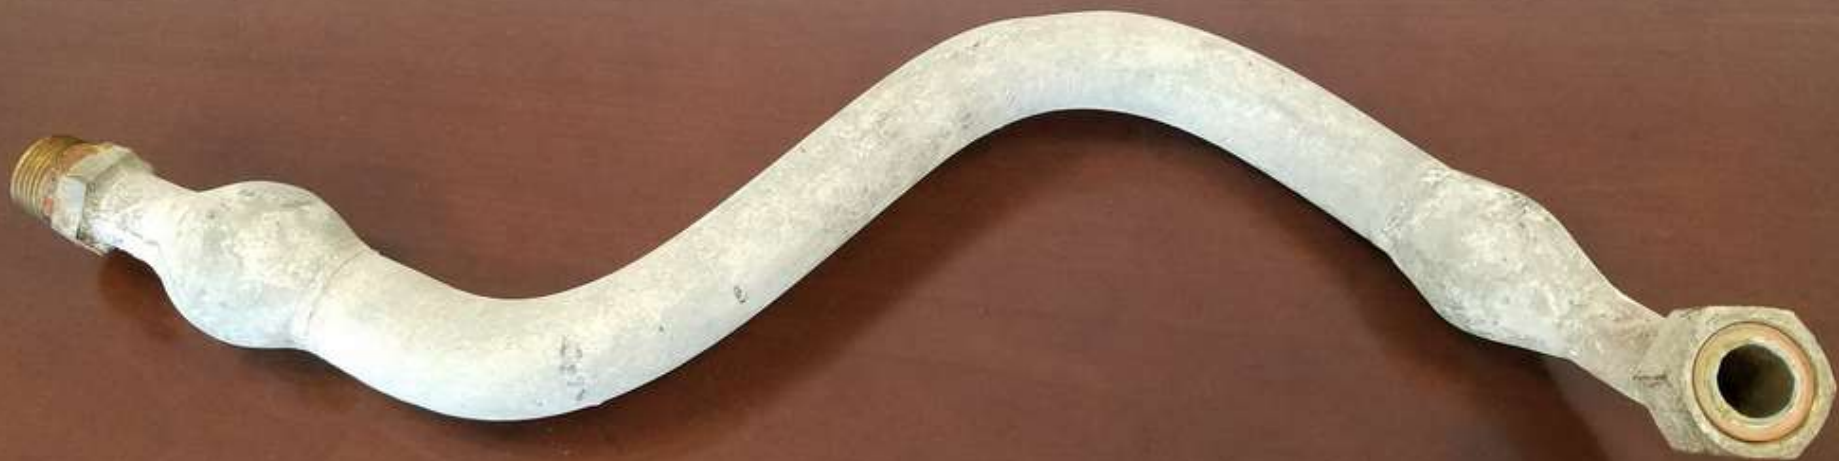
# WHAT IS A LEAD GOOSENECK?

- Typically used to provide a flexible connection between galvanized service lines and the water main
- As part of Service Line and Water Main replacement projects Tacoma Water had **removed an estimated 30,000 Lead Goosenecks over the past few decades**

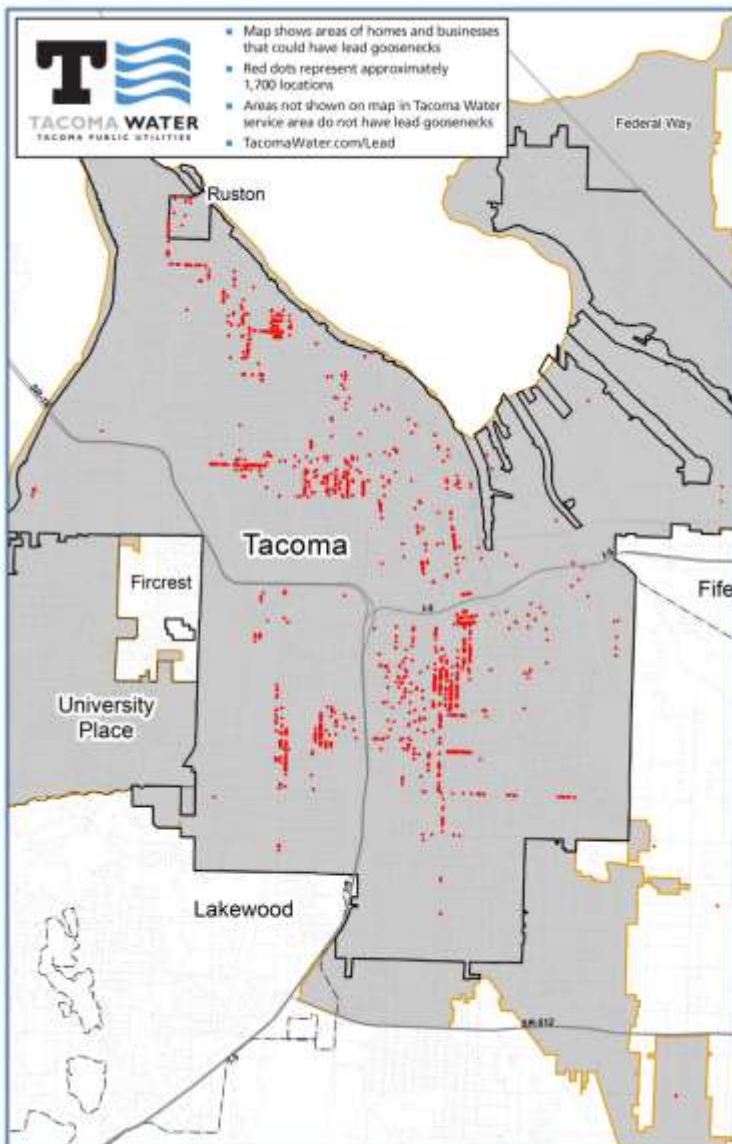
# THE “1700” ...WELL MORE LIKE 1200

## POTENTIAL LEAD GOOSENECK LOCATIONS (TACOMA'S CRITERIA)

### Services that were:

- 2-inches or smaller **AND**
- Classified in records as “galvanized”, “unknown”, or “blank” **AND**
- Installed earlier than 1940 **AND**
- Installed on mains that were older than 1940 **AND**
- Where no service renewal had occurred beyond this timeframe

*Note: Dates prior to 1940 selected to allow 10 years beyond oldest known lead gooseneck installation in Tacoma (1929)*

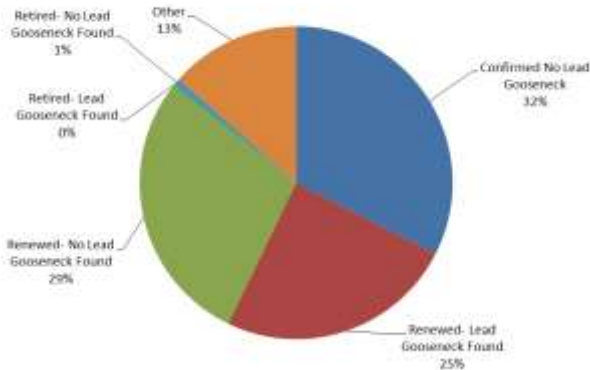
## Breakdown of Resolved Goosenecks

| Breakdown of Resolved Goosenecks | Quantity | Percent of Resolved |
| Confirmed No Lead Gooseneck | 41 | 32% |
| Renewed- Lead Gooseneck Found | 31 | 25% |
| Renewed- No Lead Gooseneck Found | 36 | 29% |
| Retired- Lead Gooseneck Found | 0 | 0% |
| Retired- No Lead Gooseneck Found | 1 | 1% |

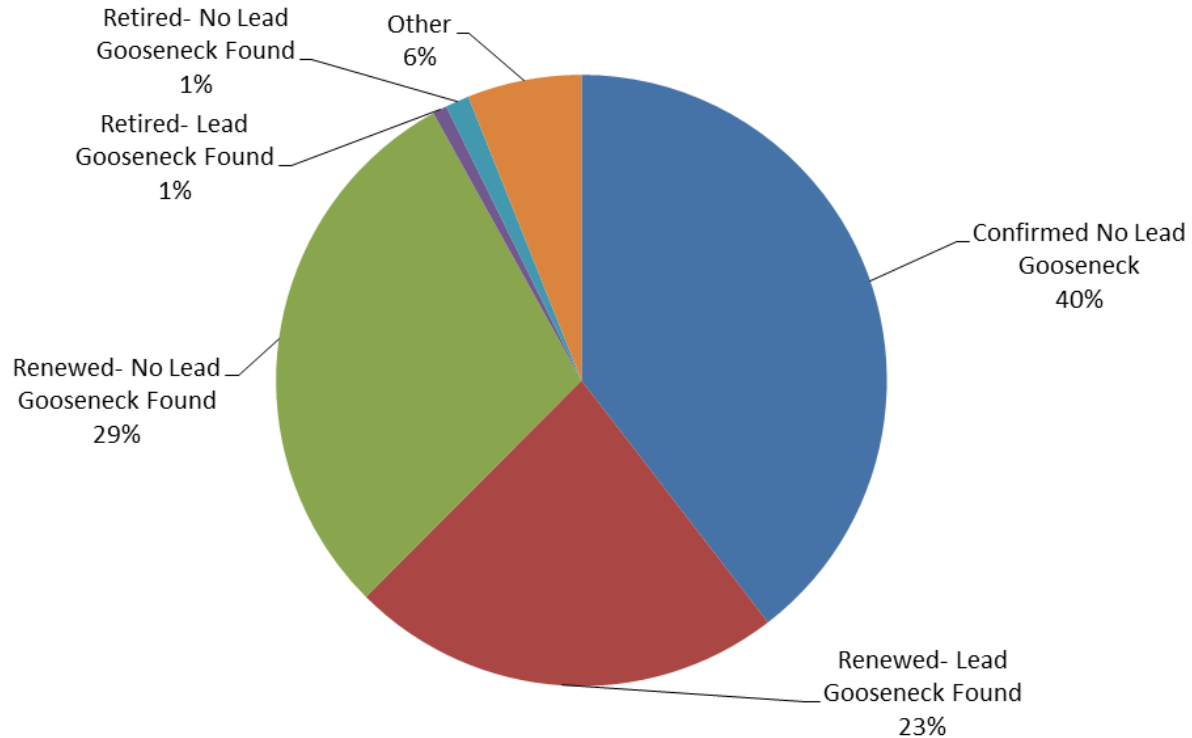
## Breakdown of Resolved Goosenecks

| Breakdown of Resolved Goosenecks | Quantity | Percent of Resolved |
| Confirmed No Lead Gooseneck | 157 | 40% |
| Renewed- Lead Gooseneck Found | 91 | 23% |
| Renewed- No Lead Gooseneck Found | 117 | 29% |
| Retired- Lead Gooseneck Found | 3 | 1% |
| Retired- No Lead Gooseneck Found | 5 | 1% |

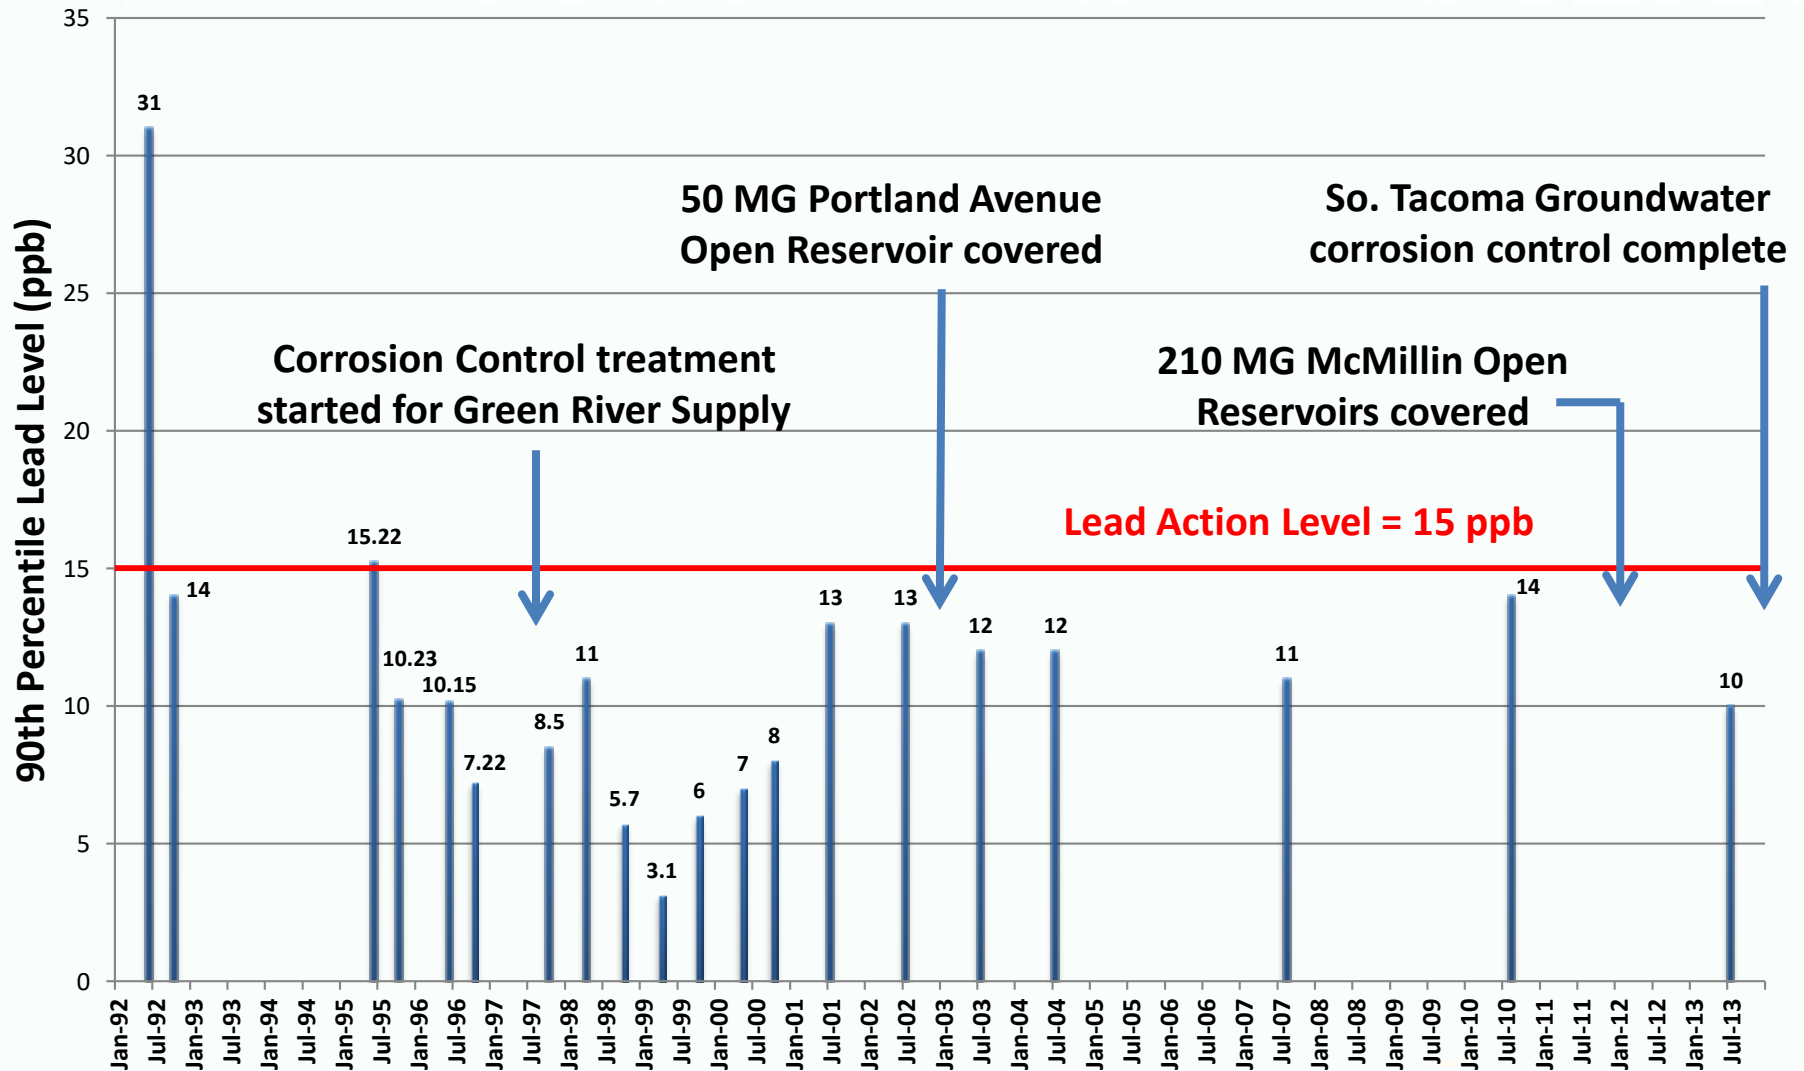
# TACOMA LCR RESULTS 1992 - 2013

## THE 1994 CORROSION CONTROL STUDY RECOMMENDED:

- Treatment initially only on the Green River supply
- pH adjustment (Sodium Hydroxide selected)
- Initial adjustment to pH 7.5 - 7.6
- Final adjustment to pH 8.2

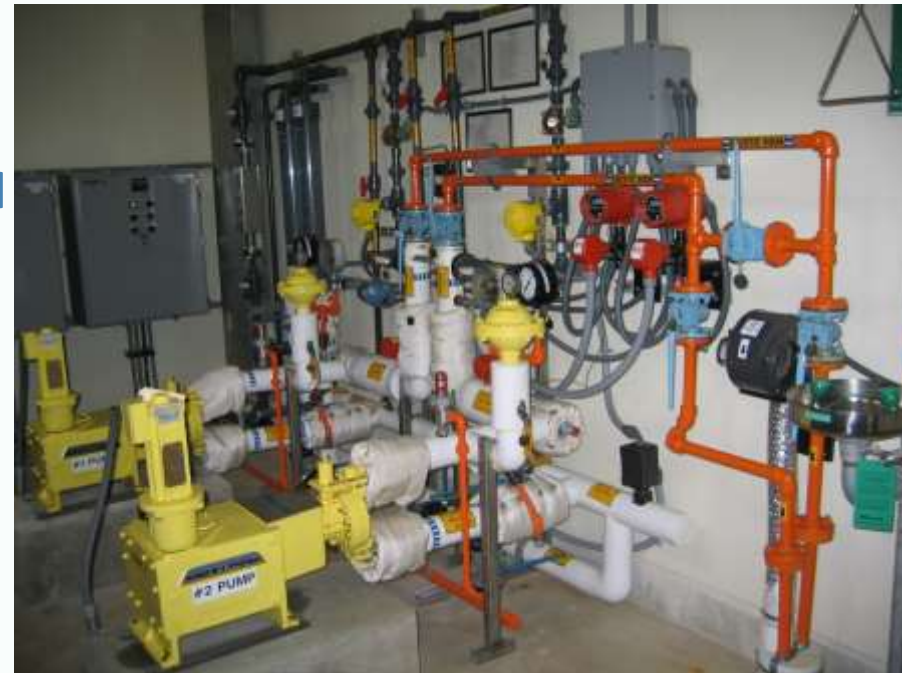
## GREEN RIVER SUPPLY TREATMENT – STARTED JULY 1997

- As an unfiltered supply Tacoma was required to meet 3-Log *Giardia* inactivation through disinfection (free chlorine) for Green River
- Sodium hydroxide initially added at 214<sup>th</sup> Ave Corrosion Control Facility along Pipeline 1 after CT Contact Time requirements met for 3-Log *Giardia* Inactivation
- Treatment transitioned to Green River Headworks and 214<sup>th</sup> Corrosion Control Facility shutdown following startup of Pipeline 5 in 2005

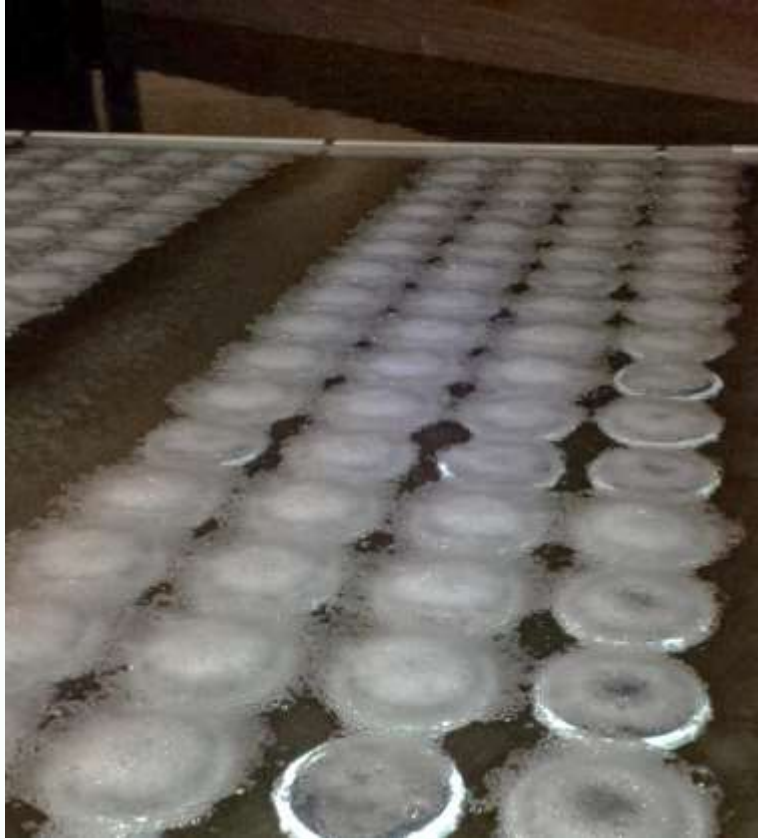
**South Tacoma Pump Station:**  
In basin aeration using bubble diffusers to strip carbon dioxide and raise pH to ~7.5

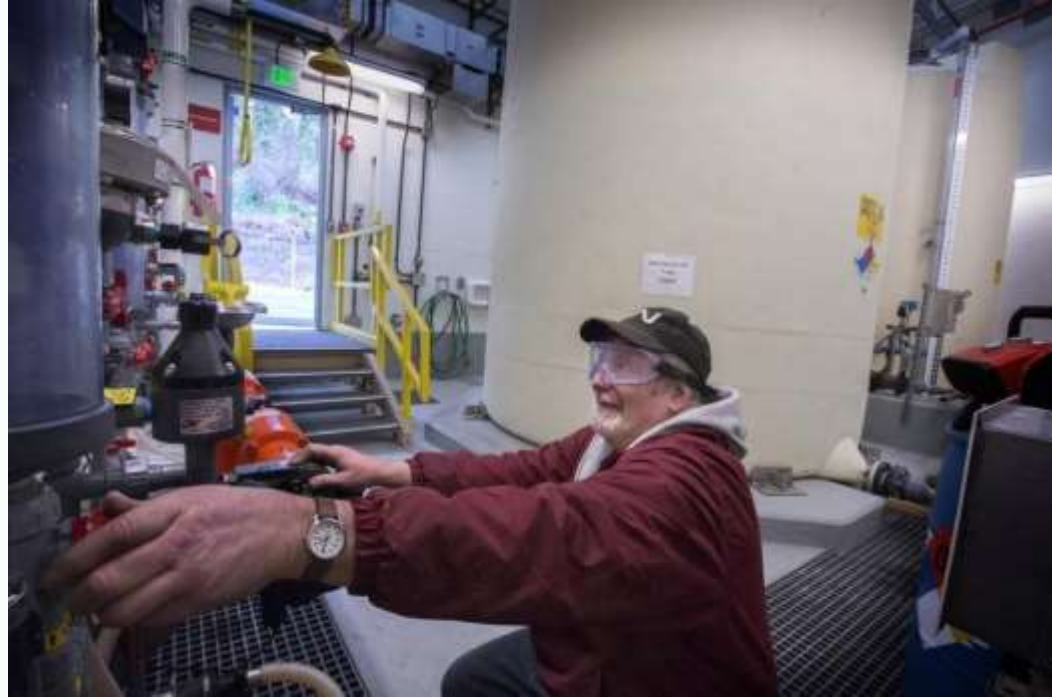
**Hood Street Reservoir  
Groundwater Treatment Facility:**  
Sodium hydroxide (25%) added to raise pH to selected target level

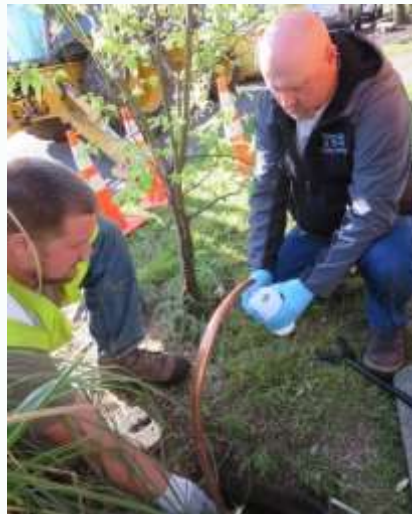
Before replacing service line:

- Disconnect home at meter, and connect home to adjacent service
- After stagnation, collect sequential samples at meter setter to see if lead gooseneck can be detected
- April 4-8 – done!

## How the tests were conducted

To find lead goosenecks that connect customer service lines to the water main below the street, Tacoma Water tested the water going to four homes for lead. This is an example of how:

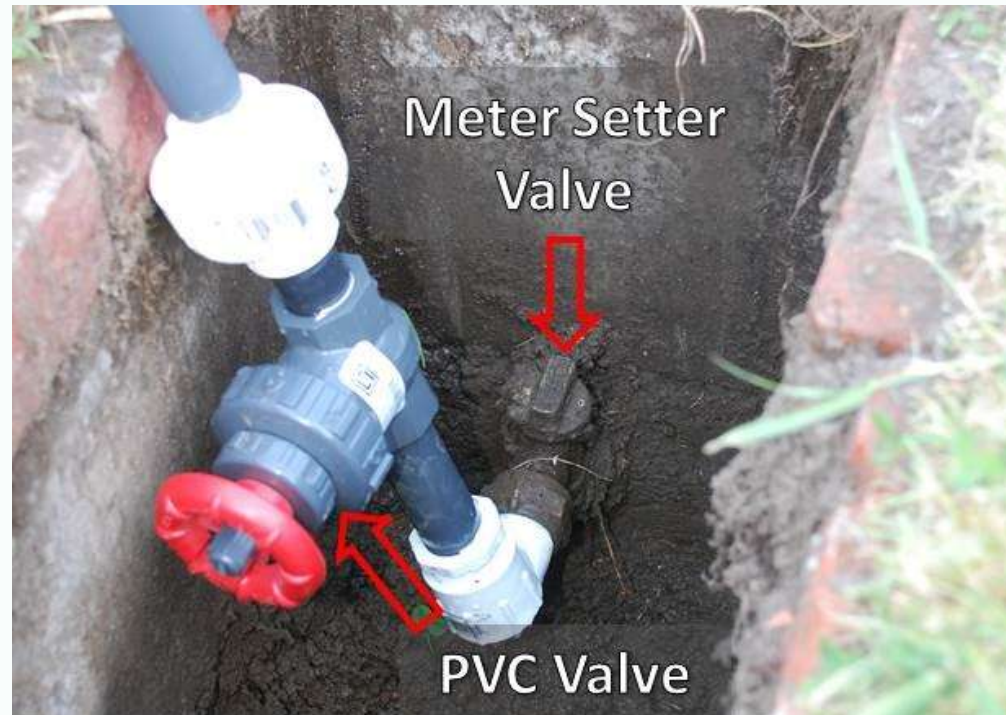
### MODIFIED “FLUSHED” PROCEDURE

- Following meter removal, downstream PVC valve installed on meter setter
- Meter setter valve opened and flushed for 2 minutes
- Meter setter valve left open and undisturbed until after stagnation samples were collected
- PVC valve closed to allow isolation for stagnation
- PVC valve used for collection of samples following stagnation

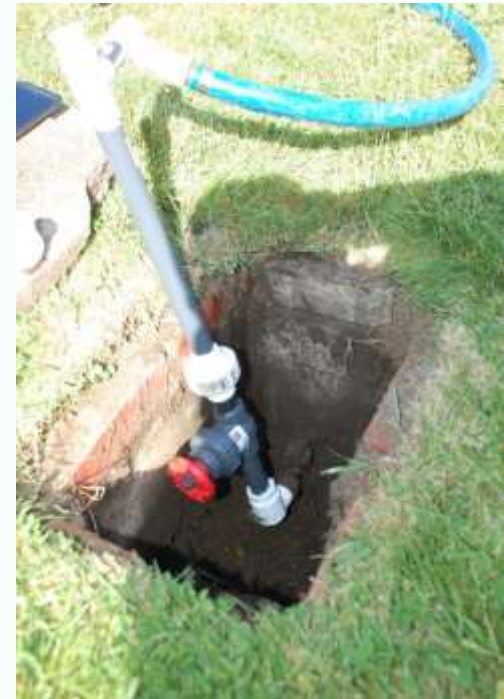
- PILOT STUDY IN-HOME FOLLOW UP TESTS
  - All below 1 ppb
- 12 ADDITIONAL HOMES TESTED (6 WITH LEAD GOOSENECKS)
  - 464 Total Samples Analyzed
  - All well below 15 ppb Action Level for lead
  - 92% of the results were less than 1 ppb
  - Highest result was 4.31 ppb
