City of Lafayette Tank Recoating Project

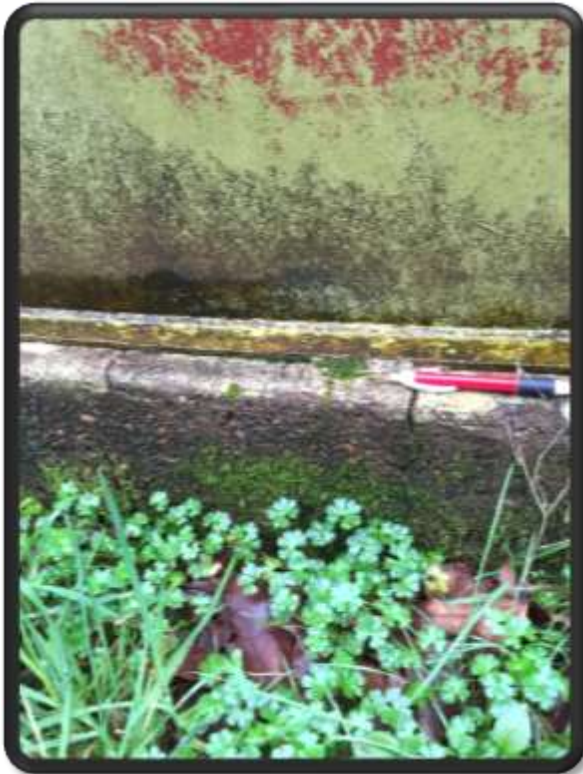
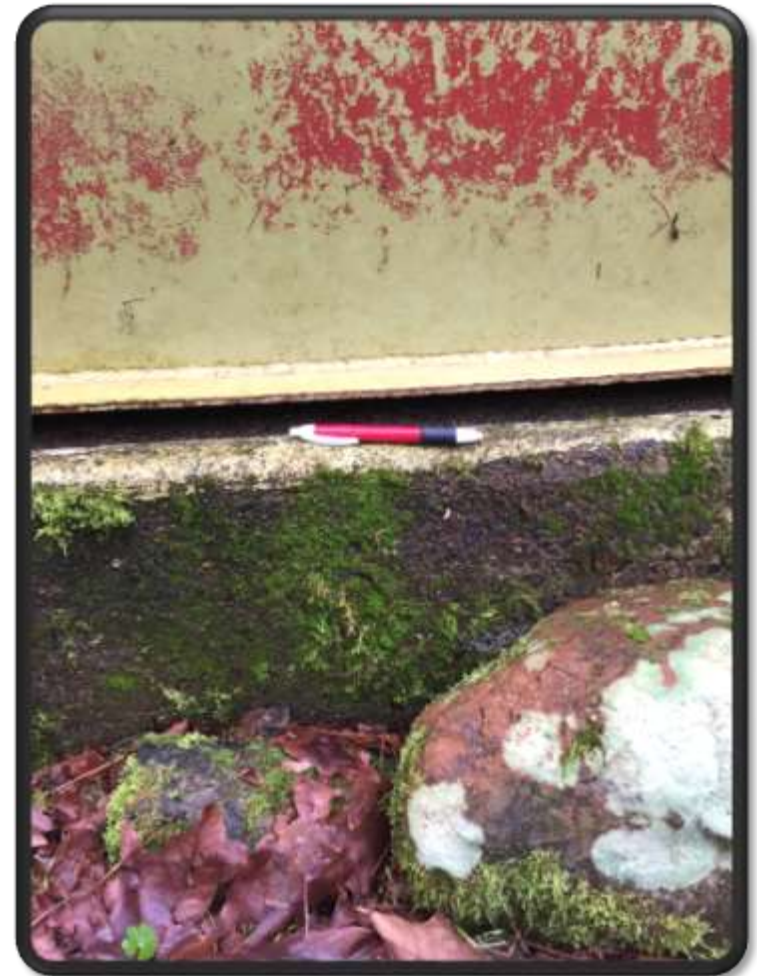
TANK ISSUES

- Separation from foundation
- Concrete foundation cracks

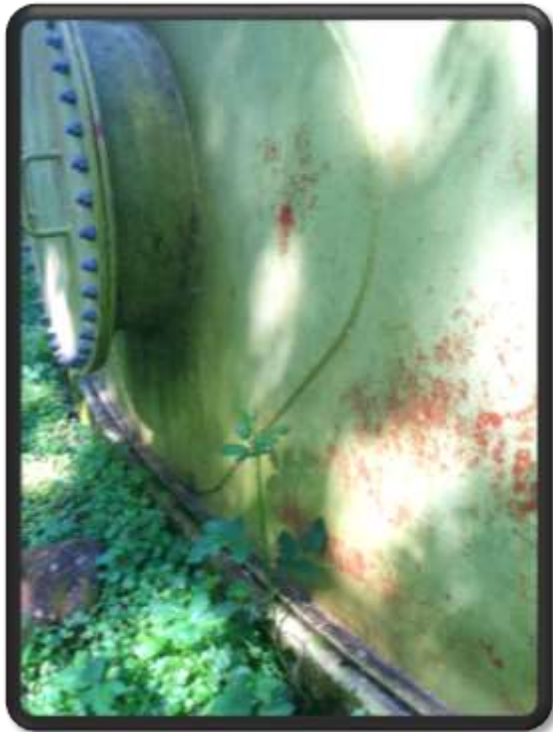
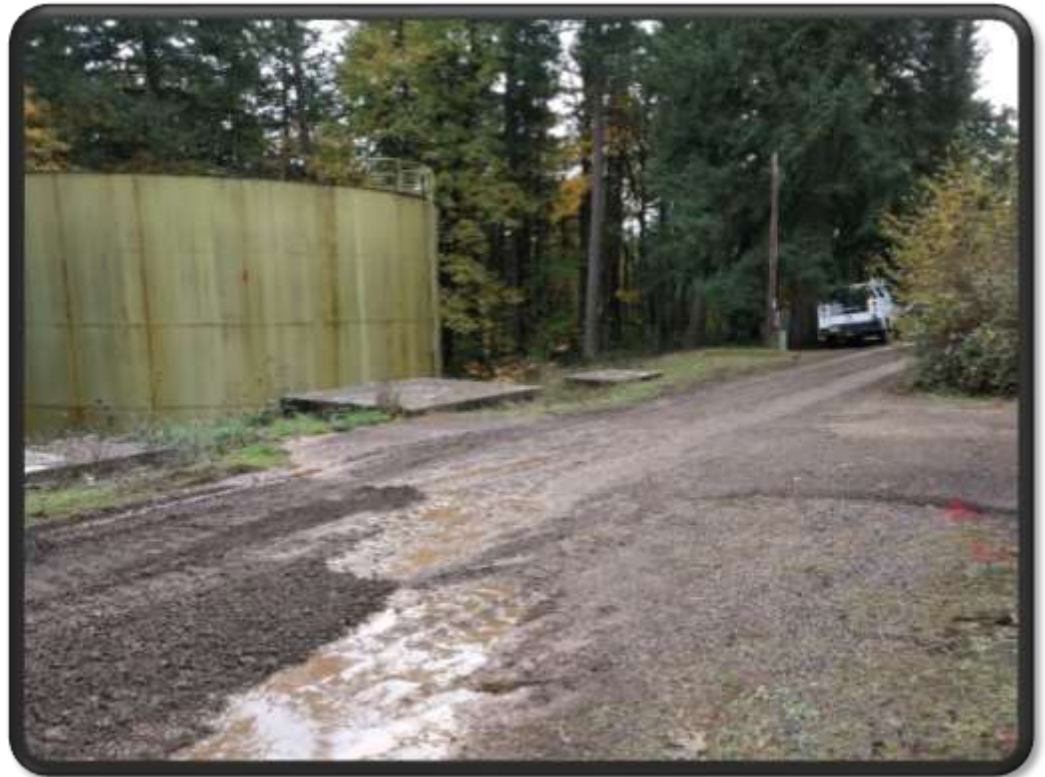
TANK ISSUES

- Base coat showing
- Last painted in 1978

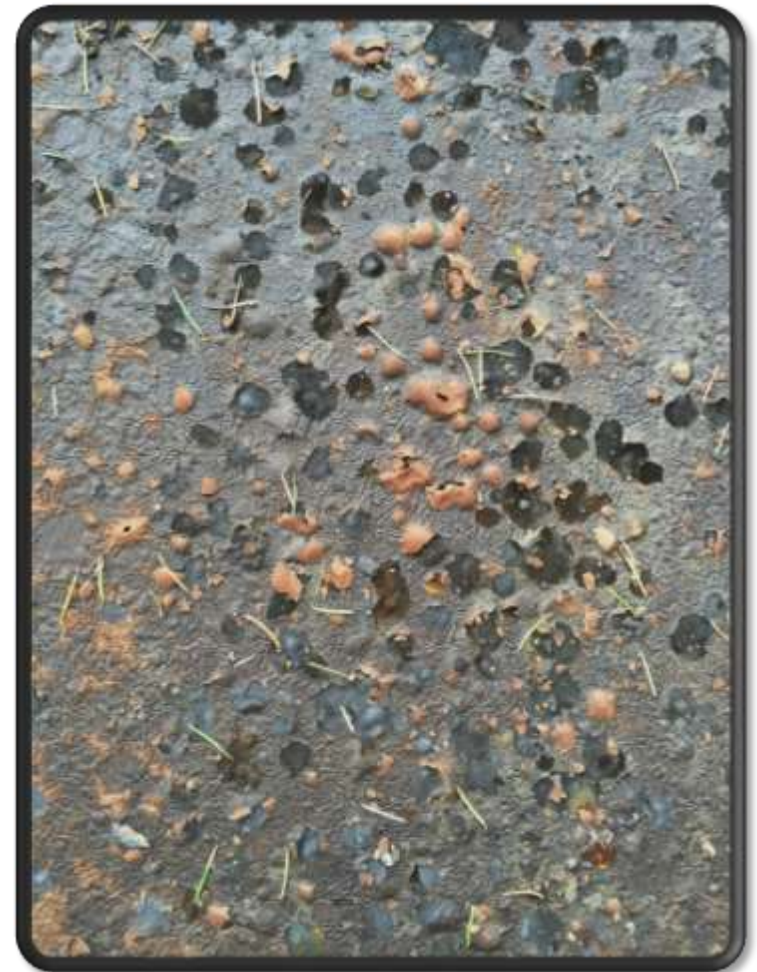
TANK ISSUES

- Internal corrosion
- Last painted in 1978

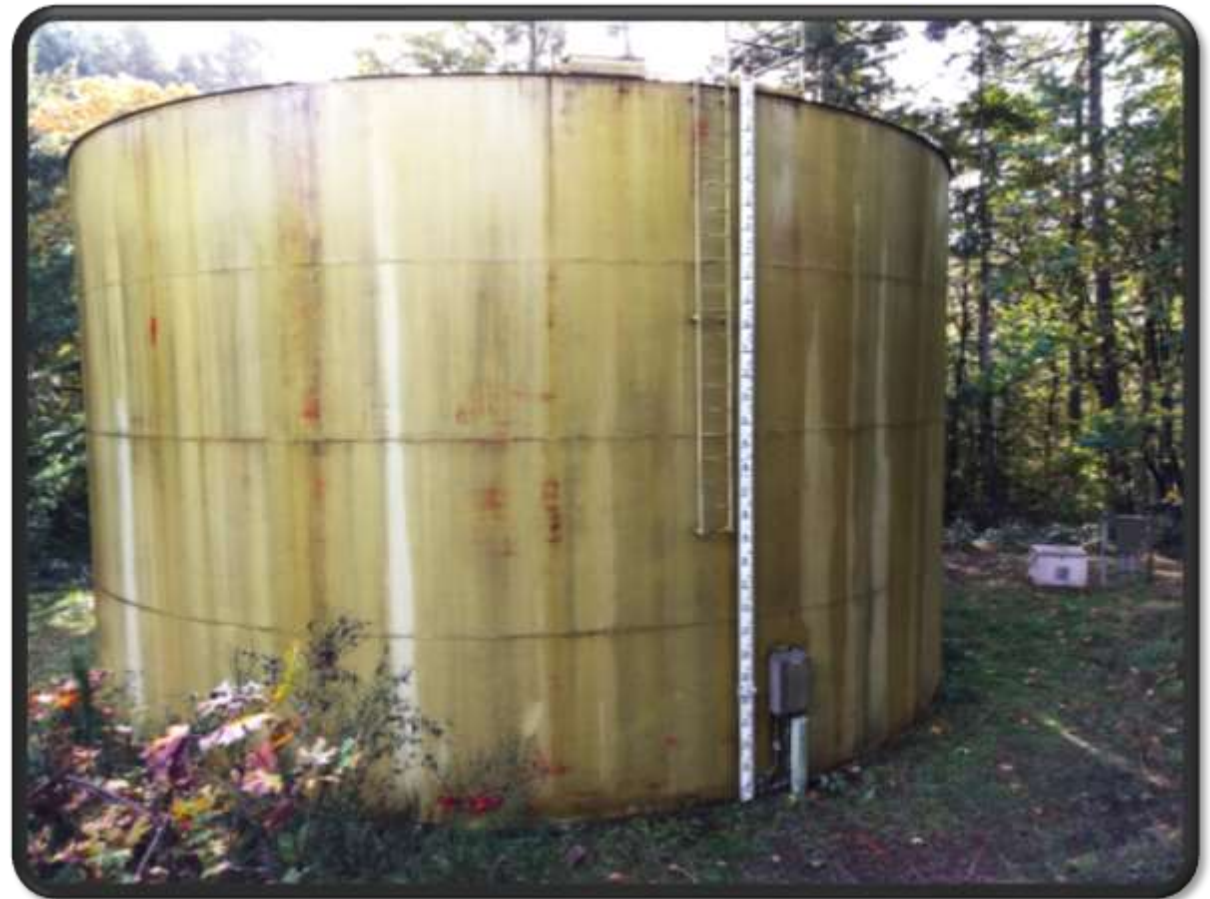
TANK ISSUES

- Safety climb

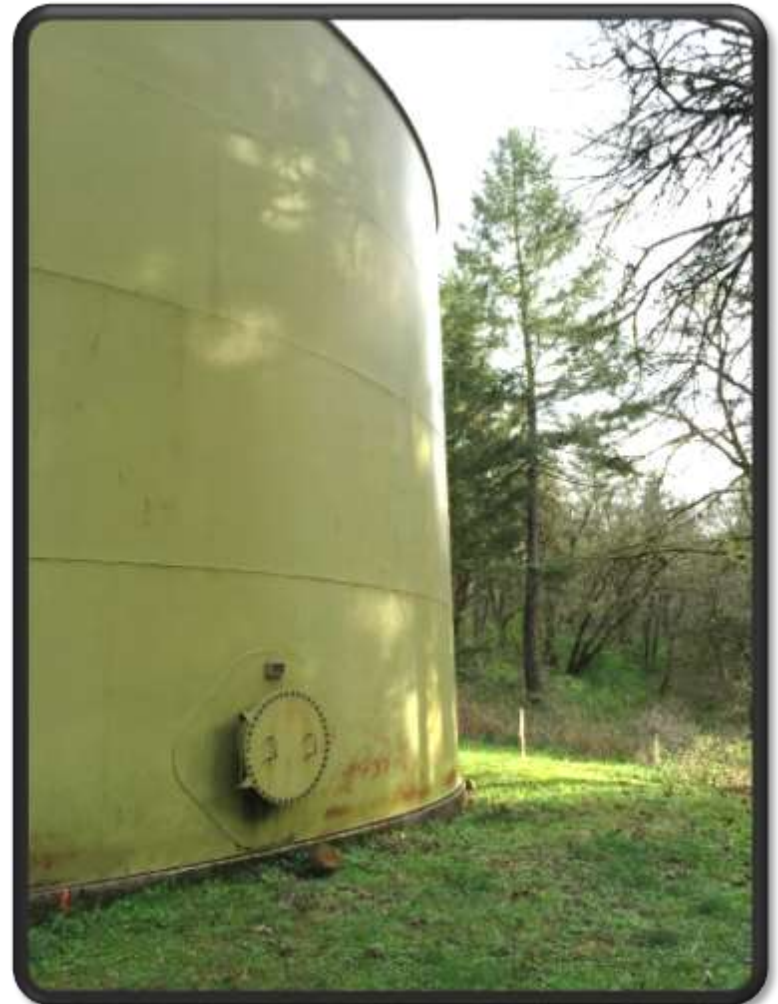
TANK ISSUES

- Ground level access – only one existing
- Latest AWWA D100-11 two recommended
- Additional cost \$10k

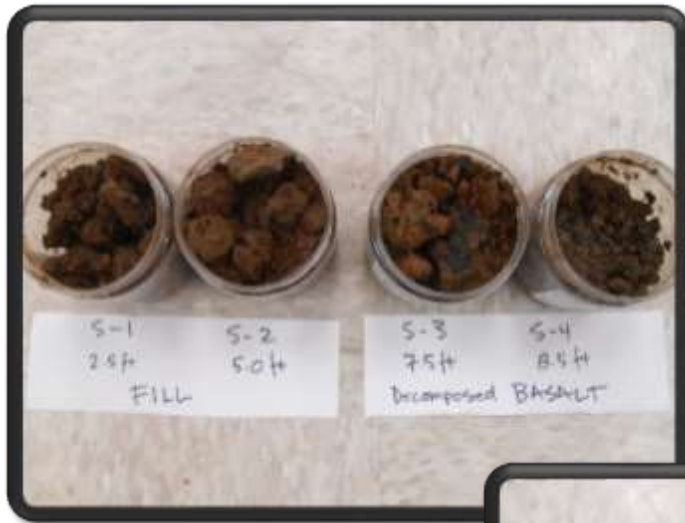
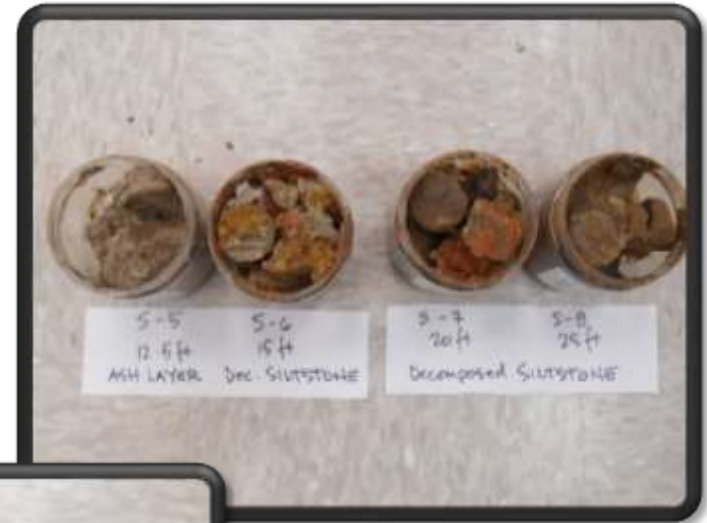
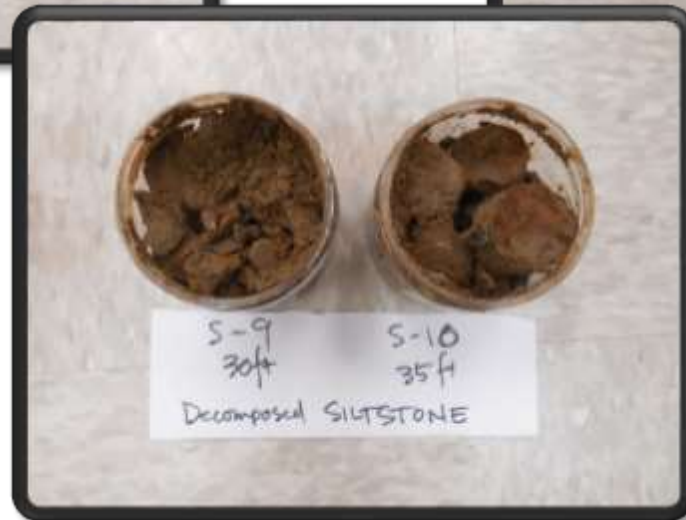
- 7.5' of fill, 5' of weathered basalt, 2.5' of clayey silt
- No obvious indications of deep-seated instability
- Vertical deformation from fill settlement
- Perhaps shallow soil creep
- Cracks in concrete appear to occur at the transition from cut to fill

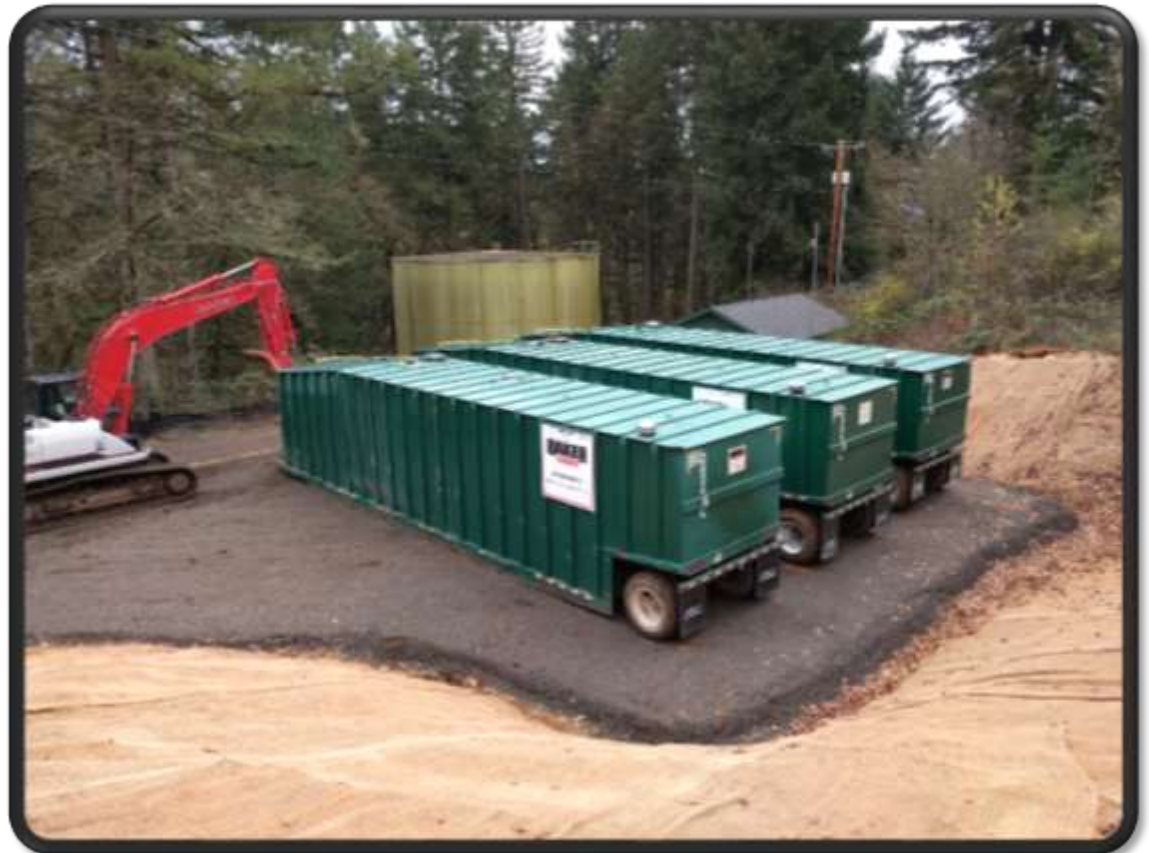
CHALLENGES – DAILY DEMAND

- Temporary storage
- Baker tanks
- 20,000 gal each
- Three tanks

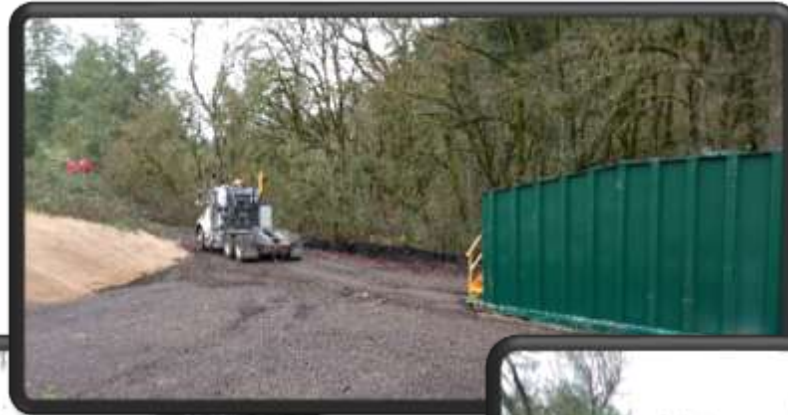
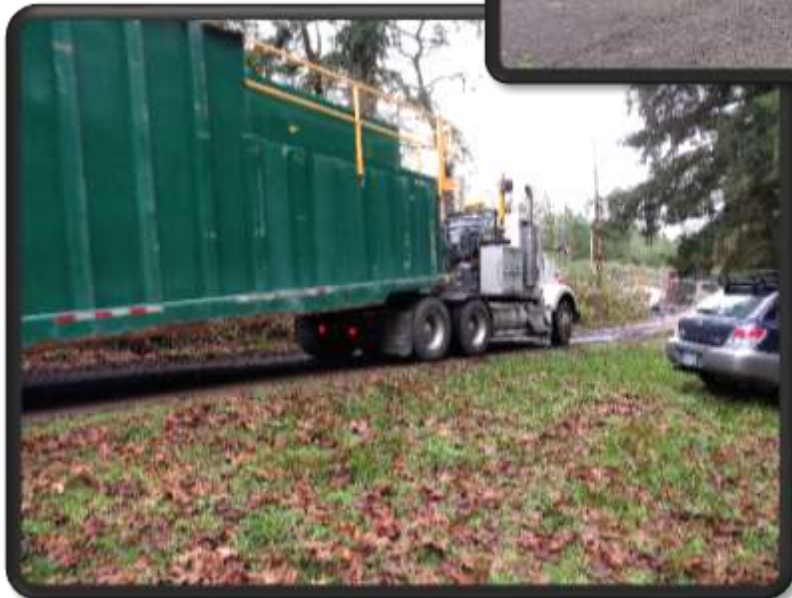
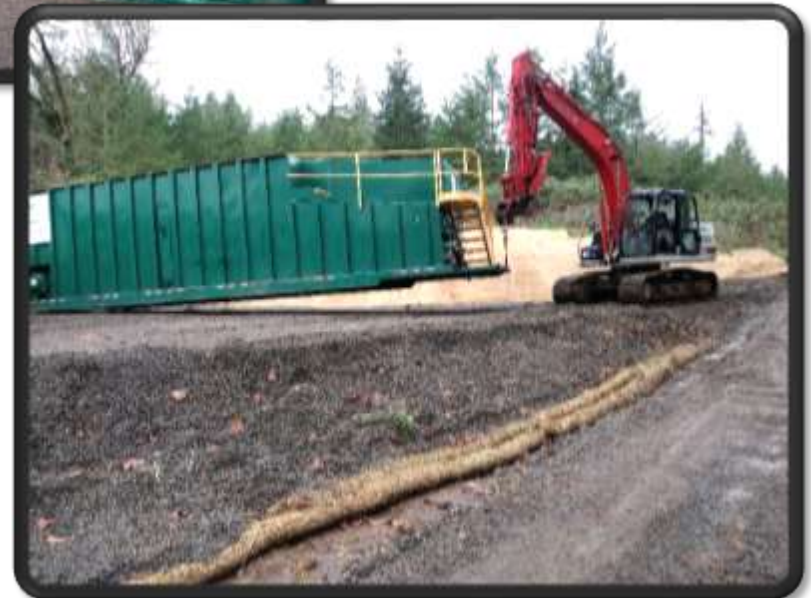
CHALLENGES – BAKER TANKS

- Access

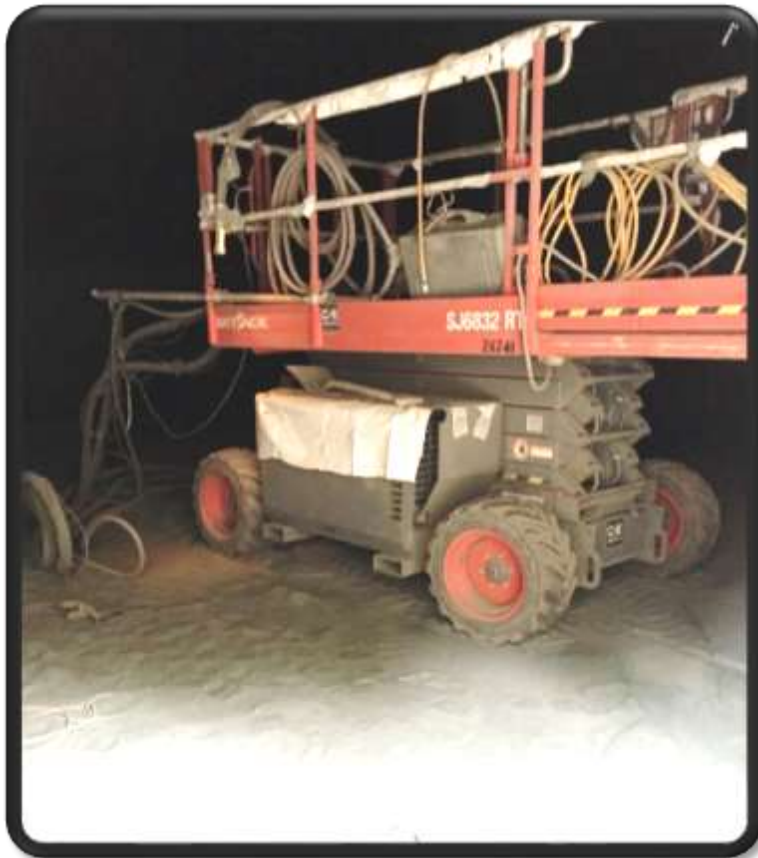
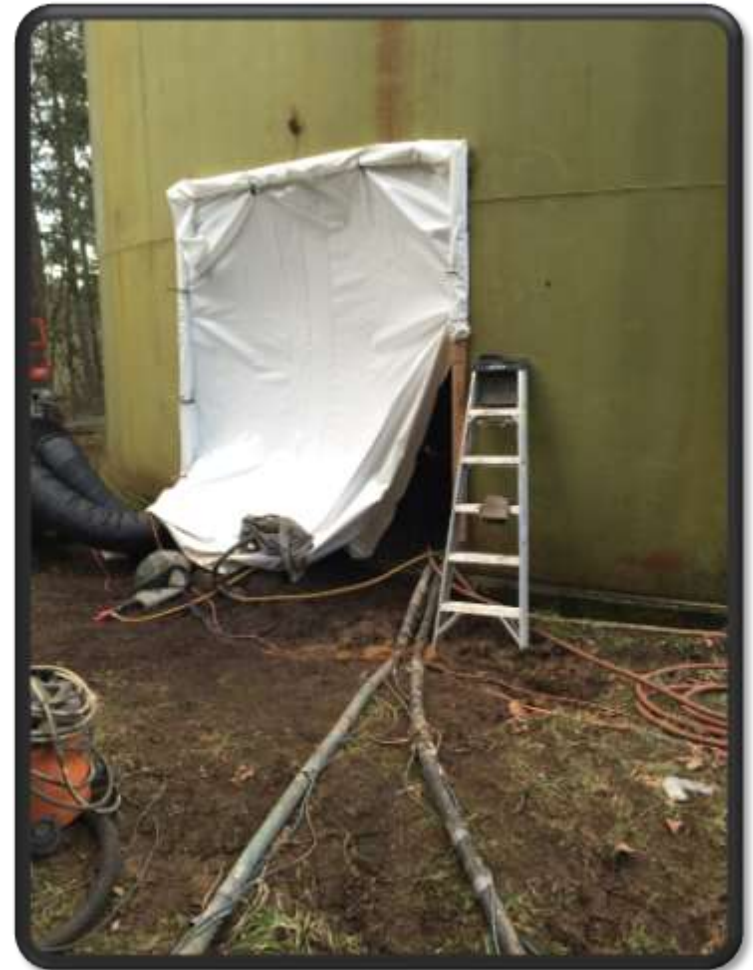
DOOR PANEL

- Speed up production

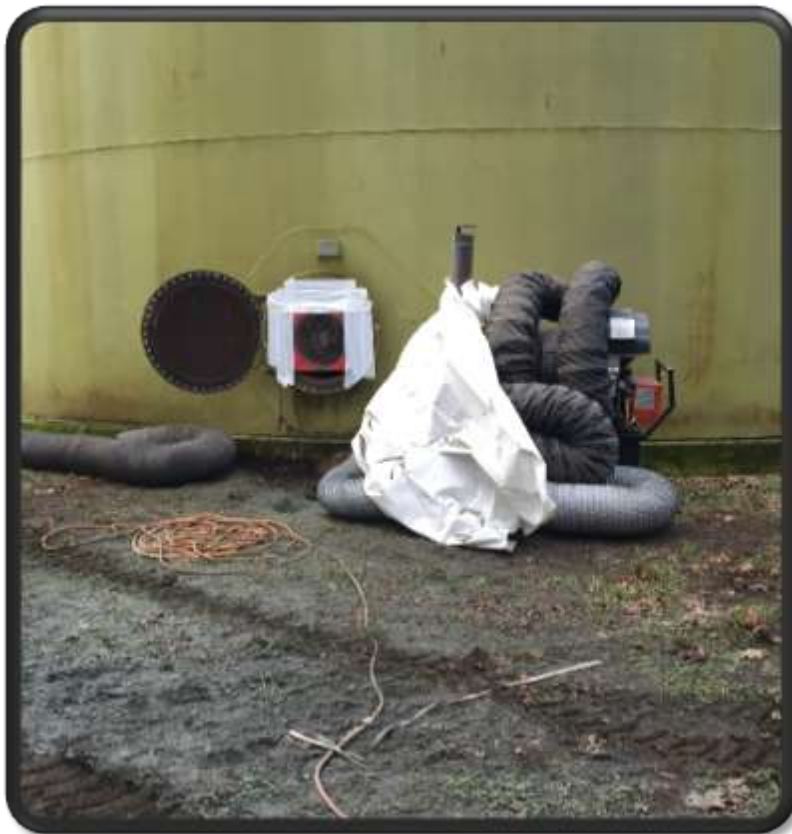
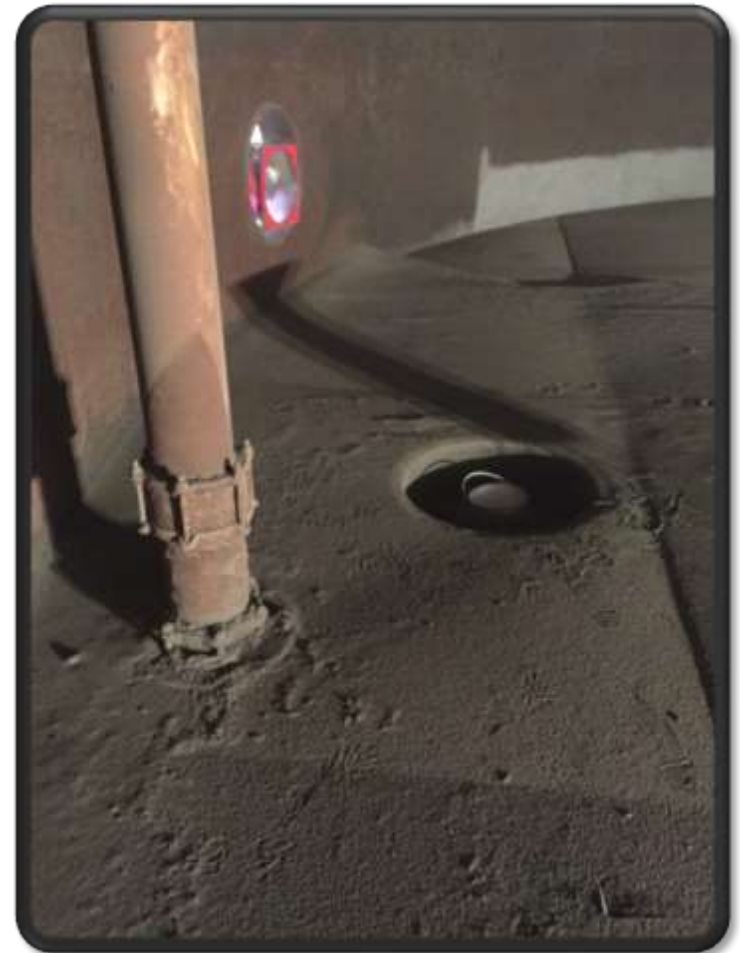
INTERNAL INSPECTION

- Floor and walls
