What if Your Meters Could Hear the
Leaks You Can't See?

kamstrup

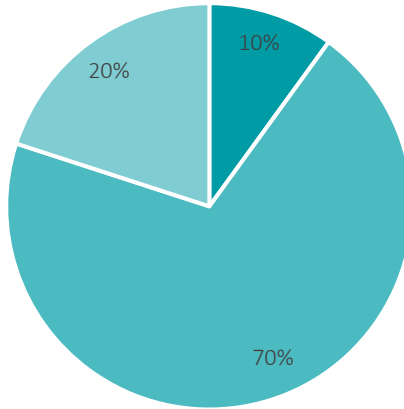
Water System Leaks By Type

■ mains ■ services ■ other

**NOTE: every water system is different*

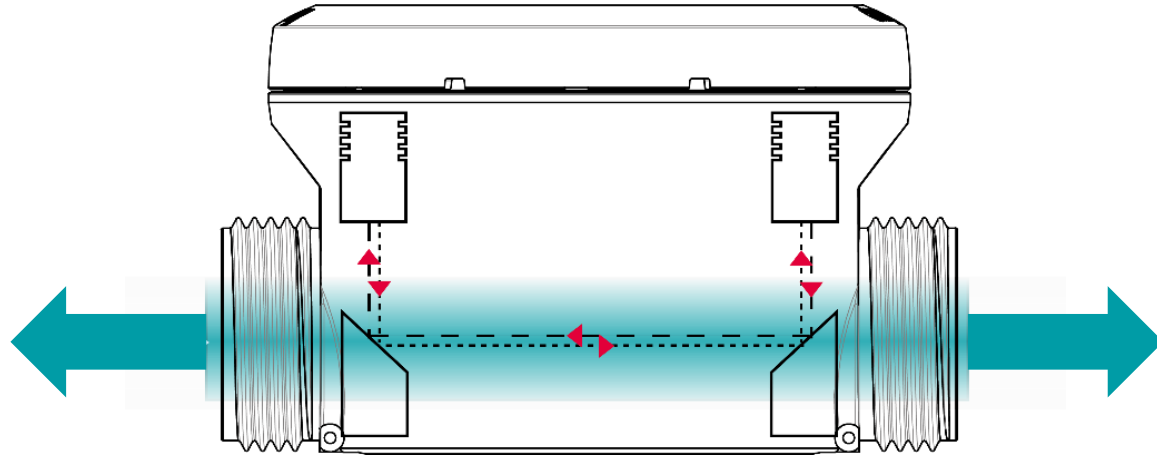
Integrated acoustic sensor with the ultrasonic measuring principle

With the integrated acoustic sensor, it is possible to measure noise in both direction of the pipe.

The acoustic sensor does not influence the flow measurements at any time.

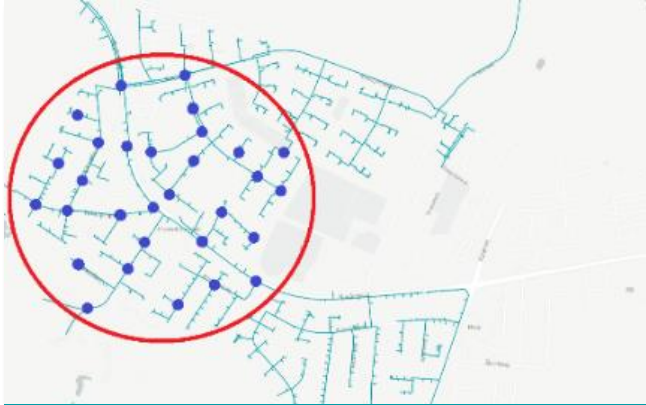
Main Line Focus / liftNshift

Ex. 30 Main Loggers => 1 Logger Per 800 Ft

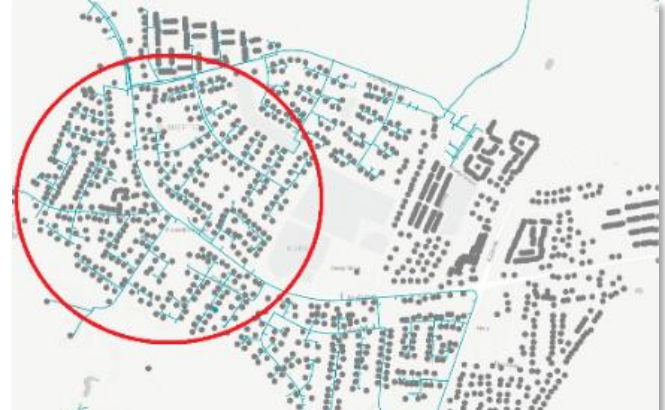
Service and Main Line Focus

Ex. 450 Water Meters => 50 Ft

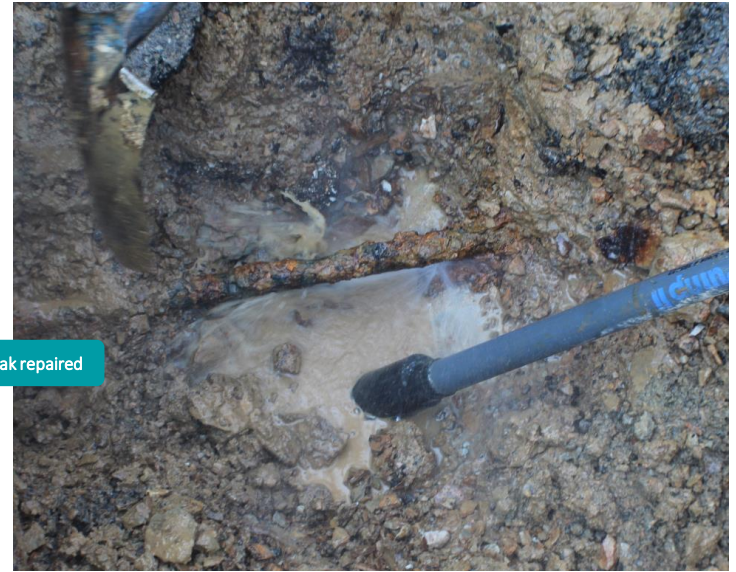
- High noise detected on several meters
- Service line leak had been running a minimum of 5 months

Leak estimated at 2 GPM and had been running for at least 5 months

Utility Service Line made from ductile iron

Distance to leak was approximately 30 feet to 150 ft

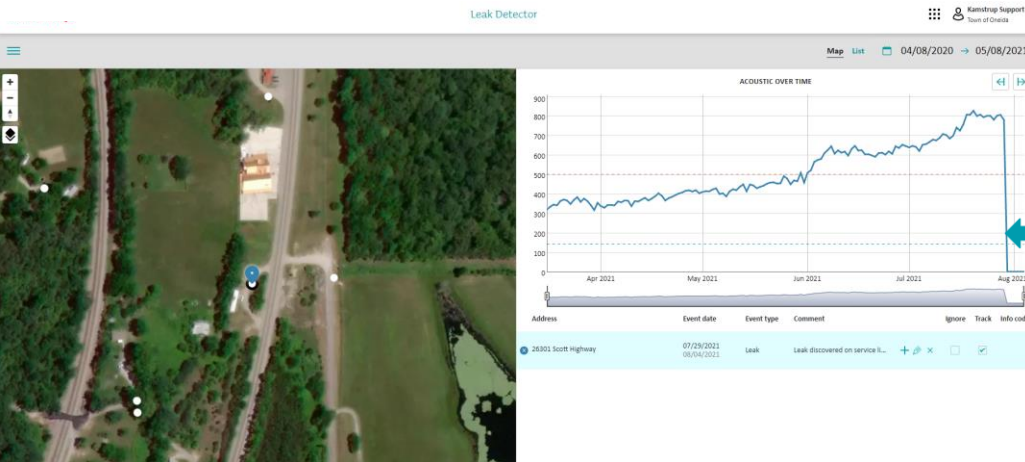
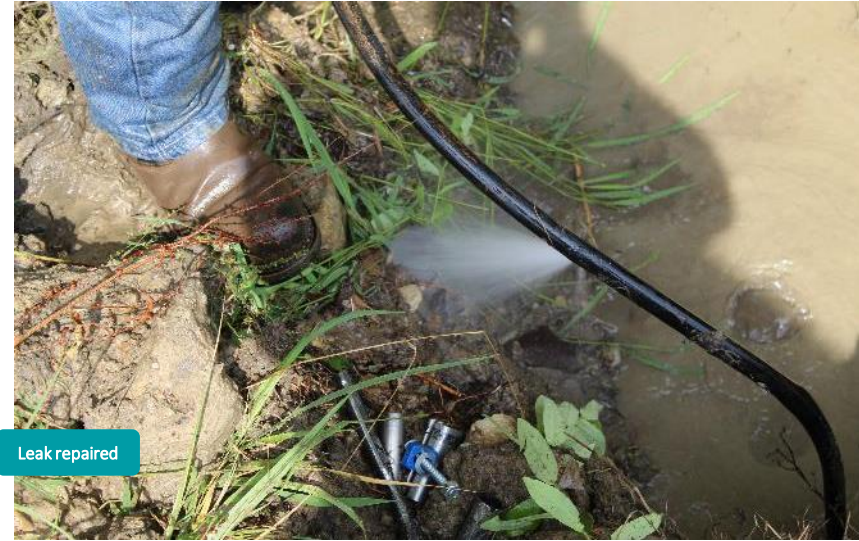
Customer Success

- High noise detected on single meter
- Service line leak had been running a minimum of **4.5 months**
- The revenue lost estimated around **\$21,000** in 12 months

Leak estimated at 4 GPM and had been running for at least 4 months

Utility Service Line made of PVC

Distance to leak was approximately 50 ft

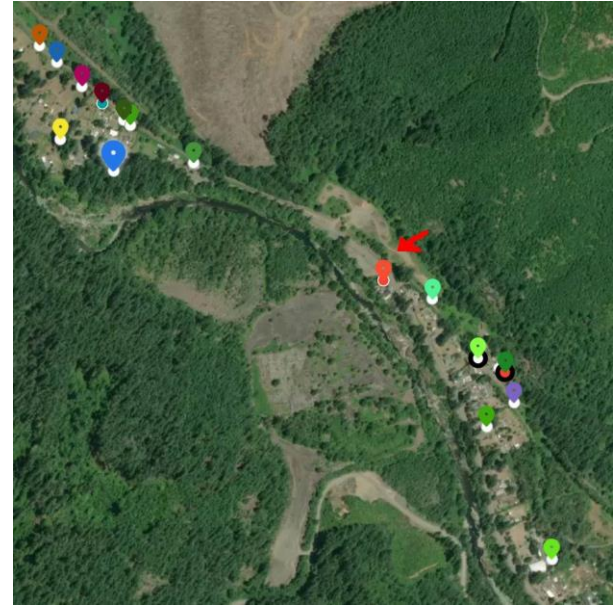
Leak on a 14" main

30 GPM rate of flow

Distance heard up to half a mile on both ends from galvanized pipe

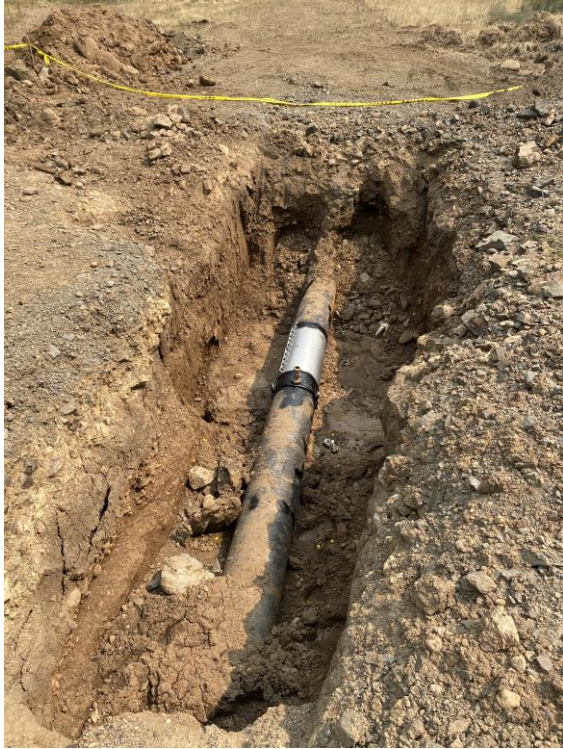
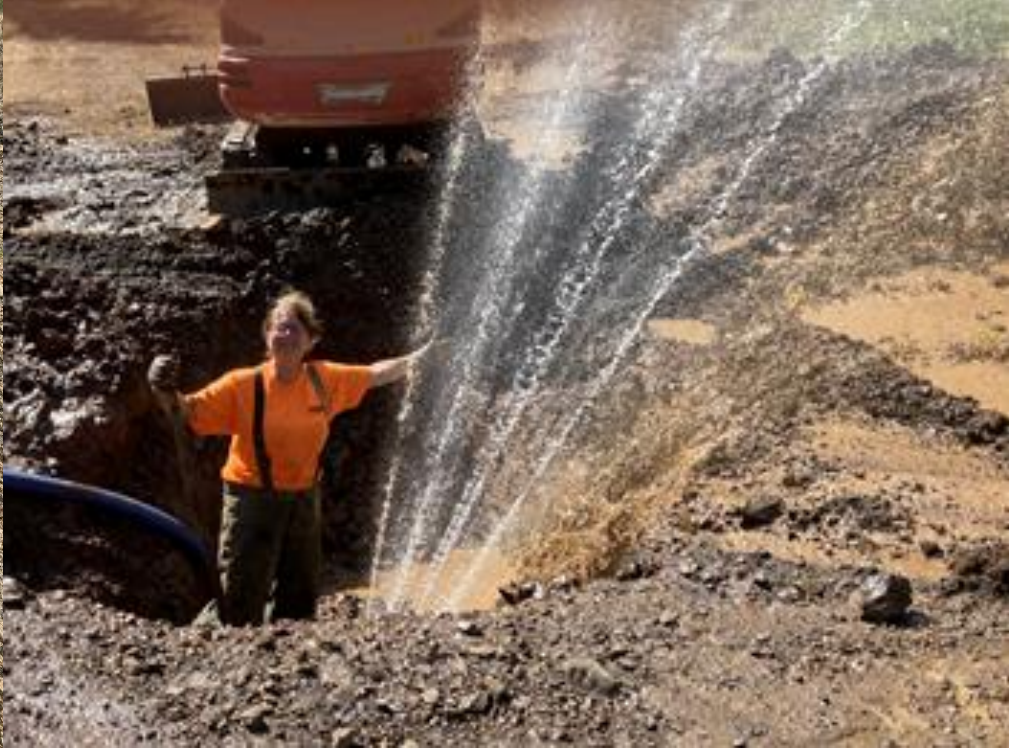
Ephrata, PA

- Leak was pinpointed and confirmed by local crews and the use of a correlator / ground mic

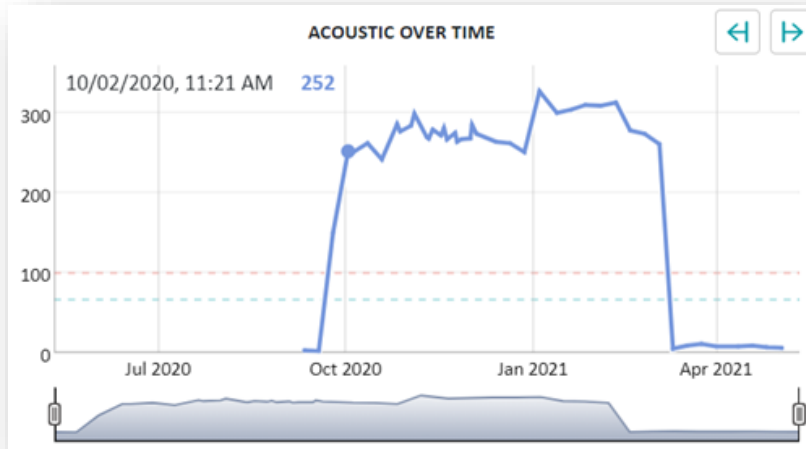
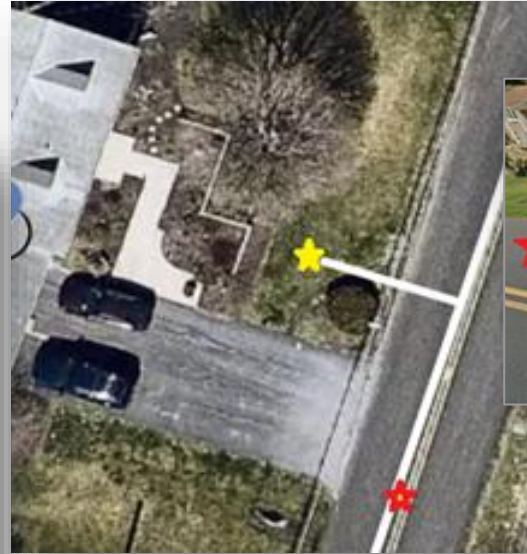
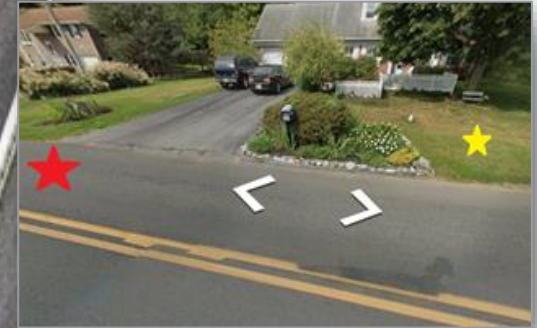
Leak on 12" main

Leaking from stainless steel clamp

55ft. From copper service line
