# HARD WATER

2024 PNWS ANNUAL CONFERENCE

CITY OF SPOKANE

WATER QUALITY COORDINATOR

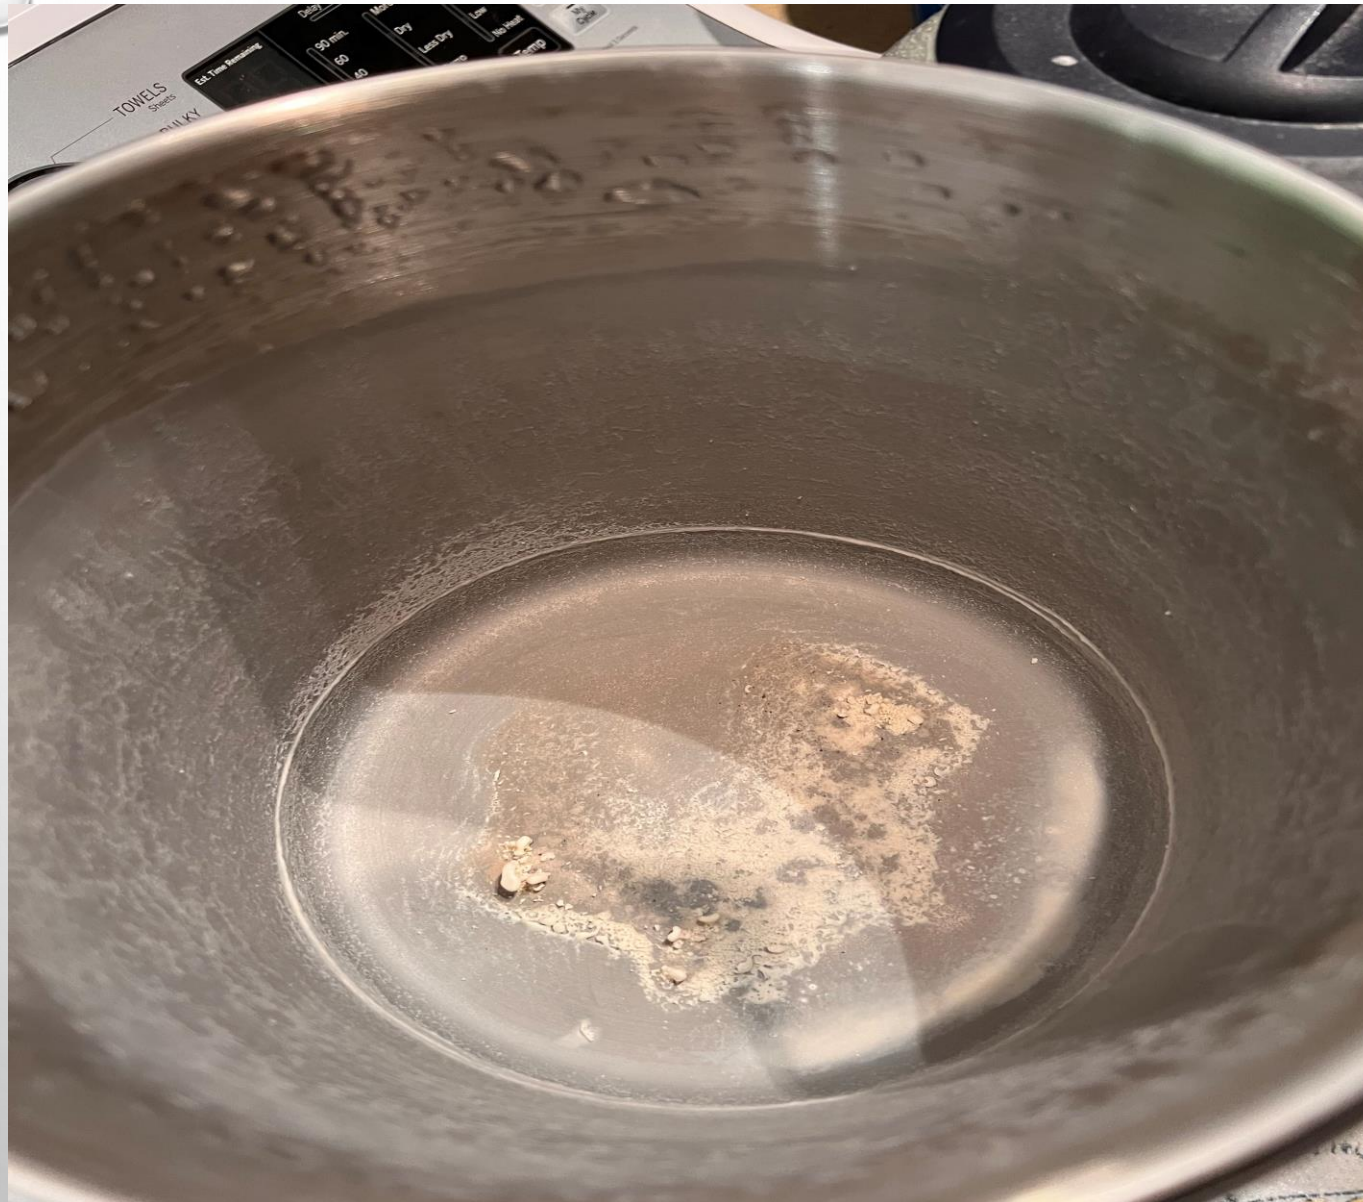
- WE HAVE HARD WATER BY USGS DEFINITION
  - USGS DEFINES HARD AS GREATER THAN 121 MG/L OF  $\text{CaCO}_3$
  - OURS DOES VARY BUT IN GENERAL IS ABOVE 131 MG/L OF  $\text{CaCO}_3$
  - ALSO REFERRED TO GRAINS PER GALLON
    - 131MG/ L IS 7.7

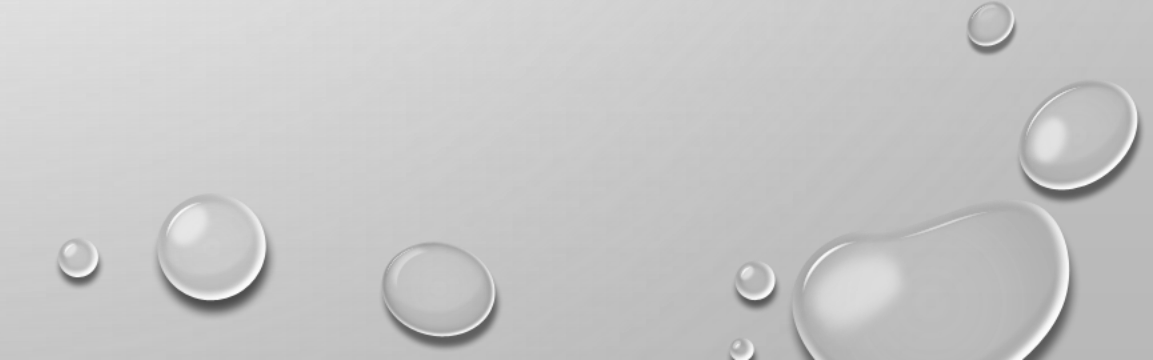
- SEE THEM IN YOUR TEA KETTLE
  - HOT WATER
  - EFFECTS HOW SOAP FOAMS
  - LEAVES SCUM ON GLASS WARE
  - DEPOSITS IN YOUR DISHWASHER
-

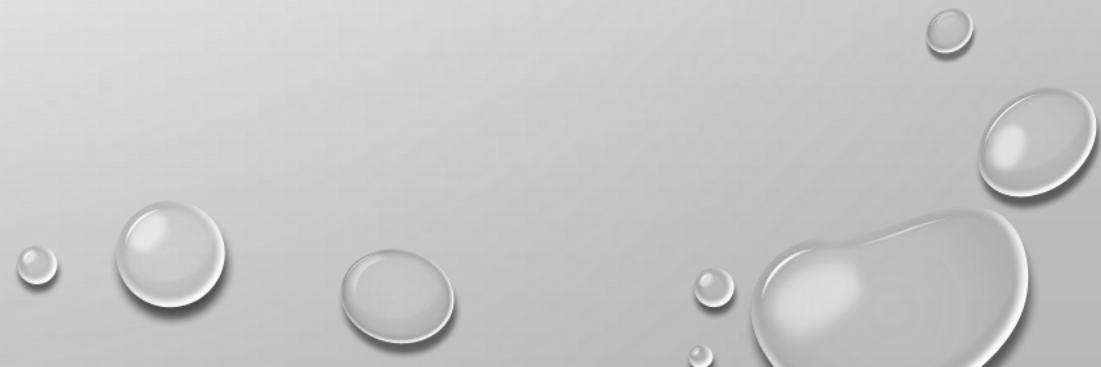
- BACTERIA
- EXCESSIVE DEPOSITS
- RUST

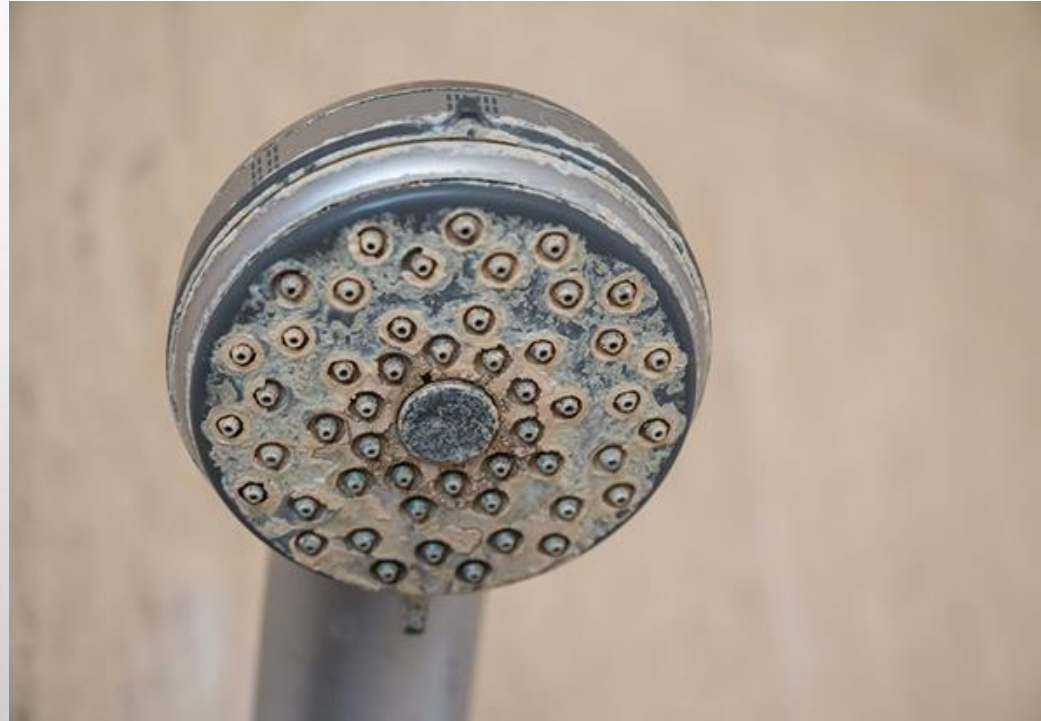
# KITCHEN FAUCET SCALE

- CUSTOMER CALL
  - WATER TASTES OFF AND SMELLS BAD
  - ICE CUBES TASTE WEIRD – DIRTY
- COLIFORM BACTERIA SAMPLE FROM KITCHEN FAUCET WAS TOTAL COLIFORM POSITIVE

- ALL OF THOSE DEPOSITS GIVE PLENTY OF HOMES FOR BACTERIA TO GROW
- IT IS VERY INEXPENSIVE AND EASY TO SOLVE
  - CLEAN WITH VINEGAR
    - FILL A PLASTIC BAG WITH VINEGAR
    - SUBMERGE FAUCET IN BAG AND SECURE END WITH A RUBBER BAND
    - SOAK 30 MINUTES
    - REMOVE FAUCET AND CLEAN OFF SCALE WITH SOFT BRUSH
- VINEGAR IS AN ACID DISSOLVING THE SCALE AND ANTI-BACTERIAL TO DISINFECT

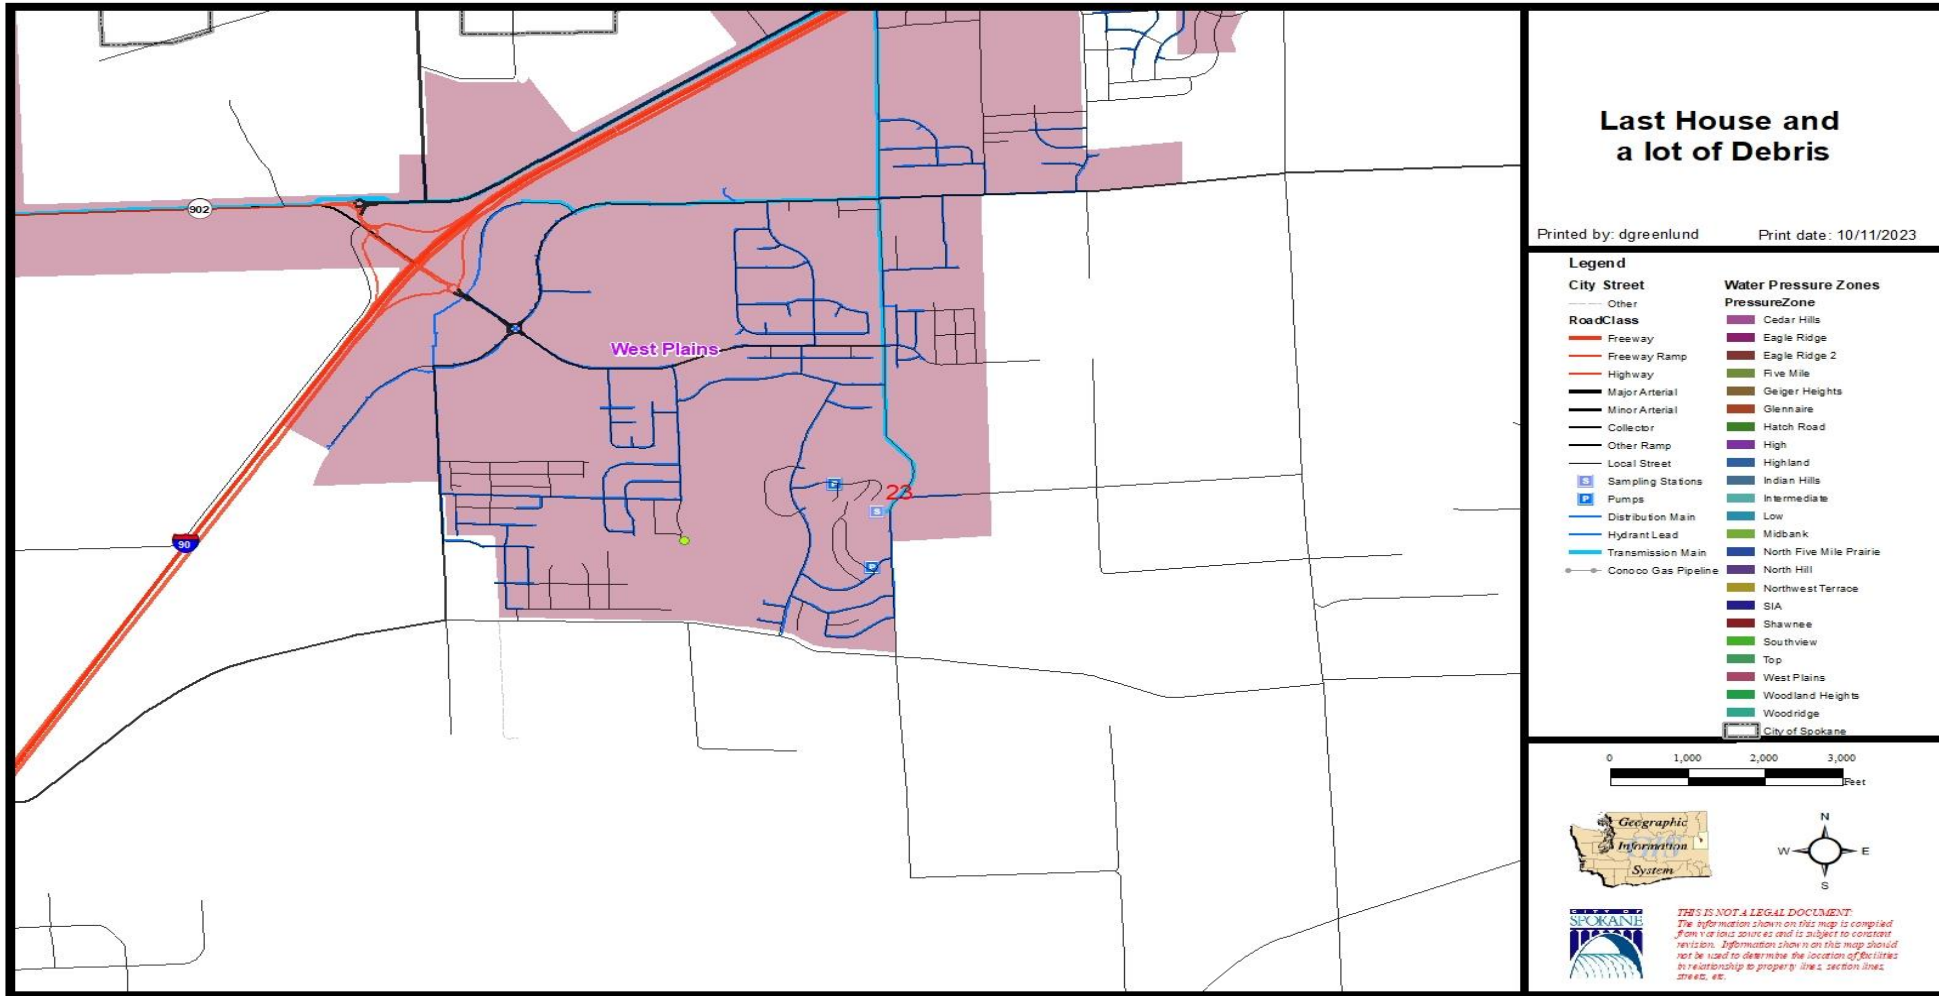
# THE LAST HOUSE

- RECEIVED A CALL FROM A CUSTOMER OF A LOT OF DEPOSITS IN AERATOR
- HAD MATERIAL PACKED INTO THE KITCHEN SINK AERATOR
- WASHING MACHINE LINE WAS SO PACKED THE UNIT BARELY FILLED
- MATERIAL LOOKED LIKE DRY WALL
- TWO PEOPLE LIVED IN HOME ABOUT 2 YEARS
