AWWA-PNWS

Abrasive Situation: Rehab and Protection of 21-foot Diameter Raw Water Supply Piping

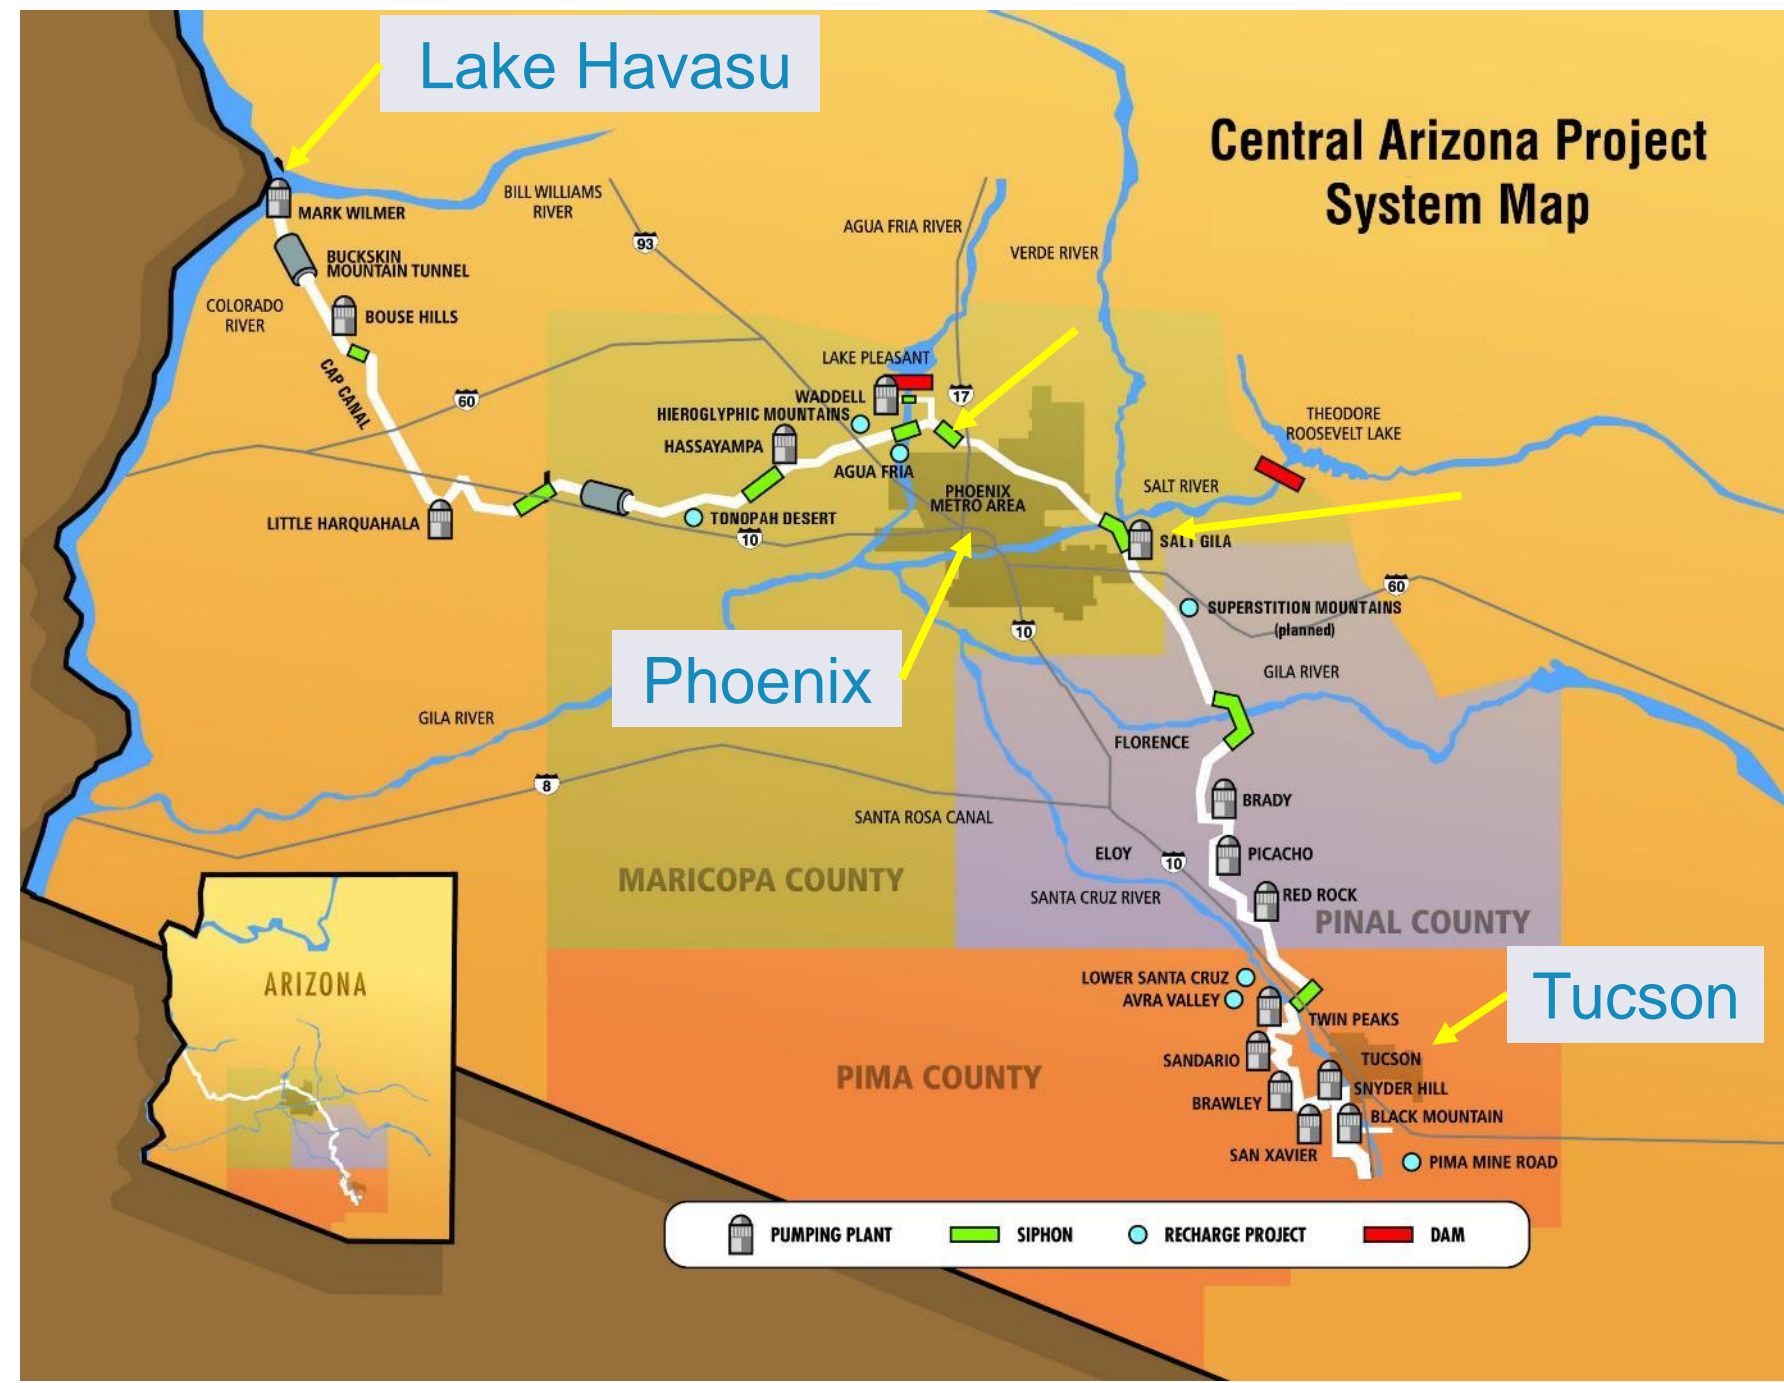
Locations of Siphons

- 7 siphons
- Agua Fria & Salt River Siphons are the focus of the Study
- 21' diameter steel pipelines
- Constructed in mid-1990's to replace pre-stressed concrete pipes
- Each just under 10,000 feet

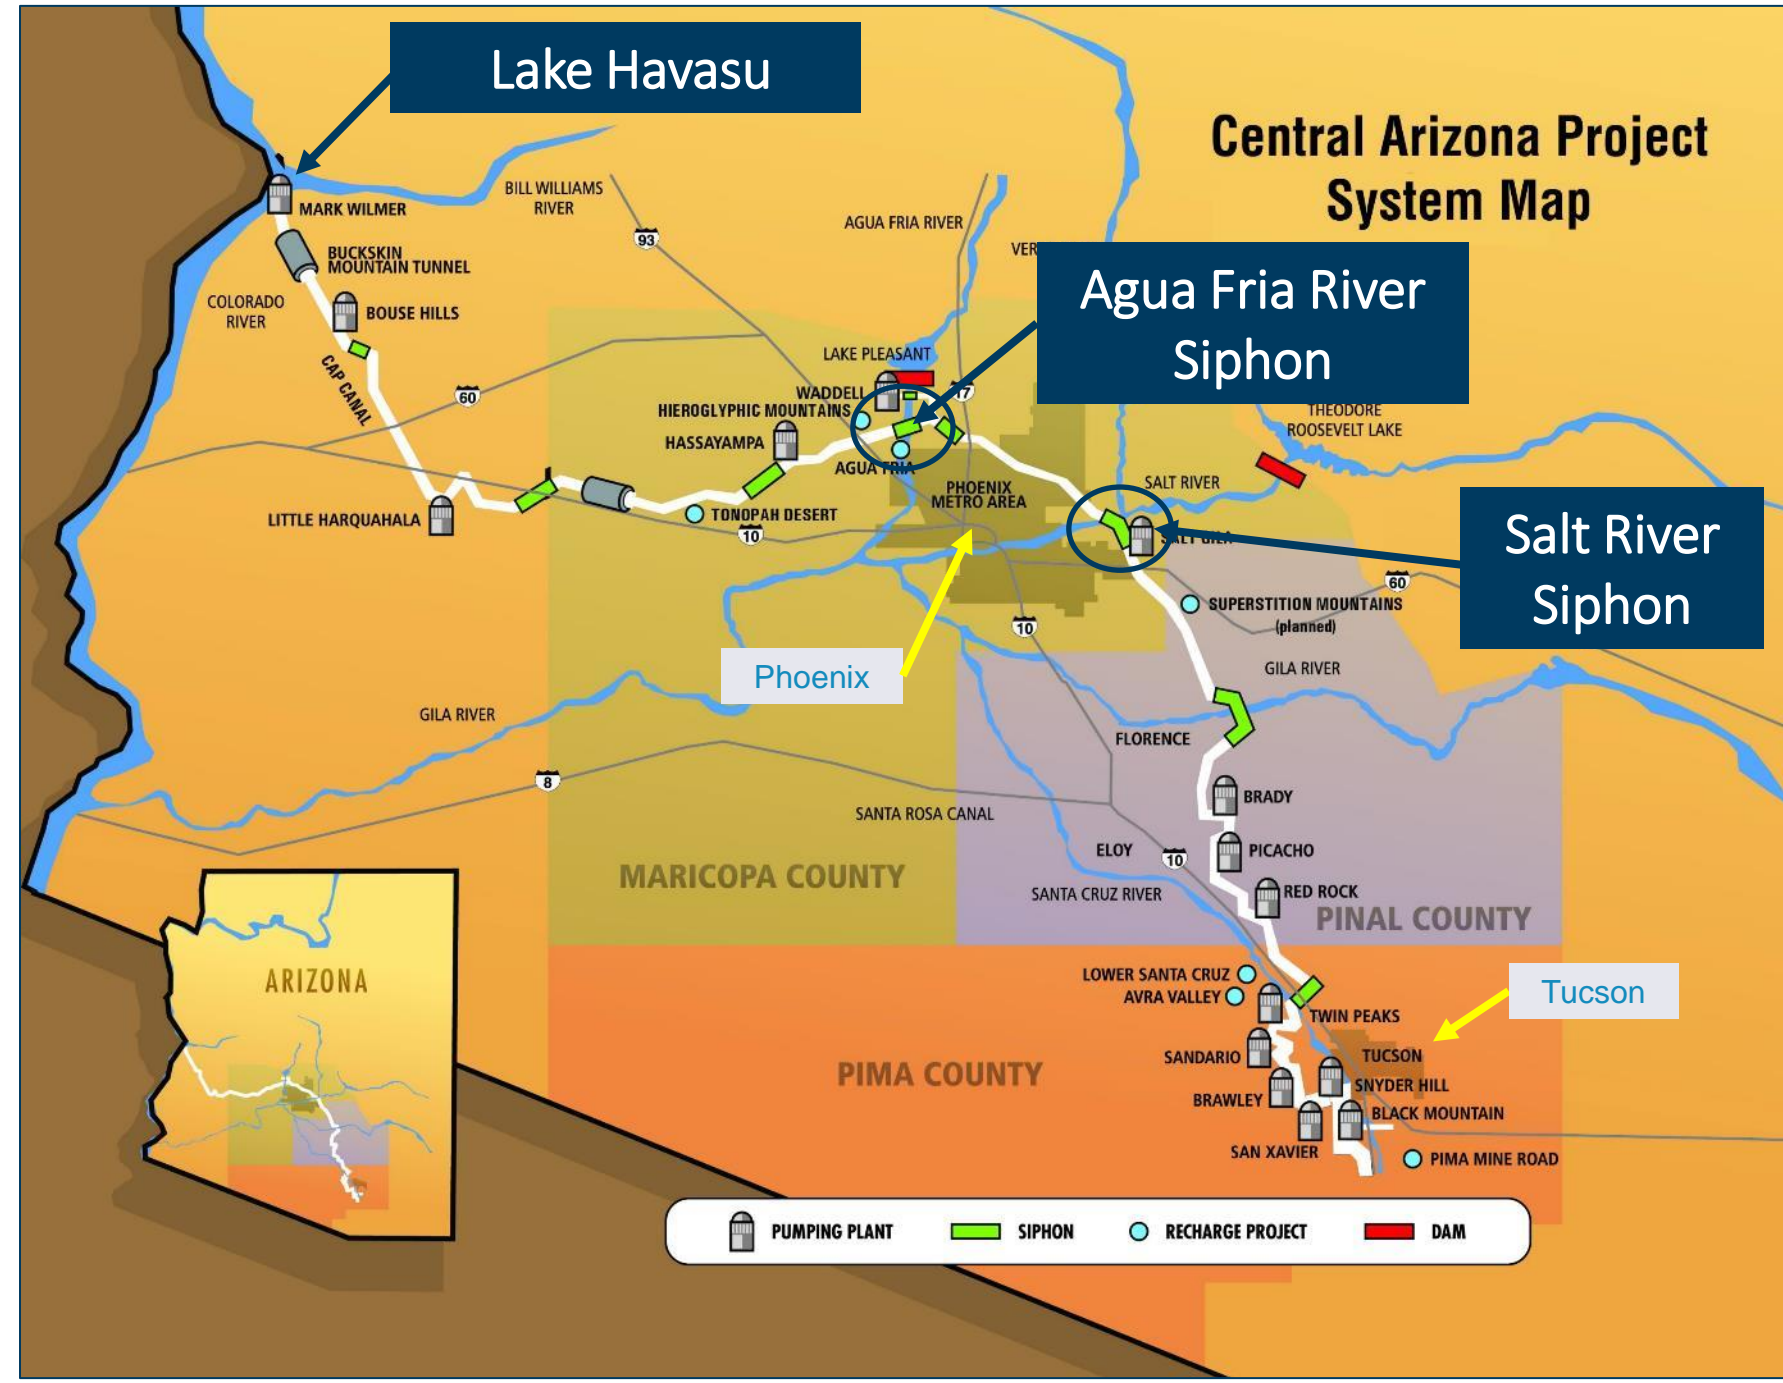
Profile View of Salt River Siphon (SRS)

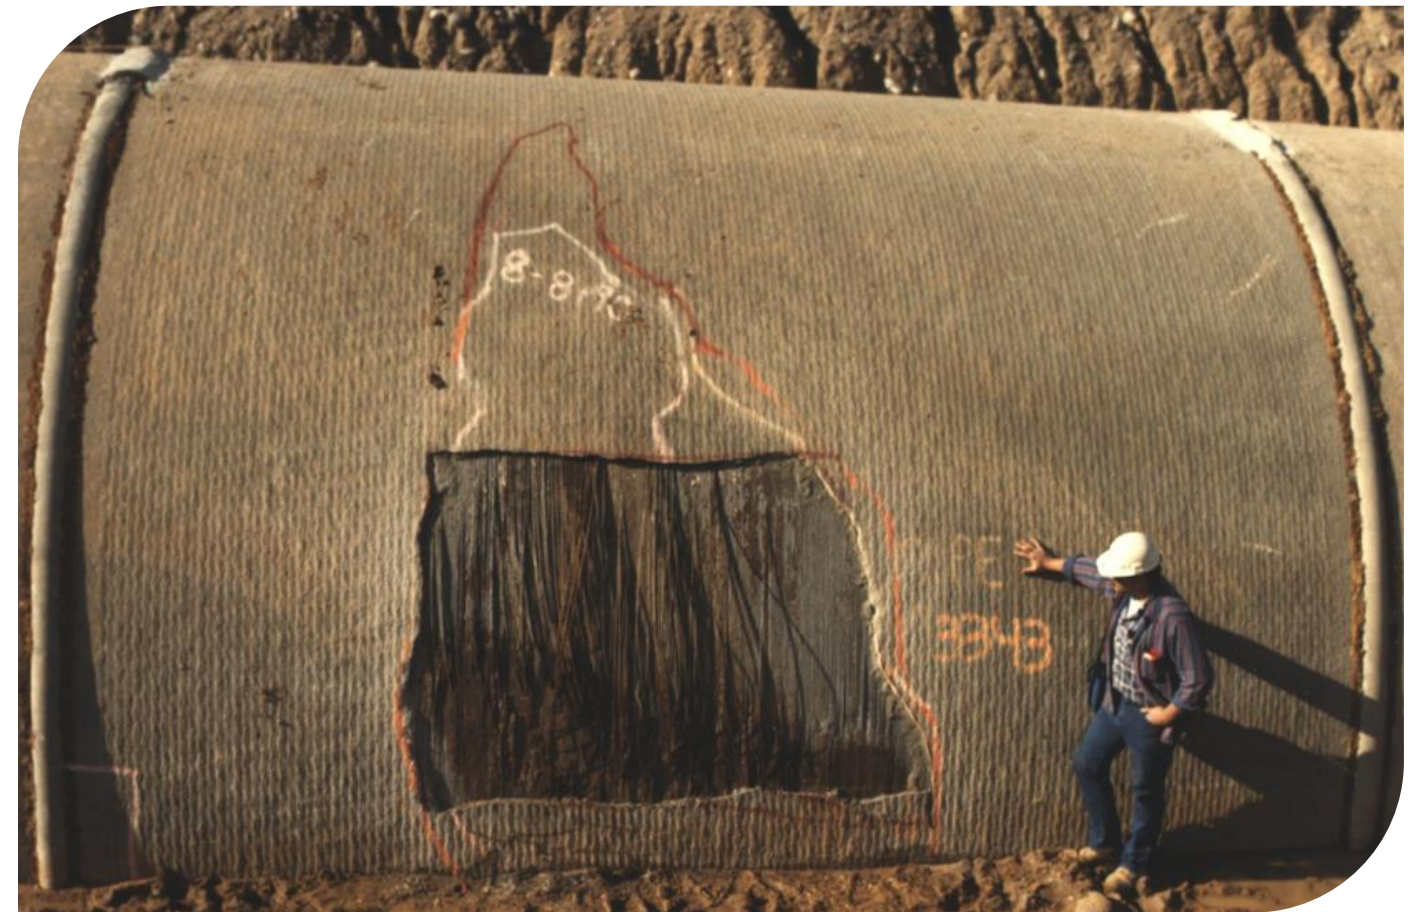
Example of Prestressed Concrete Pipe with Corrode Prestressing Wires

- Late 1970's – Prestressed concrete pipelines constructed
- Early 1990's - Decision to replace prestressed concrete pipelines
- Latter 1990's – Current steel pipelines constructed and commissioned
- Late 1990's/Early 2000s – Conducted extensive repairs to the liner
- 2018 – Inspected Steel Pipelines – Found significant loss of liner and corrosion of the substrate
- 2019 – Repairs/replaces liner in <10% of Salt River Siphon ~ \$5.5 Million in 6-week outage
 - Determined to be unsustainable

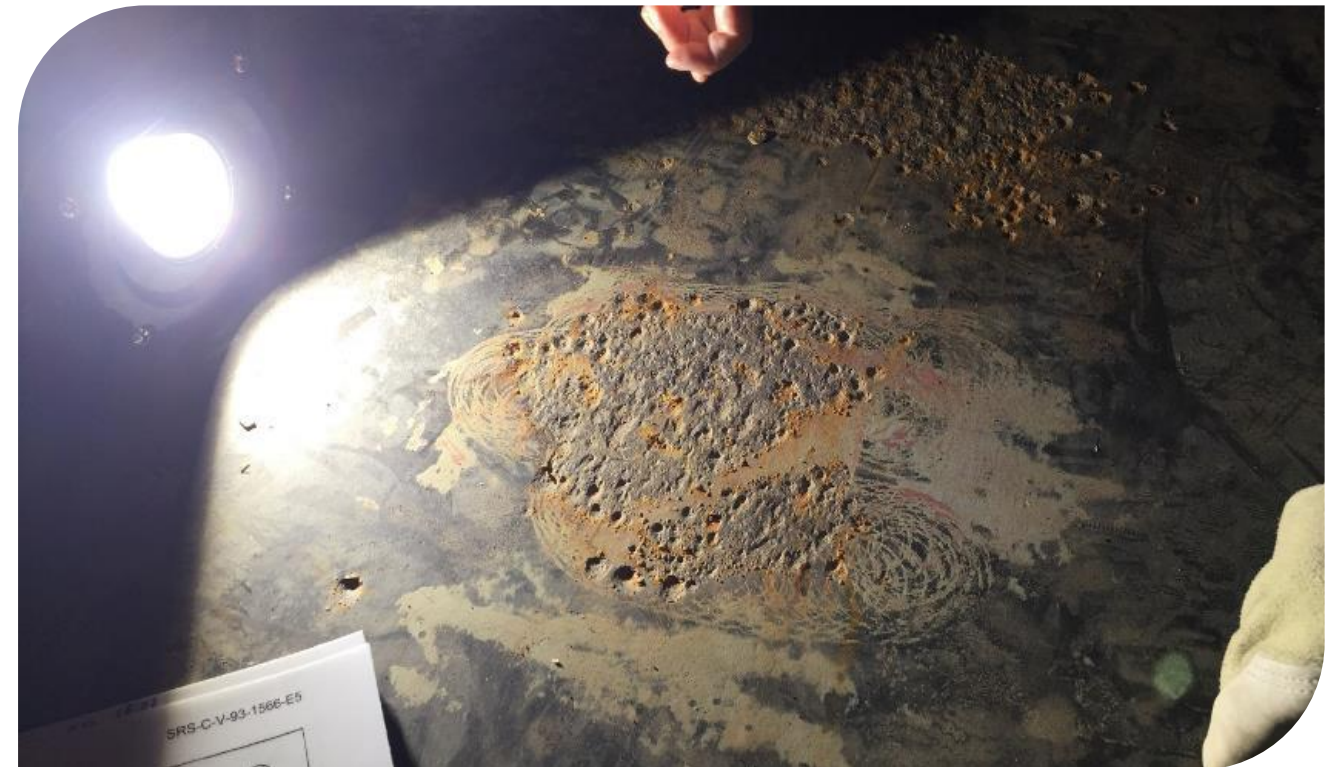
SRS Invert

Interior Coating Failure and Pitted Steel

- On-line in 1996
- Warranty work 1999
- Extensive repair work to liner in 2001
- 2009 inspection indicated 10 more years before any work necessary
- 2018 inspection revealed extensive damage to liner & substrate

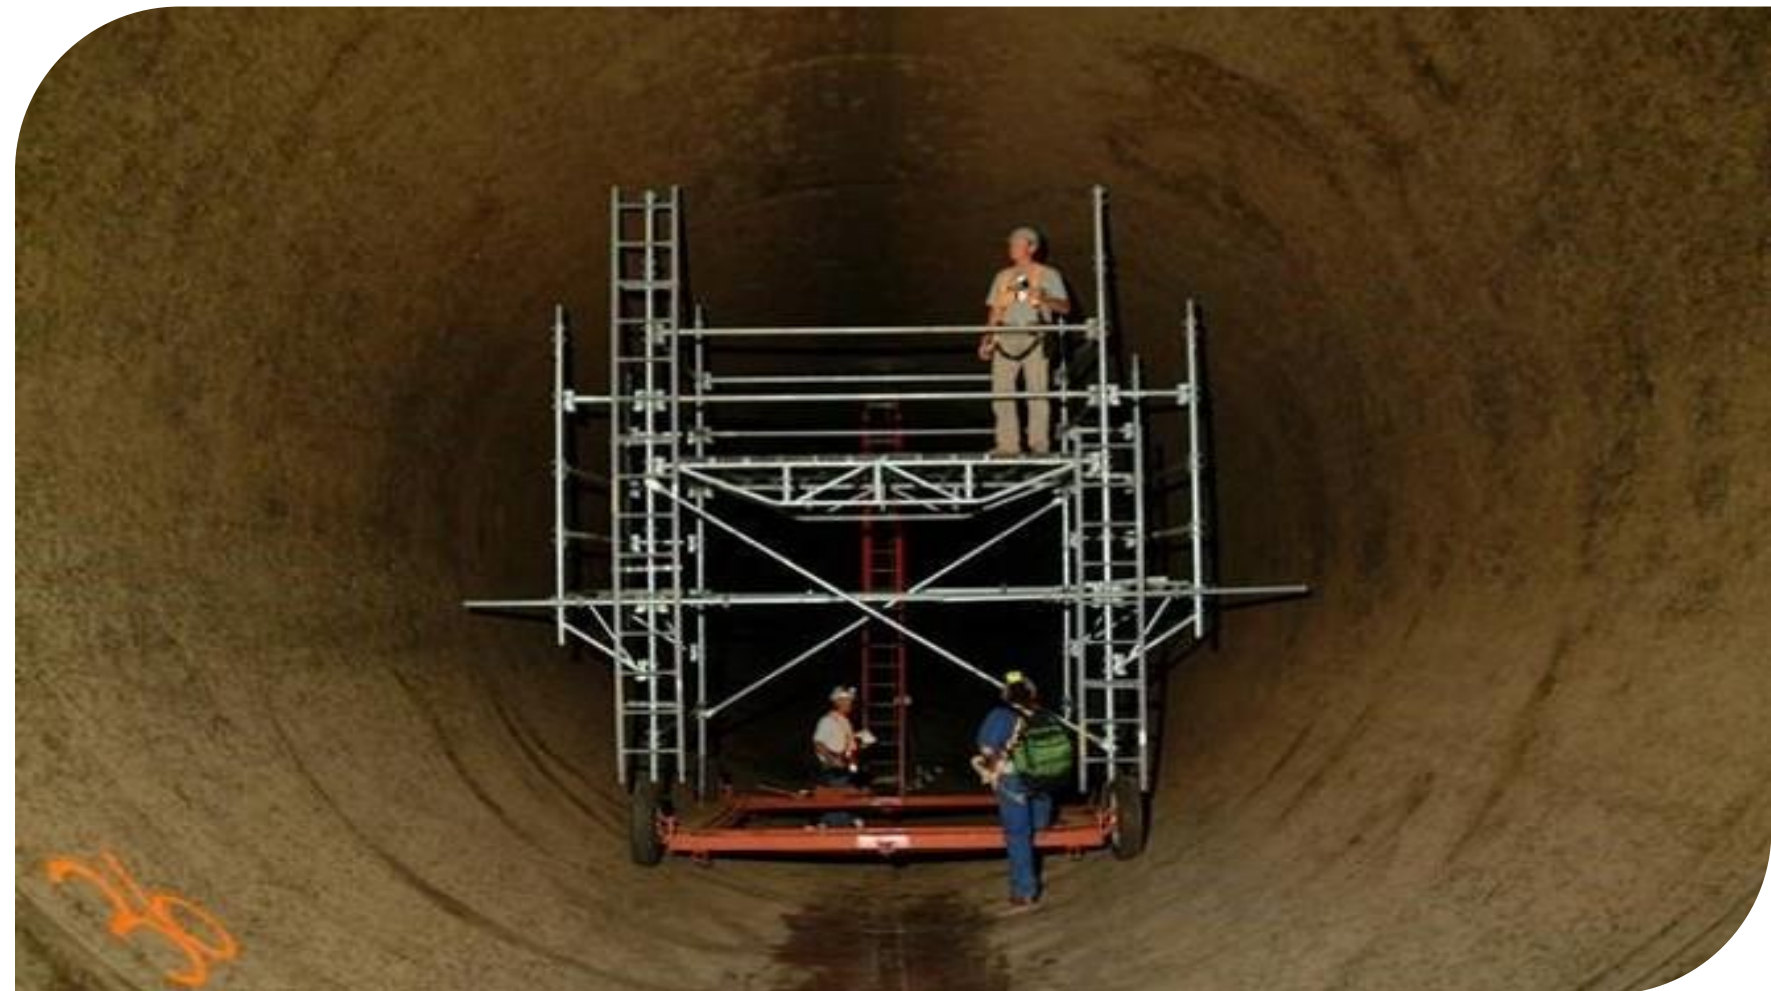
Scaffolding for Inspection

- On-line in 1997
- Warranty work 2000
- Extensive repair work to liner in 2003
- 2018 inspection revealed extensive damage to liner & substrate
- No plans to address liner or steel yet

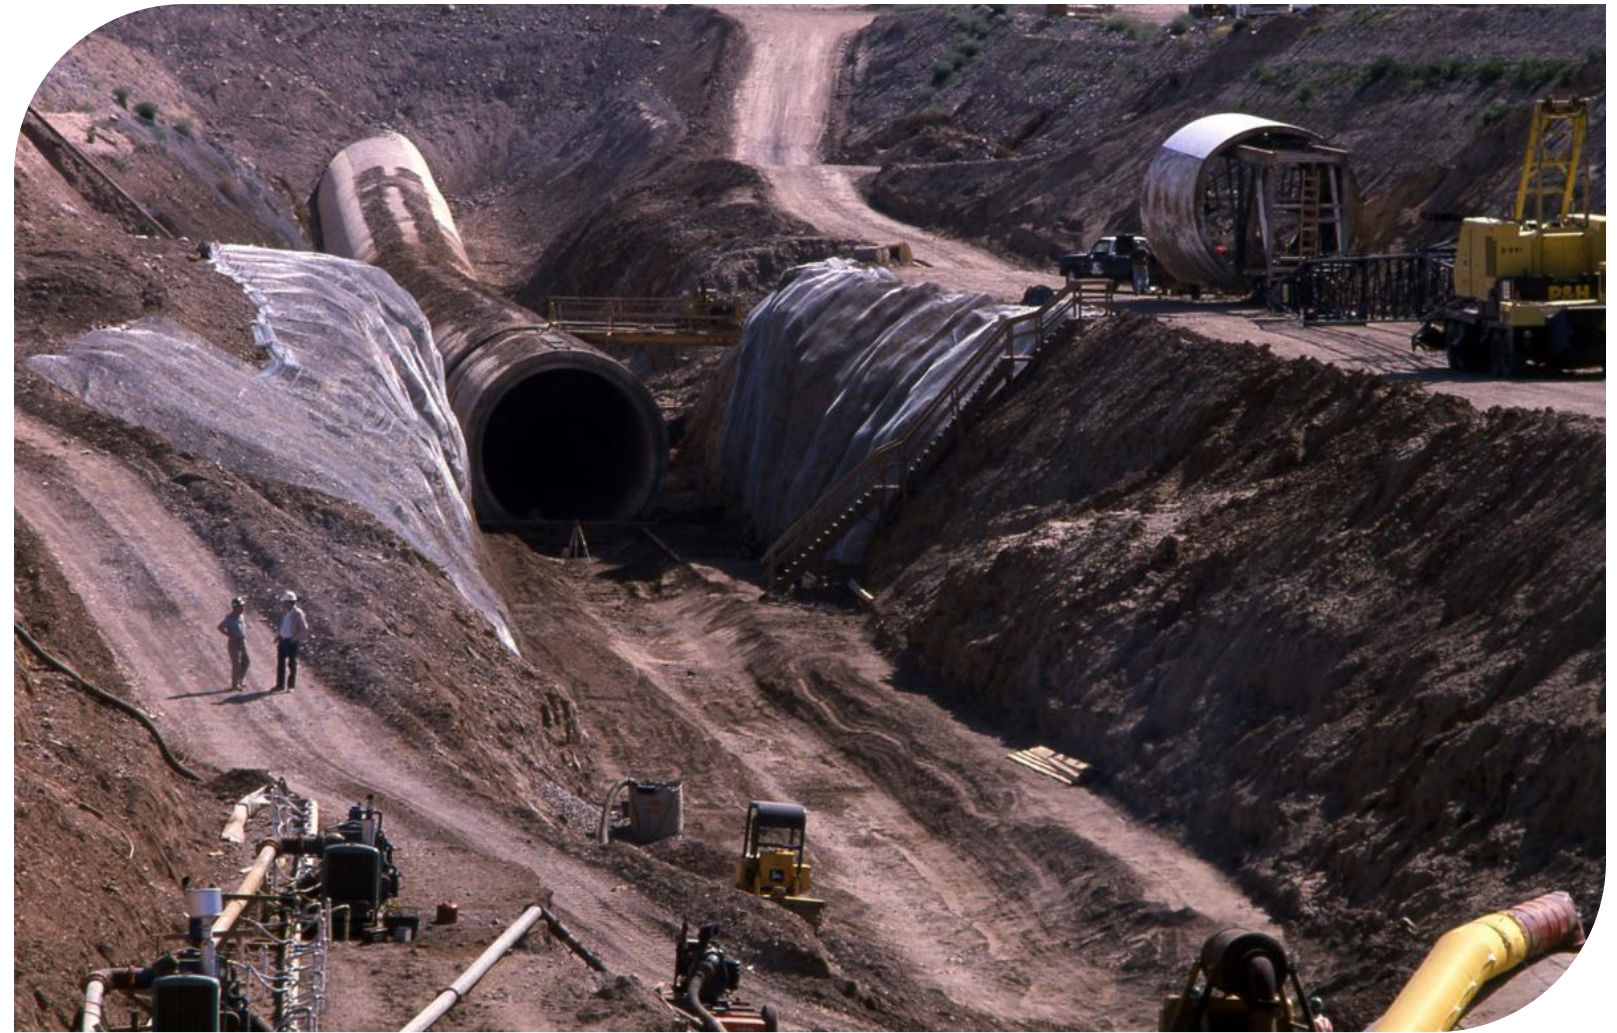
PCP Installation 1979

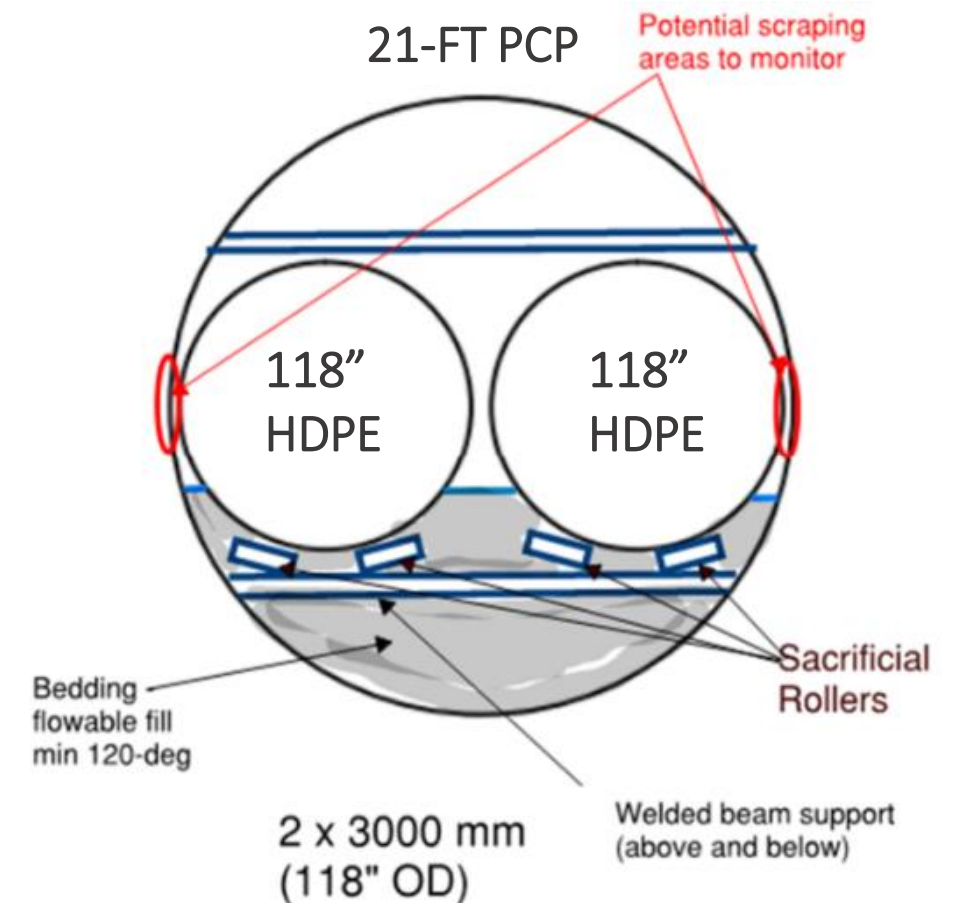
Bypass Concept -- Pipes in Existing PCP

- CAP requested the team evaluate – chemical coating option with and without providing a bypass.
 - Without a bypass – canal could be shut down for 6 weeks every five years.
 - With a bypass of 1,000 cfs the canal could be shutdown up to 16 weeks every 5 years
- **Bypass options**
 - Install a pipe or pipes inside the abandoned PCP
 - Construct a bypass by direct bury (trenching) - ruled out due to excessive excavation and dewatering costs.
- **Consort/Sonoran Alternative**
 - Install structural liner in abandoned PCP
 - 2,000 cfs bypass allowing for eight month canal/steel pipe shut down

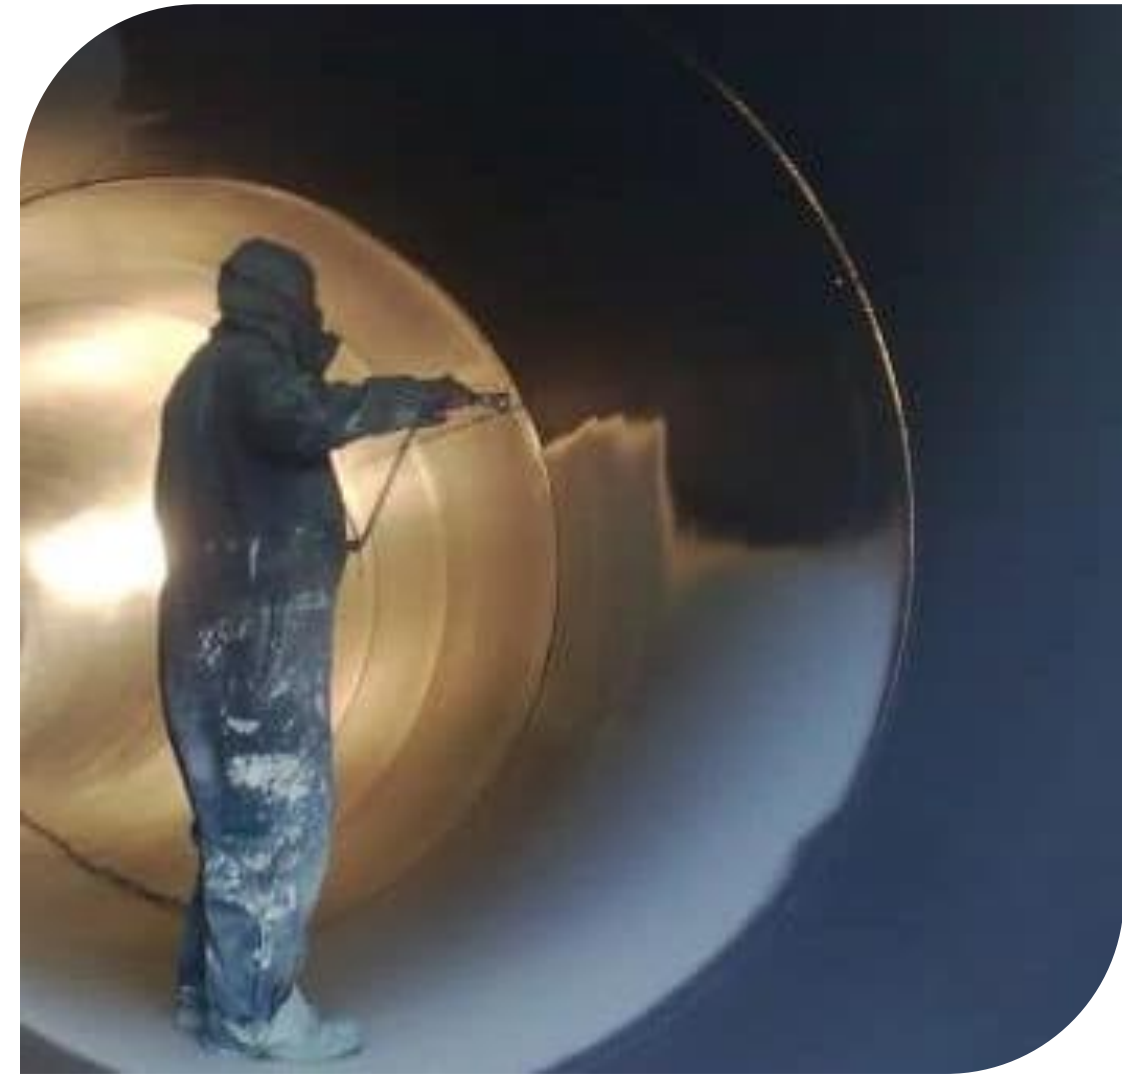
Example Piping Lining Application

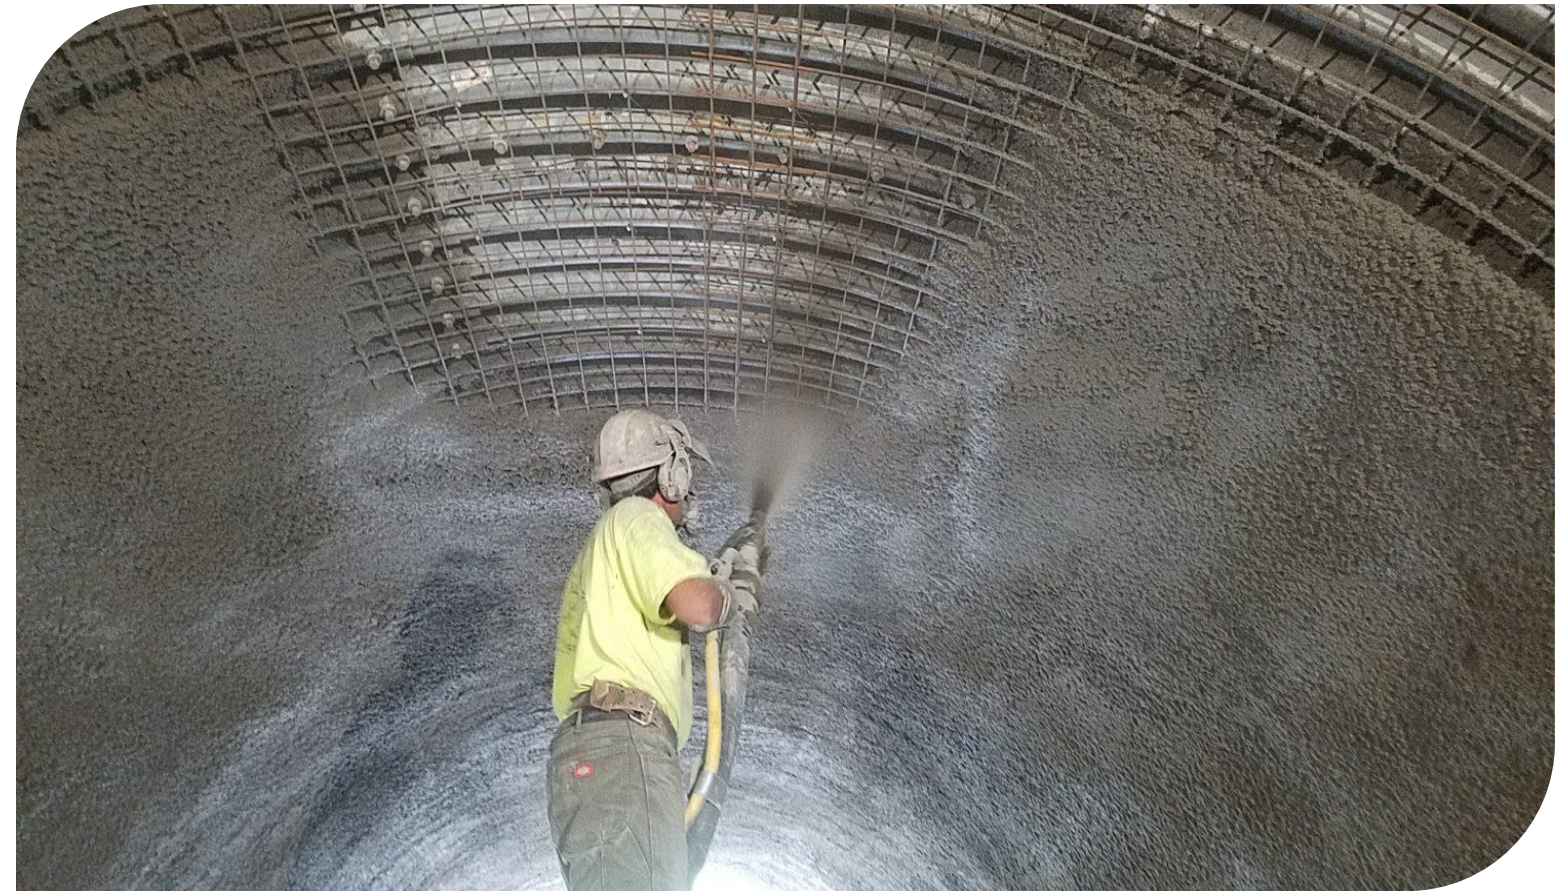
Example Pipe Lining Shotcrete Application

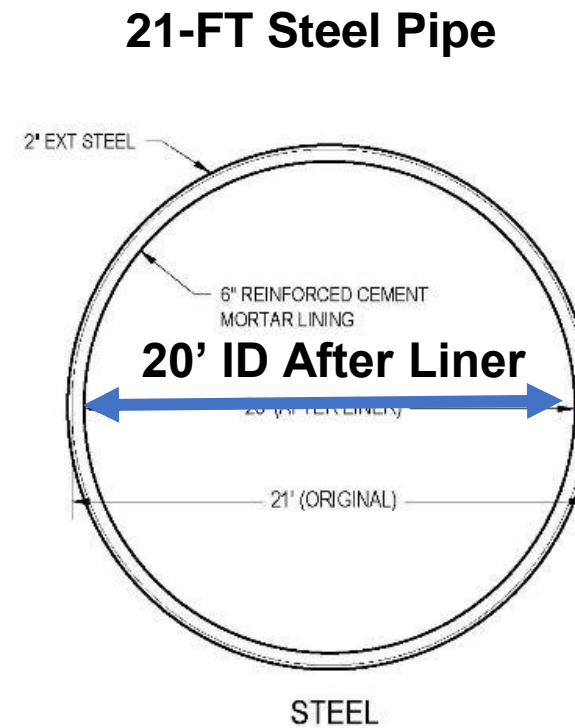
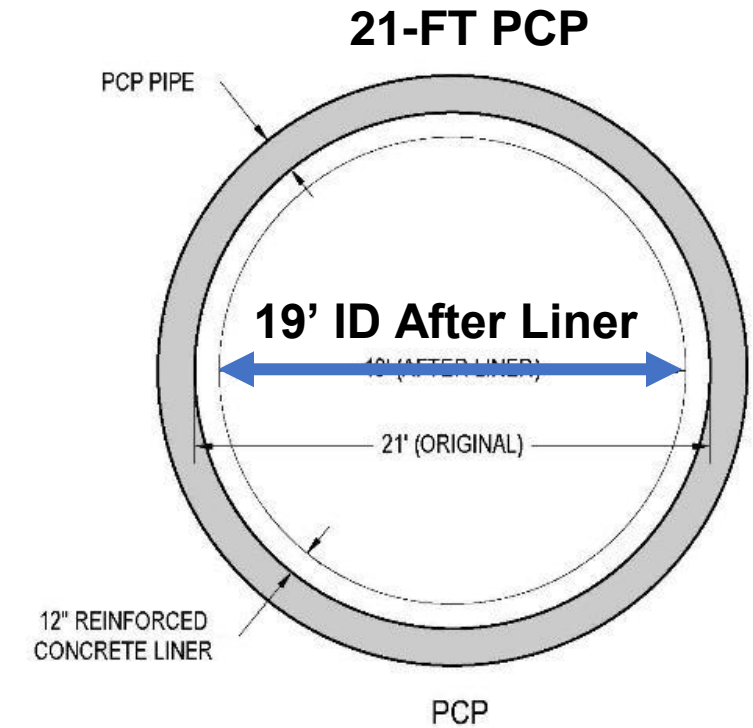
<i>Alternative 1: Continue spot repairs of steel pipelines with epoxy (current Maintenance program)</i>	486
<i>Alternative 2B: Install structural concrete liner in PCP for bypass, use monolithic concrete pipelines for canal tie-ins and use cement mortar to line the steel pipelines</i>	981
<i>Alternative 3: Construct a new monolithic concrete pipeline</i>	761

(C) Total Weighted Score				Opt 1 = 486		Opt 2 = 981		Opt 3 = 768

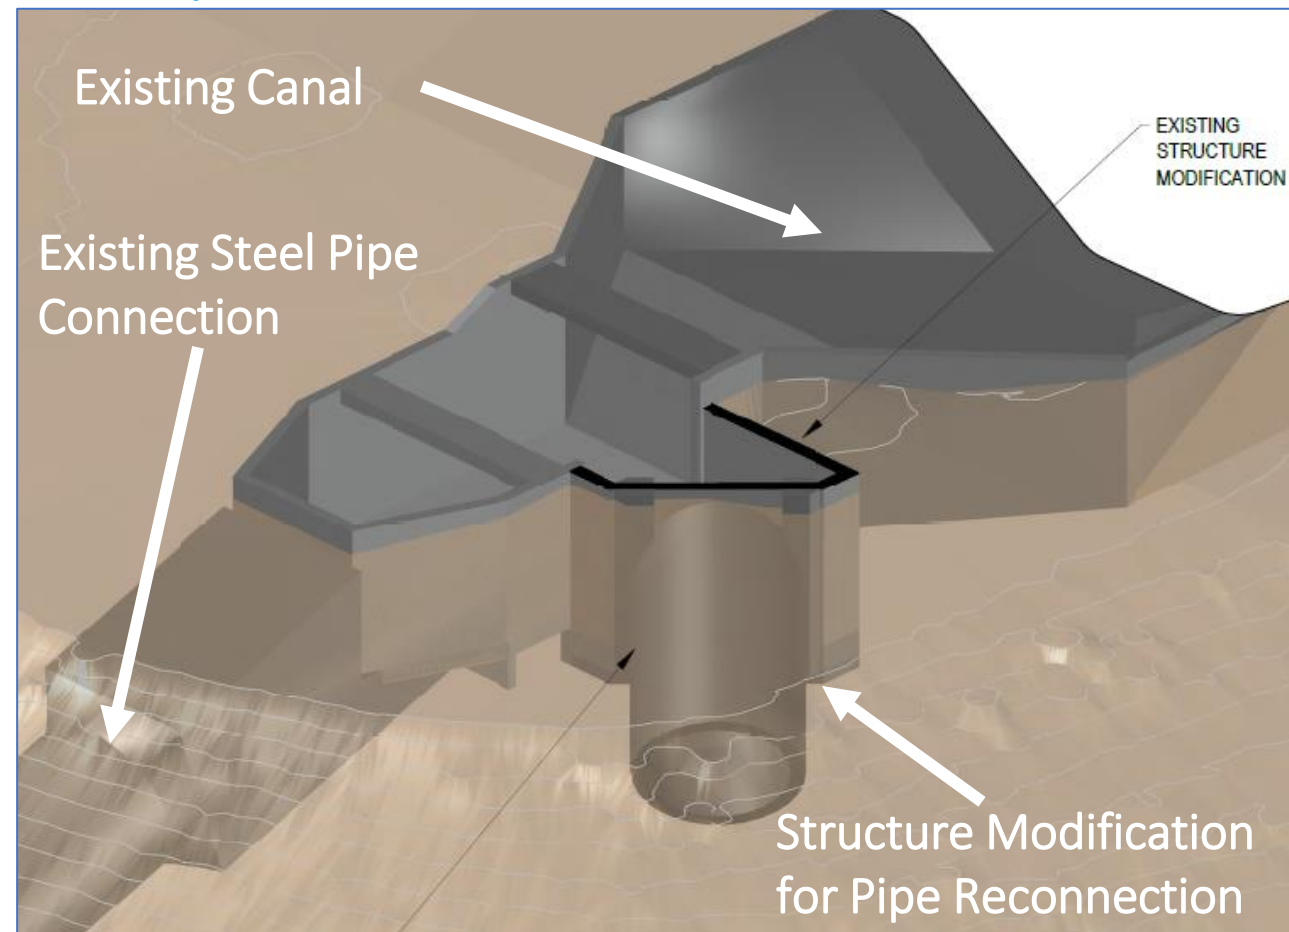
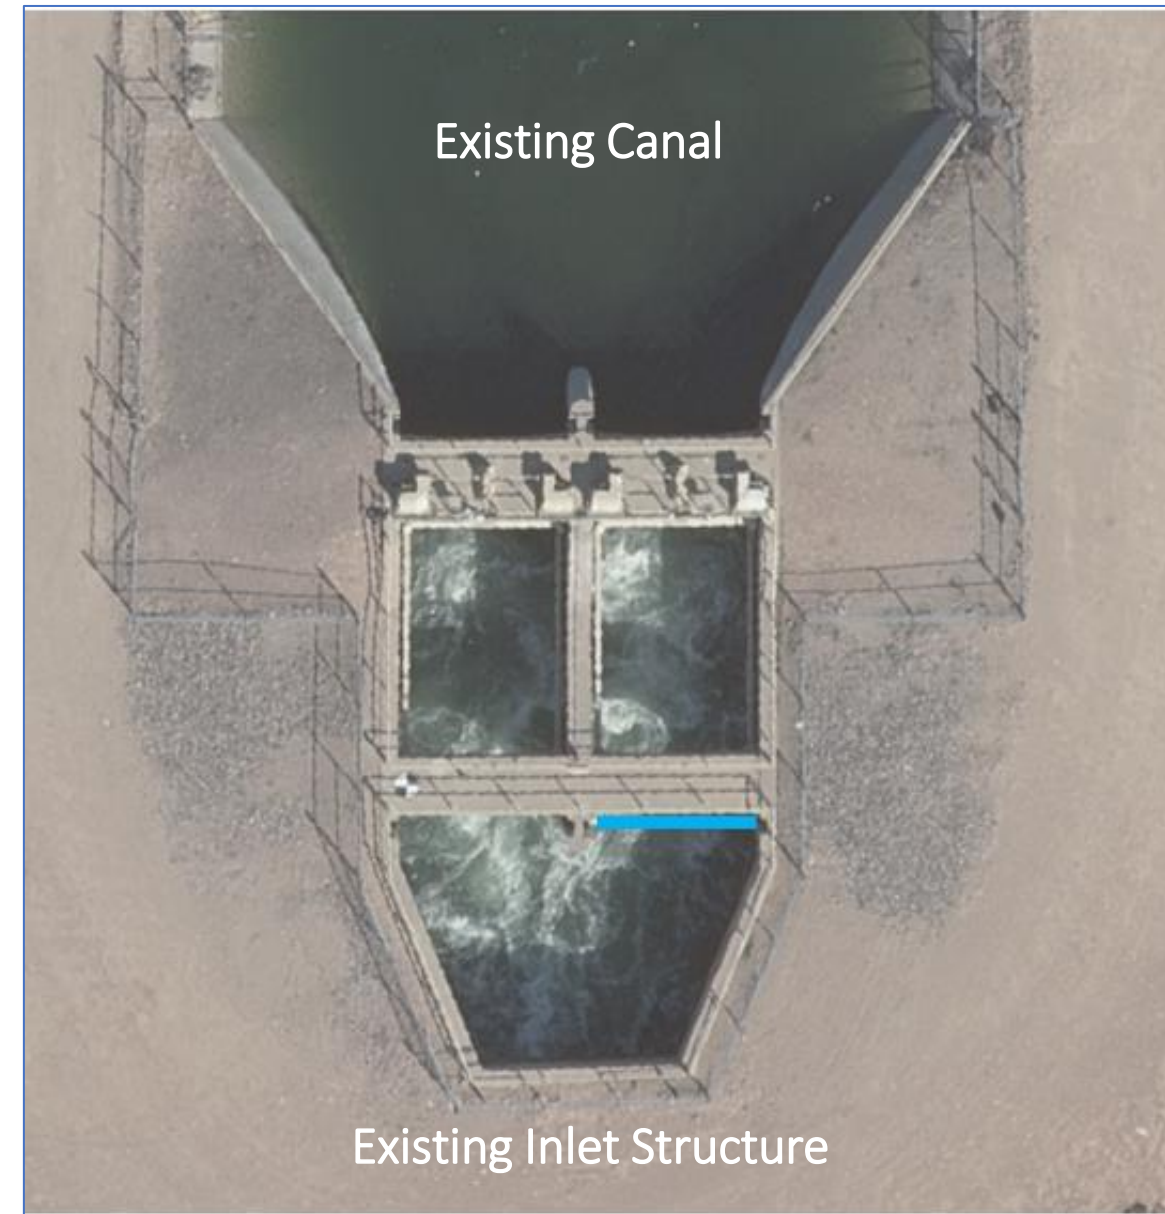
Salt River Siphon (Check Structure 25) Upstream End

Alternative 2B Pipeline Connections

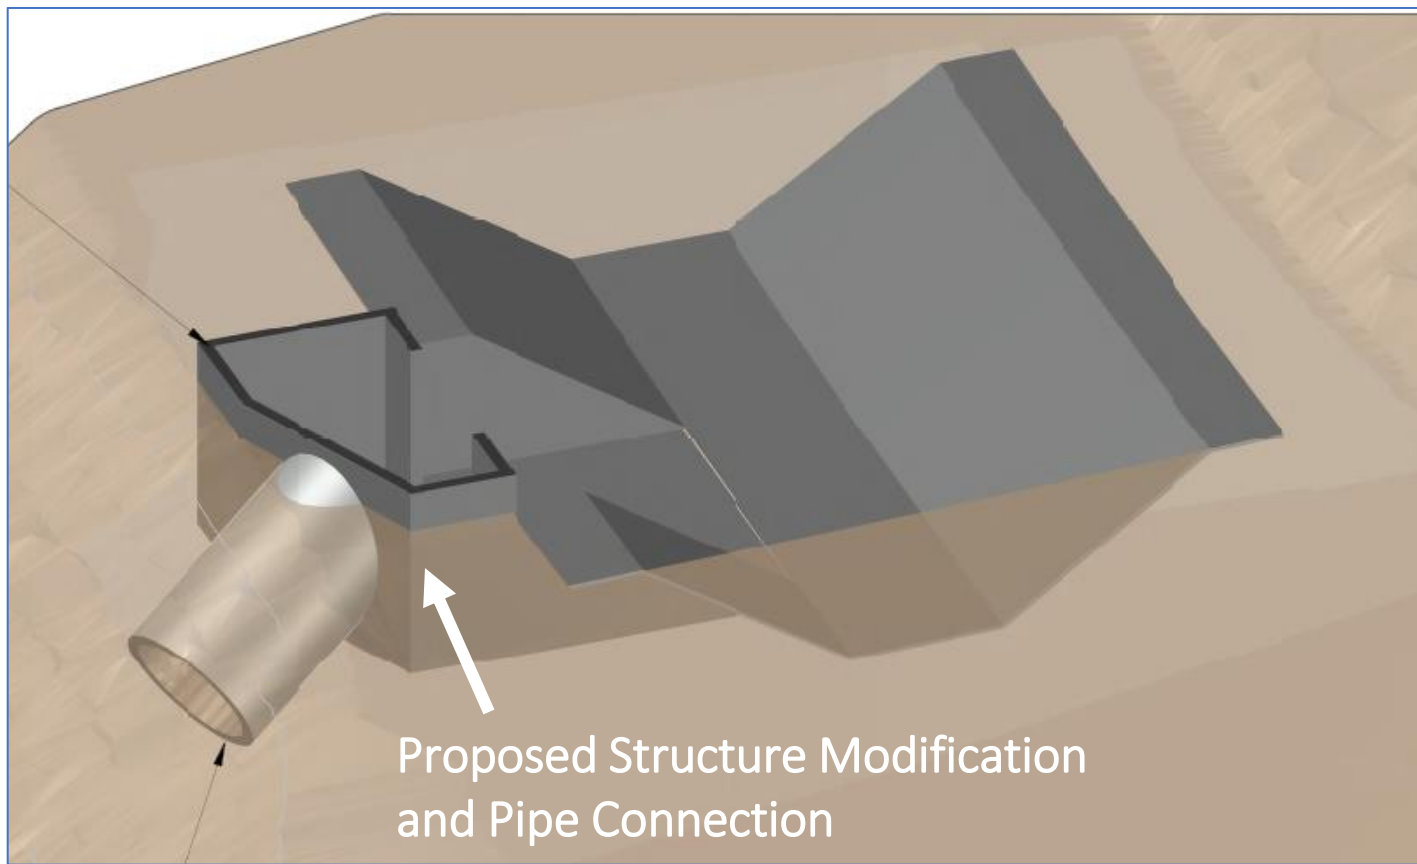
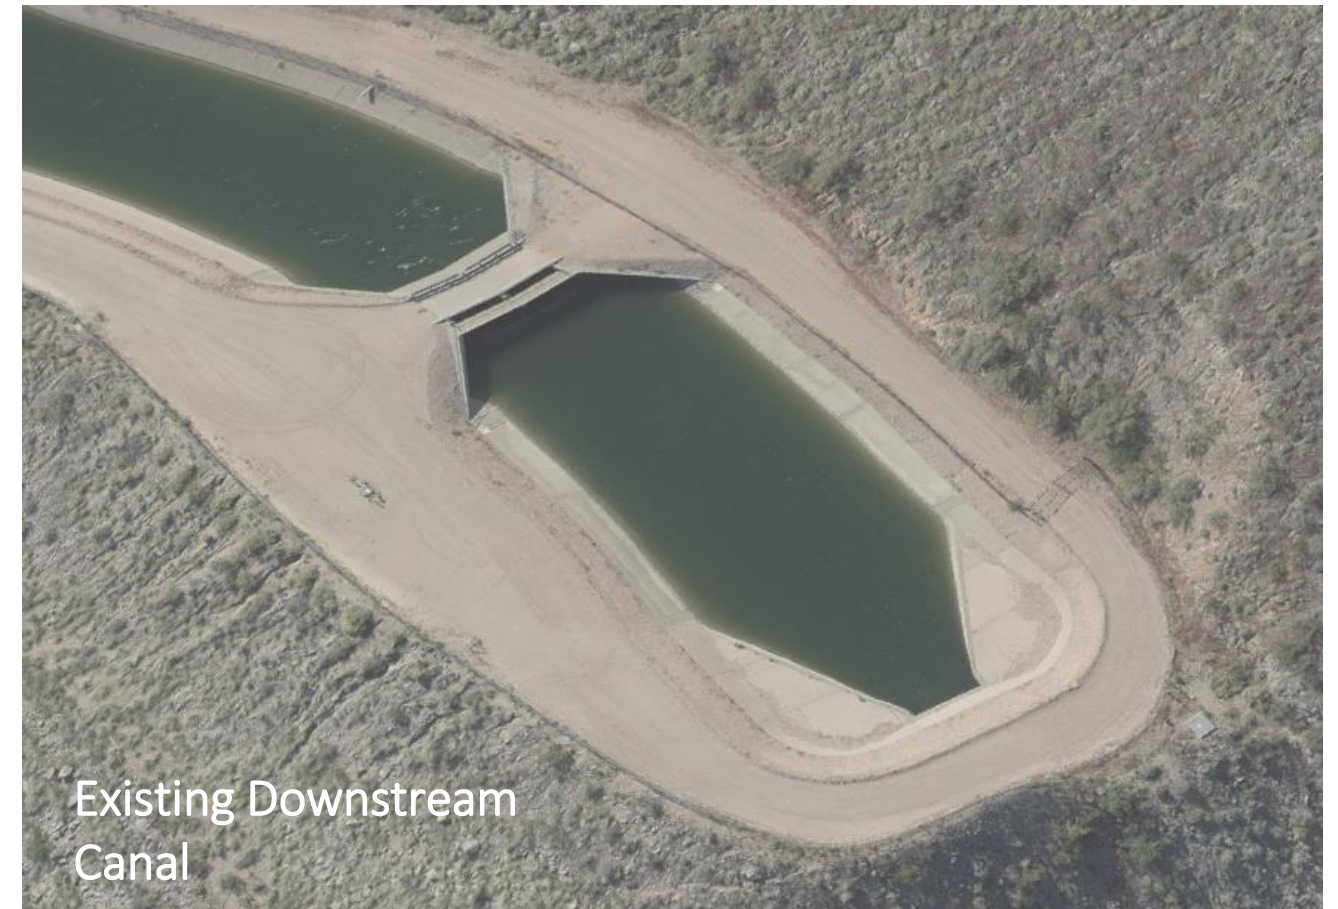
Salt River Siphon Downstream End

Alternative 2B Pipeline Connections

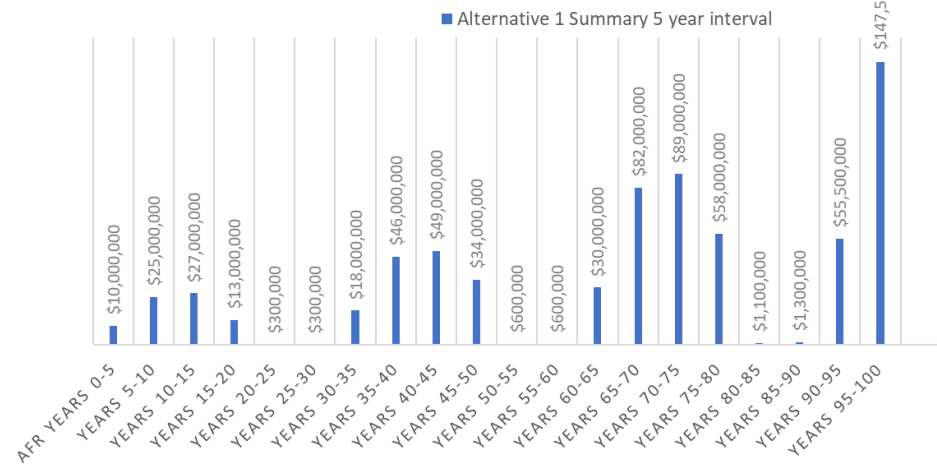
ALTERNATIVE 1 SUMMARY 5 YEAR INTERVAL
AGUA FRIA

Σ \$688,200,000

AFRS	Alternative 1 Summary 5 year interval
YEARS 0-5	\$10,000,000
YEARS 5-10	\$25,000,000
YEARS 10-15	\$27,000,000
YEARS 15-20	\$13,000,000
YEARS 20-25	\$300,000
YEARS 25-30	\$300,000
YEARS 30-35	\$18,000,000
YEARS 35-40	\$46,000,000
YEARS 40-45	\$49,000,000
YEARS 45-50	\$34,000,000
YEARS 50-55	\$600,000
YEARS 55-60	\$600,000
YEARS 60-65	\$30,000,000
YEARS 65-70	\$82,000,000
YEARS 70-75	\$89,000,000
YEARS 75-80	\$58,000,000
YEARS 80-85	\$1,100,000
YEARS 85-90	\$1,300,000
YEARS 90-95	\$55,500,000
YEARS 95-100	\$147,500,000

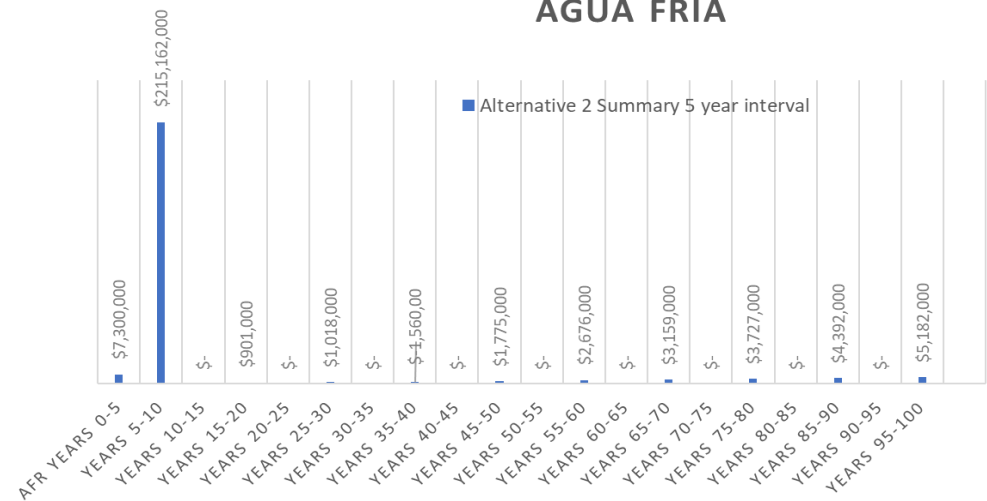
ALTERNATIVE 2B SUMMARY 5 YEAR INTERVAL
AGUA FRIA

Σ \$247,202,000

AFRS	Alternative 2B Summary 5 year interval
YEARS 0-5	\$ 7,300,000
YEARS 5-10	\$ 215,162,000
YEARS 15-20	\$ 901,000
YEARS 25-30	\$ 1,018,000
YEARS 35-40	\$ 1,560,000
YEARS 45-50	\$ 1,775,000
YEARS 55-60	\$ 2,676,000
YEARS 65-70	\$ 3,159,000
YEARS 75-80	\$ 3,727,000
YEARS 85-90	\$ 4,392,000
YEARS 95-100	\$ 5,182,000
