Corrosion Control Treatment: Lessons Learned from the Field

Milt Larsen,
Kennedy/Jenks

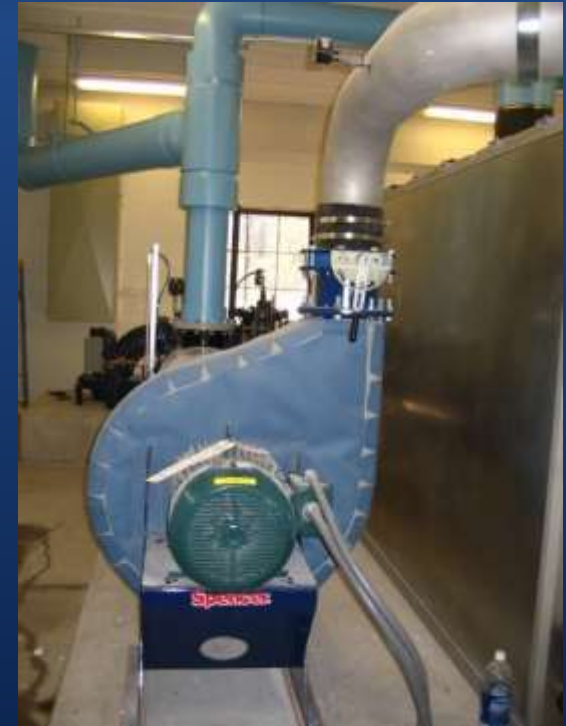
- ◆ 2 DeepBubble Multi-Stage Aeration Units
- ◆ Results
 - ◆ Raised pH from 6.35 to 7.75
 - ◆ Reduced CO₂ from 30 mg/l to <2 mg/l
 - ◆ Reduced Rn from 589 pCi/l to 44 pCi/l
 - ◆ Christmas Valley tap samples (90th percentile)
 - Pb <2.5 µg/l
 - Cu 0.03 mg/l
 - ◆ Supplemental sodium hydroxide is not necessary

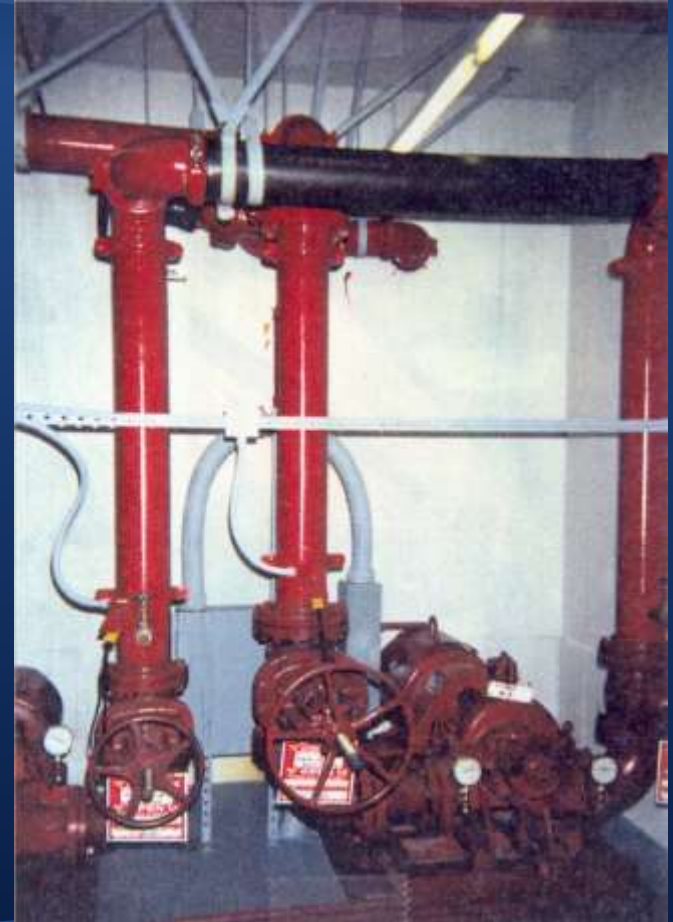
- Three Buildings Housing 450 Elderly Assisted Living Housing
- Buildings – 5 to 20 Years Old.
- Water Supply: LCR Optimized
 - pH – 8.0 - 8.2,
 - Alkalinity > 20 mg/l CaCO₃
- Problems:
 - Recirculating Hot Water Copper Pipe Pitting Failures
 - 10 - 15 years
 - Fire Sprinkler Water Supply Steel Pipe Pitting Failures
 - 15-20 years

- Sink Sampling for Copper
 - ◆ Hot Water – 0.5 mg/L + 0.2 mg/l
 - ◆ Cold Water – 0.2 mg/l + 0.1 mg/l
- Corrective Measures:
 - ◆ Smaller hot water circulating pumps to lower velocity from 7 to 3 ½ FPS
 - ◆ Use Type L copper rather than Type M (increased wall thickness)
 - ◆ Phosphate corrosion pot feeders for fire sprinkler supply
 - ◆ Reduce frequency of fire sprinkler pipe flushing from weekly to monthly

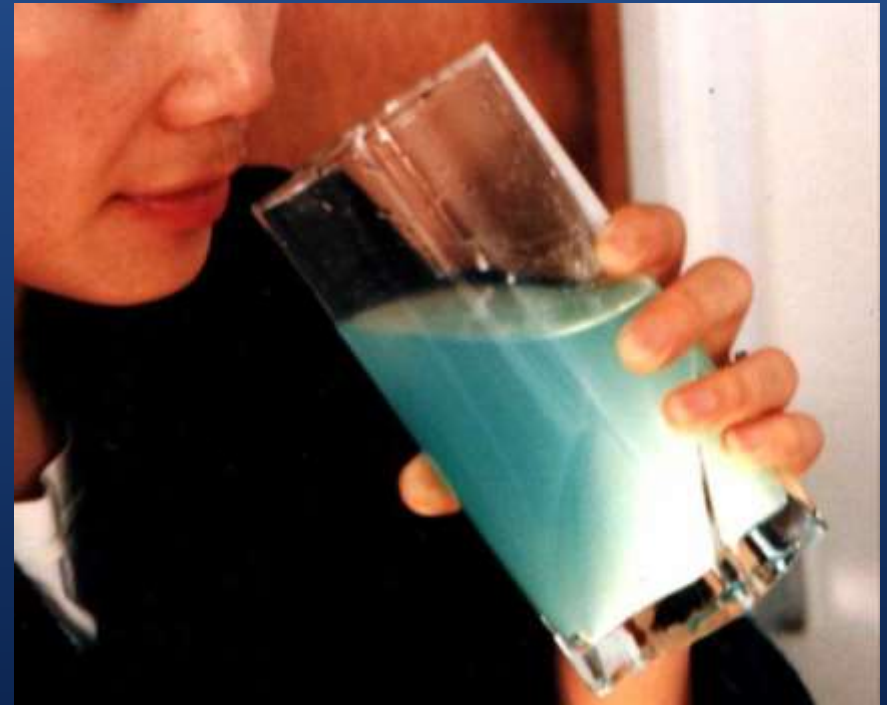
- EBMUD optimized for corrosion control
- Source: S Bay Aqueduct
- Extended transmission main with new reservoir to serve developing area
- Water age
 - Lost chlorine residual
- ≈ 5,000 residences
- 40 - 50% blue water complaints

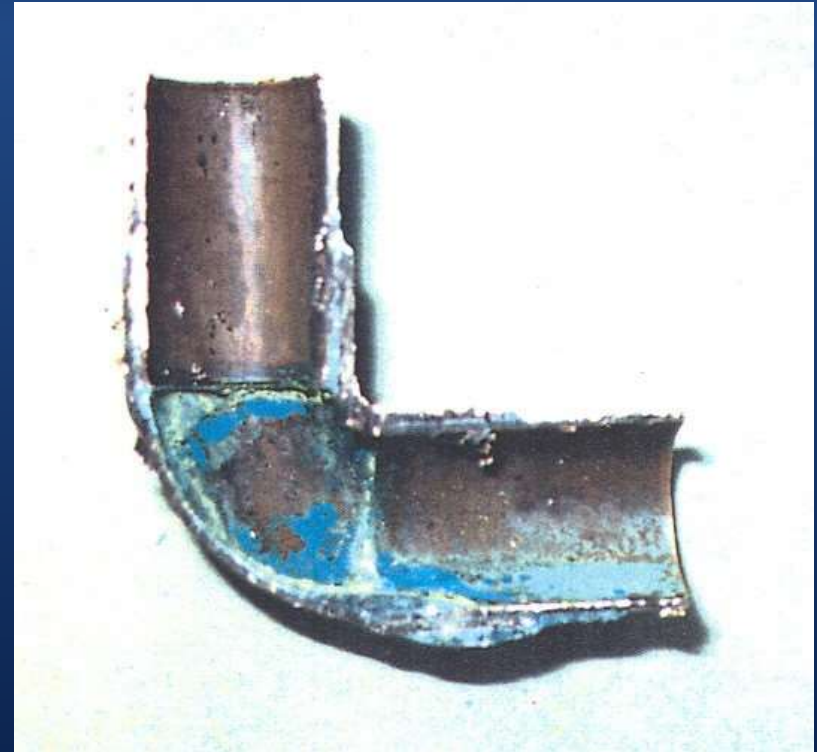
- First draw copper > 6 mg/l
- Concerned resident
- Attorneys got involved
- Plumbing samples collected
- Acidic flux runs

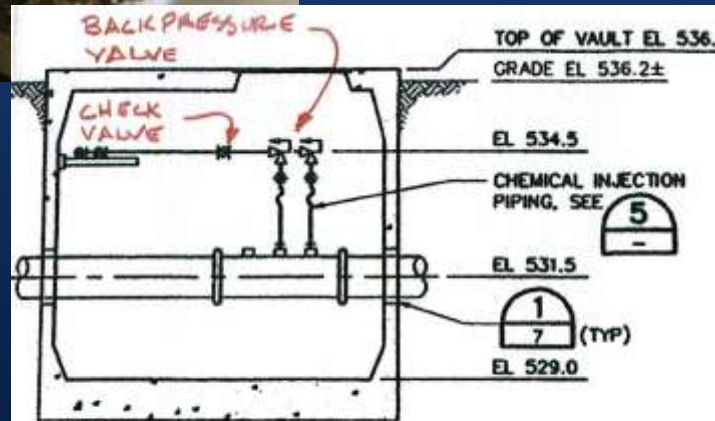
INJECTION VAULT SECTION

- NaOH may leak into water main when the well shuts down
- CaCO_3 precipitate will form in the pipe

- Install the injector & NaOH piping below horizontal centerline
- Consider installing an electrically actuated ball valve near the injector interlocked with the well pump starter
