Repair or Replace? Using Inline Technology to Assess Critical Steel Transmission Mains

Presented By:
Seth McIntosh
Jeanne Finger, P.E.
Christopher Kyea
April 27, 2018

City of Spokane Water Department Overview

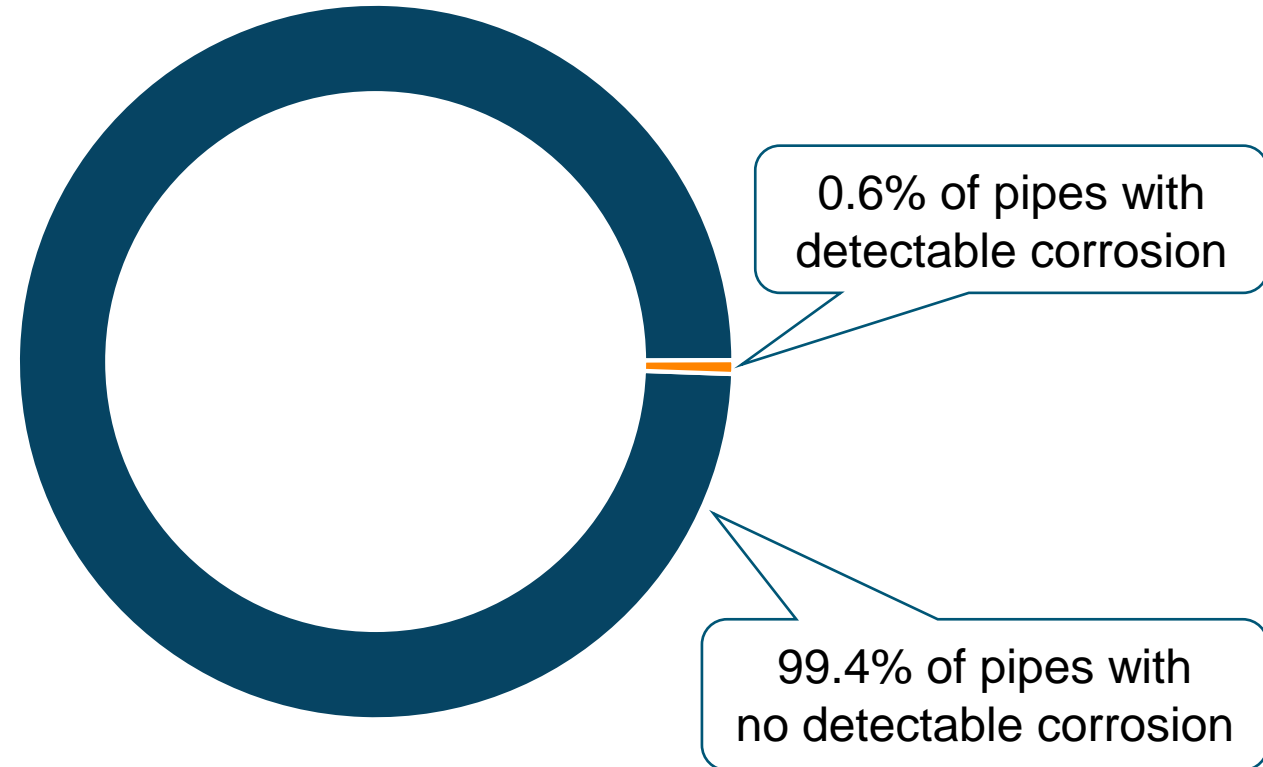
57th Avenue Transmission Main

- 282 Pipes inspected
- 1 “Leak” Detected
- 3 Pipes with Electromagnetic Anomalies

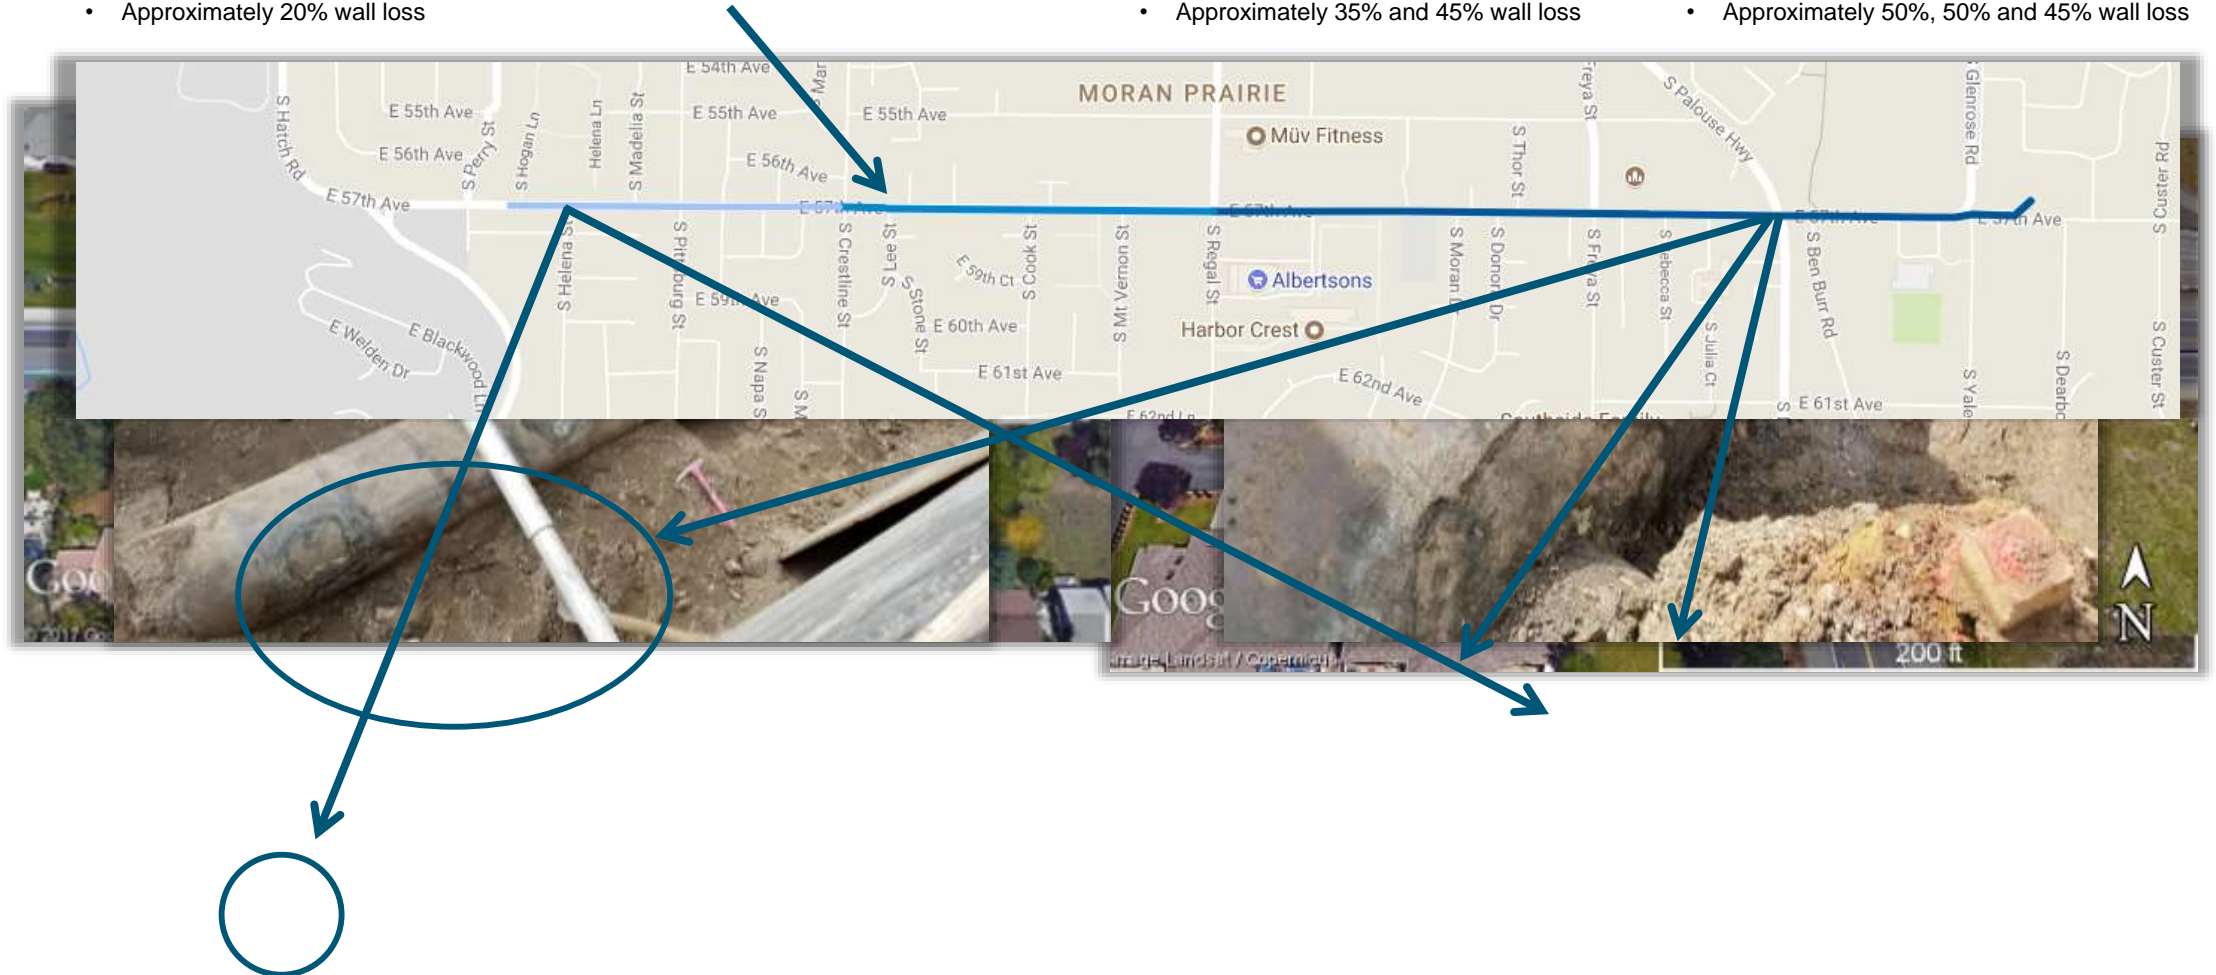
Electromagnetic Inspection Results

- Pipe 11 – S Helena St
 - 1 EM corrosion anomaly
 - Approximately 20% wall loss
- Pipe 1080 - S Lee St
 - 1 EM Anomaly not characteristic of corrosion
- Pipe 1172 – S Palouse Hwy
 - 2 EM corrosion anomalies
 - Approximately 35% and 45% wall loss
- Pipe 1174
 - 3 EM corrosion anomalies
 - Approximately 50%, 50% and 45% wall loss
