WELL REHABILITATION IN ALASKA'S BUSH COUNTRY: TECHNIQUES TO IMPROVE WELLFIELD PRODUCTIVITY

2019 PNWS-AWWA

Ida Fischer, HDR, Hydrologist

CASE STUDY KING COVE, ALASKA

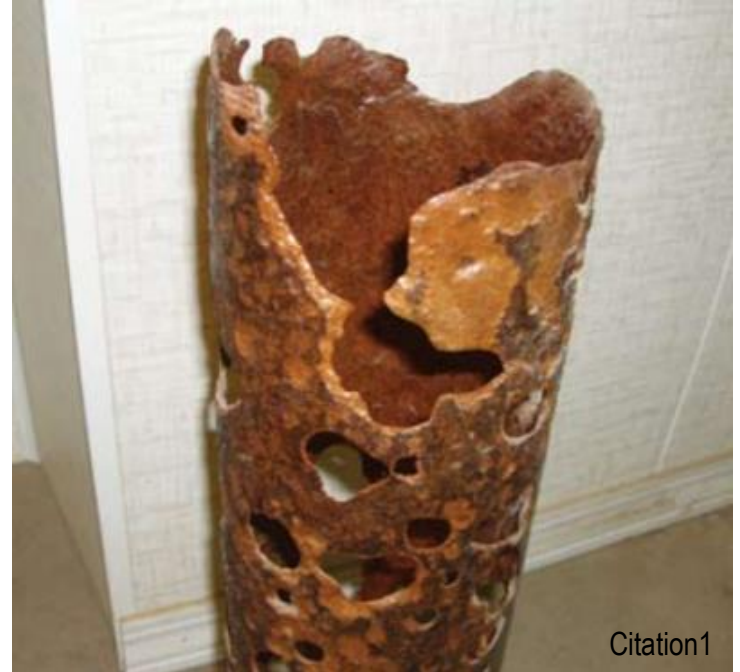
Citation1

CORROSION

- Screen slot enlargement
 - Sanding
- Strength reduction
 - Collapse of well screen or casing
- Re-deposition of corrosion products
 - Screen blocking
- Decrease in water quality

- Depends on:
 - pH
 - Redox conditions
 - Hydrogen sulfide

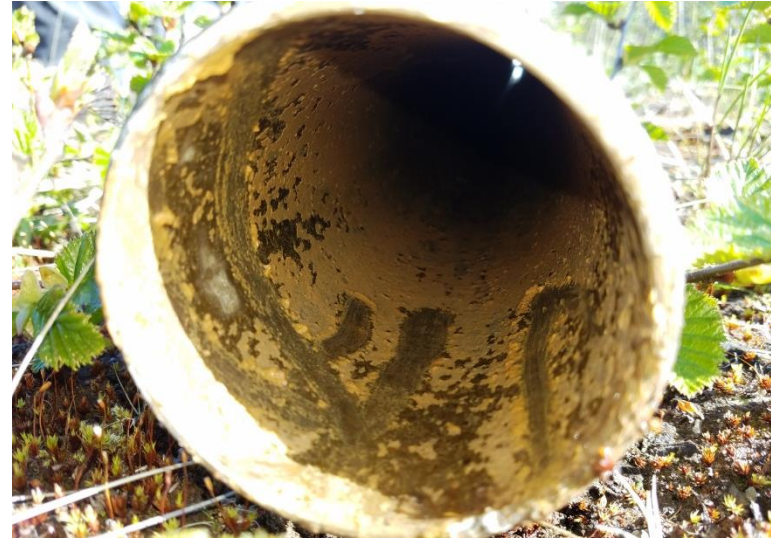
CAUSES OF WELL YIELD DECLINE

- **VISUAL INSPECTION:** Formation of biological slime and mineral encrustation

- **SCALE MINERAL ANALYSIS:**

Well 9 – deposits of manganese

Wells 2, 6, 8, 16 – deposits of iron, manganese, calcium and decomposed organic matter (biological slime)

- **WATER QUALITY ANALYSIS:**

High Iron: Wells 2, 8, 9, 16

High Manganese: Wells 2 and 9

High Calcium: Wells 2, 6, 9, 16

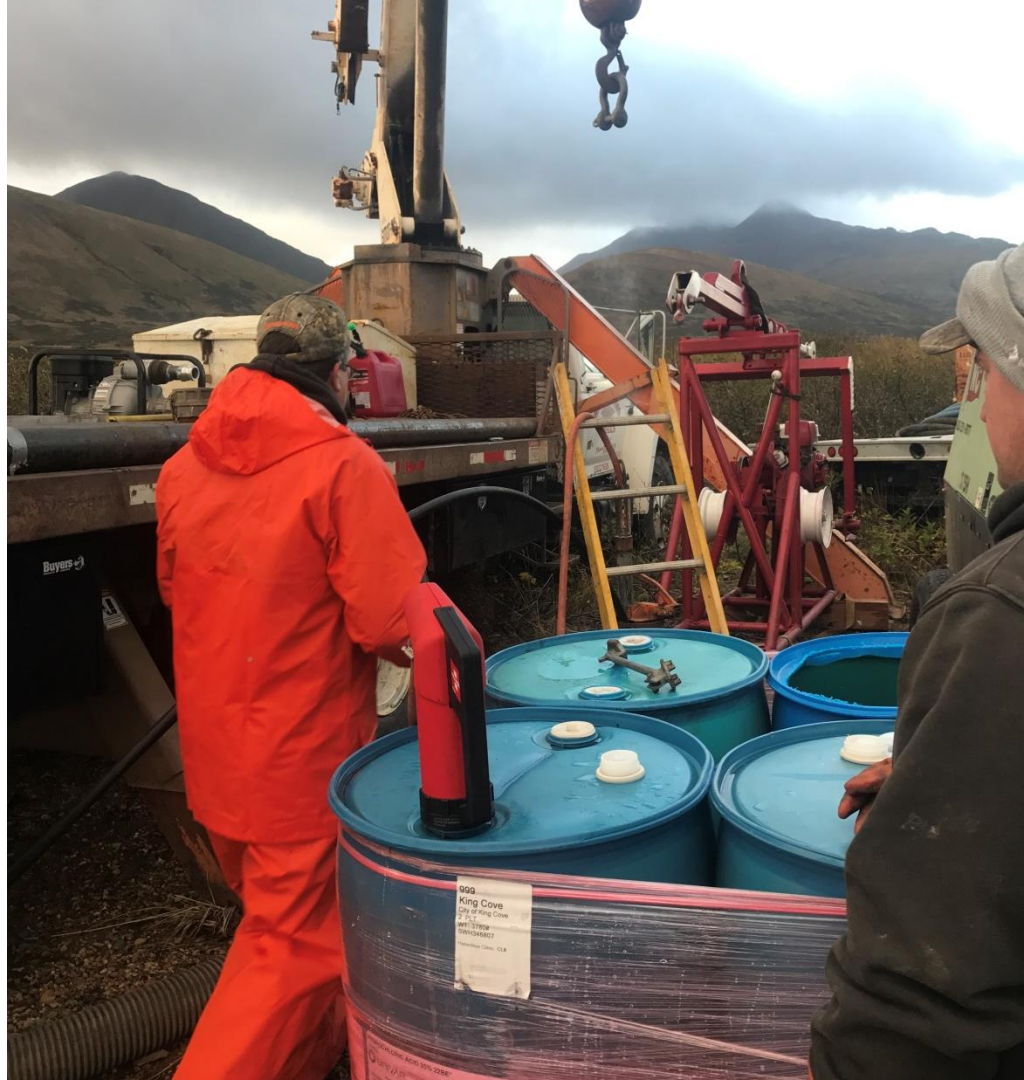
CHEMICAL TREATMENT

- Specified chemicals were applied to the well based on scale analysis
 - Blended treatment – “Unicid”
 - HCl
- Amount of chemicals dependent on water volume in well
- Monitor pH

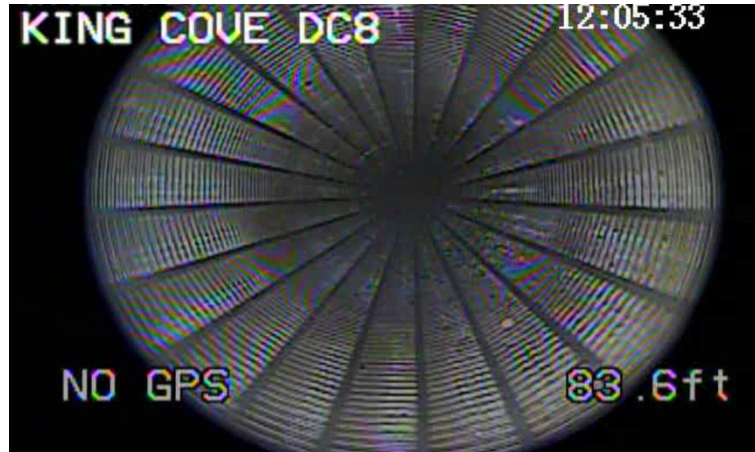
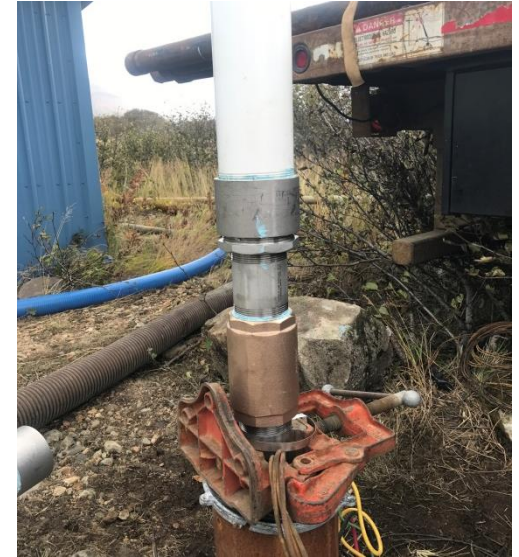
TREATMENT PROCESS (CONTINUED)

- Clean pump
- Video Inspection
- Reinstallation
- Disinfection
