Bellevue's AC Water Main Replacement Program

AWWA PNWS Annual Conference and Exposition April 26, 2018

Andrew Lee, City of Bellevue

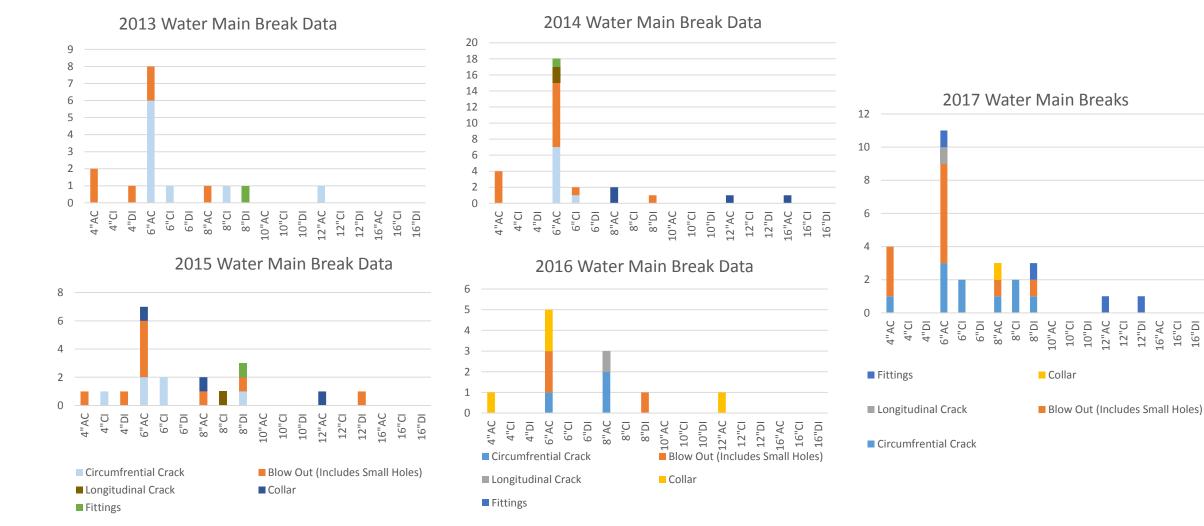
Historical Water Main Break Data

Watermain Break Data AC Break Rate

4"	6"	8"	10"	12"
Annual average of condition					
related breaks 2010 to 2017	2.62	8.75	2.50	0.00	0.50
Remaining Miles of AC pipe in					
the system as of 2017	8.92	133.11	74.78	8.08	23.82
Average breaks per 100 miles	26.87	6.37	3.20	0.00	2.00

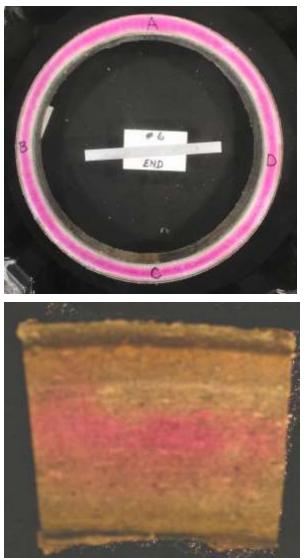
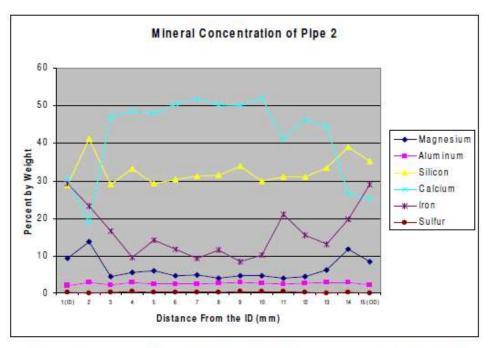
Fig. 15. Elemental Distribution through Cross Section of Pipe #2

AC Watermain laboratory testing

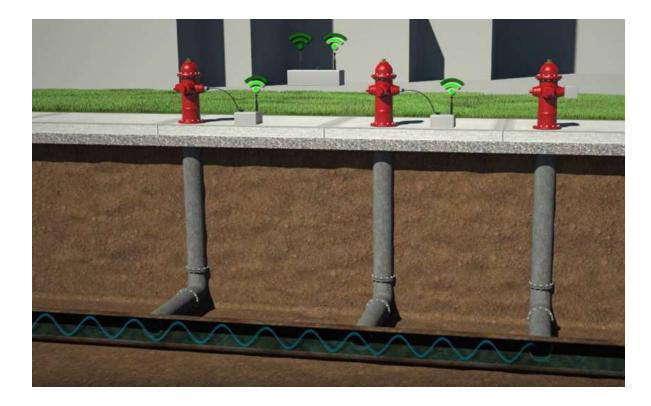
Acoustic Testing for Condition Assessment

- Acoustic Testing
 - Non-invasive
 - Uses sound waves to Measure pipe wall thickness
 - Averages the results across the length evaluated
- Confirmation of Testing Results
 - Innisglen
 - Valley Green

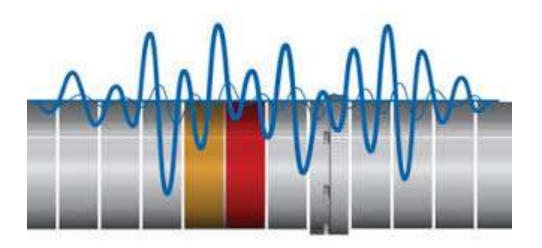
Pressure Transients for Condition Assessment

• P-CAT

- Non invasive technology
- Pressure waves injected into pipeline
- Pinpoints problem areas (30 foot increments)
- Limited to long straight pipe runs

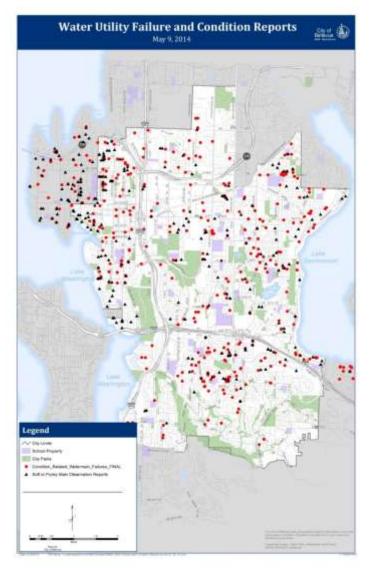
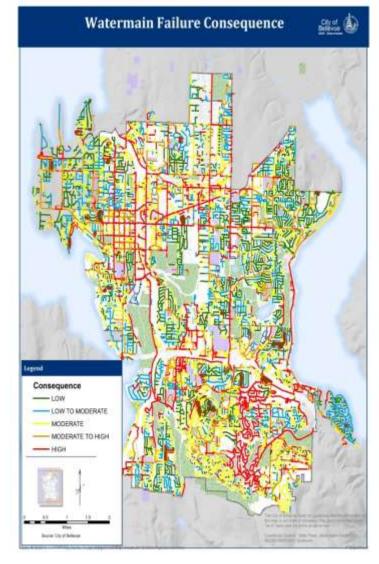
Existing Risk Model Inputs

- GIS Risk Model
- Failure and Condition Report Map
- Consequence of failure map

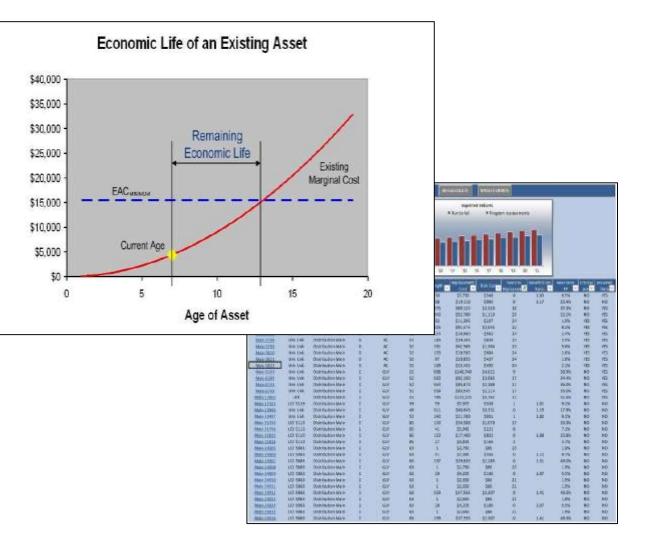
Economic Model

Risk based economic model that determines optimal replacement timing for water and wastewater piped assets.

Model provides a full picture of:

- Asset risk
 - Failure probability based on historical failures
 - Consequence of failure based on site-specific data
- Current and forecasted cost of ownership.
