# DEMONSTRATING & COMMUNICATING THE ABSENCE OF LEAD SERVICE LINES

Joel Cary, TVWD

TUALATIN VALLEY  
WATER DISTRICT

May 3, 2024

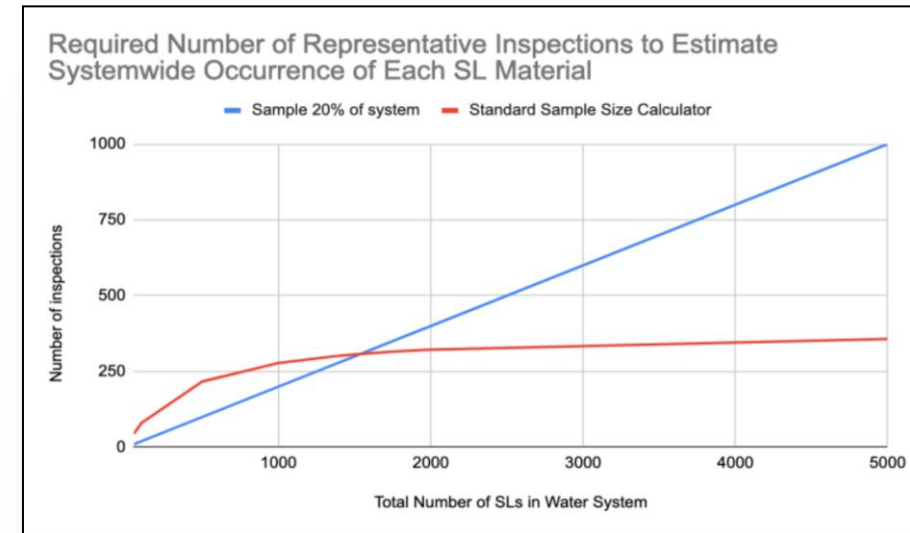
Example curve, ASDWA, 2020

26,788 services classified as “unknown” under OHA methodology

- Minimum of 378 randomly selected sites for inspection

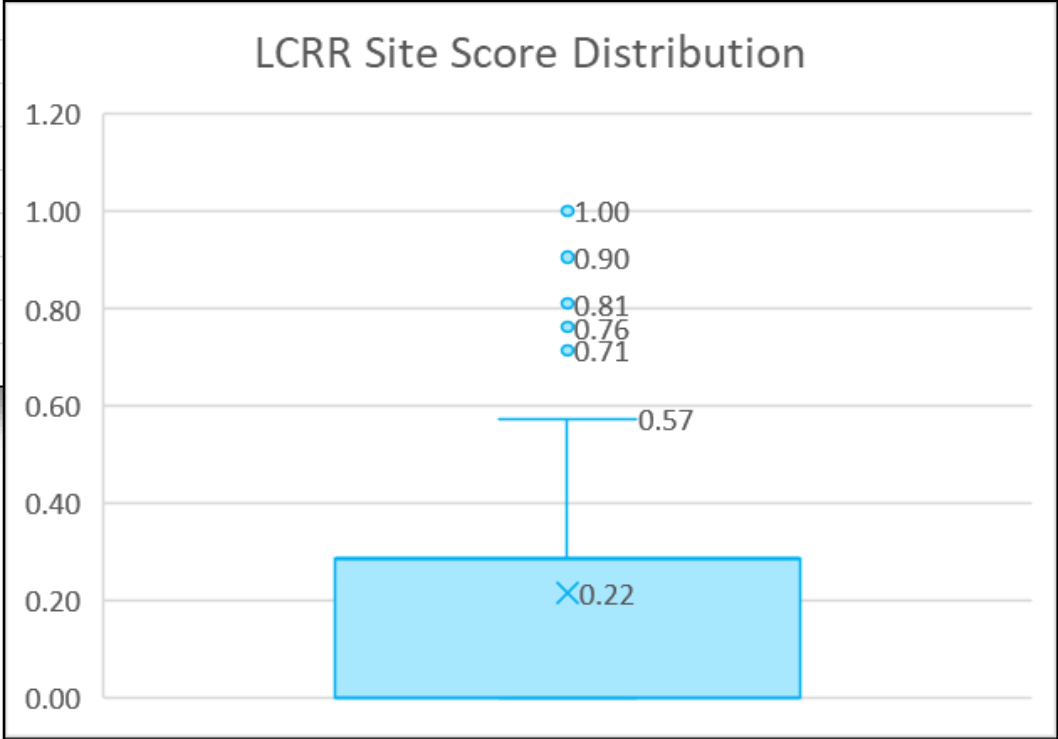
# INITIAL SITE ASSESSMENT RANKING

6	5	4	3	2	1
		Utility	Concrete/F	Obstructio	Traffic Con	Trees/Drip	Landscaping
6	Utility	234	33	8	19	37	7
5	Concrete/F	33	46	7	3	6	6
4	Obstructio	--	--	9	2	4	3
3	Traffic Con	--	--	--	20	5	2
2	Trees/Drip	--	--	--	--	60	3
1	Landscapir	--	--	--	--	--	13

Utility	Concrete/F	Obstructio	Traffic Con	Trees/Drip	Landscaping
	Utility	57%	8%	2%	5%	9%	2%
	Concrete/F	--	11%	2%	1%	1%	1%
	Obstructio	--	--	2%	0%	1%	1%
	Traffic Con	--	--	--	5%	1%	0%
	Trees/Drip	--	--	--	--	15%	1%
	Landscapir	--	--	--	--	--	3%

- Quantitative assessment of qualitative site characteristics to better understand impediments (singular and paired)

To provide an estimated profile of the work locations, the District performed a desktop evaluation of a 409 randomly selected sites, which is more than the minimum excavations needed to account for replacement sites during the inventory process. Based on this evaluation, the District estimates the following:

- a. 389 (95%) occur in low-traffic locations and are likely to need only minor traffic control measures.
- b. 46 (11%) are likely to require minor to moderate sidewalk or asphalt repair, such as sidewalk panel replacement or patching of existing roadway asphalt after excavation.

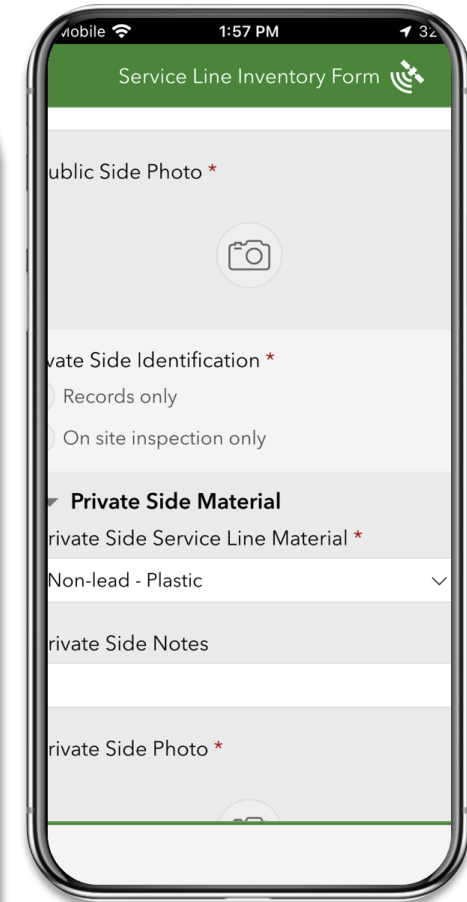
## 2020-2021 Pilot effort helped to establish data collection in the field

- Used mobile based field application called Survey123
- Aligned terminology to LCRR/OHA language
- Provided iPads to contractor
  - Security, minimize technology “hiccups,” etc.
