WATER METERS CAN'T FIND
DISTRIBUTION MAIN LEAKS, CAN THEY?

YOU BET THEY CAN!

Graham Mattison

kamstrup

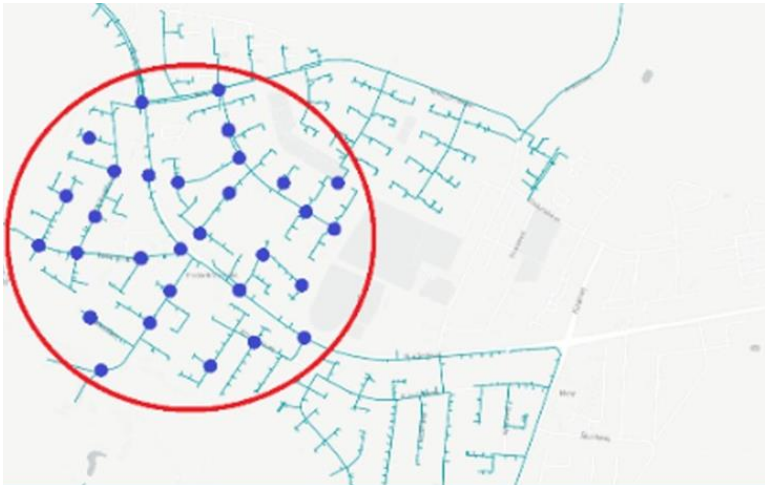
Main Line Coverage Only

Ex. 5-10 x Leak Sensors Per Mile

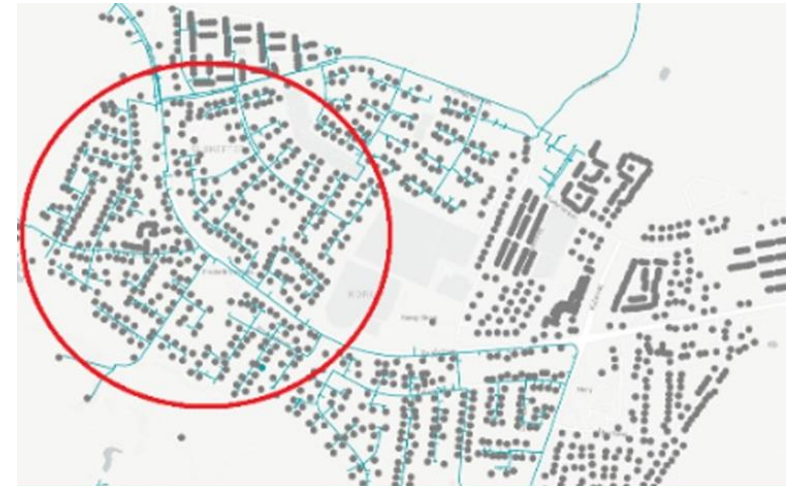
Service & Main Line Coverage

Ex. Up to 100 x Leak Sensors Per Mile

50%+ Of All
Distribution System
Leaks Occur At Or
Near Service
Connections.

With 10x As Many Sensors Per Mile Compared To Acoustic Leak Monitoring Solutions Installed On Valves And Hydrants - It's Almost Impossible For Leaks To Hide

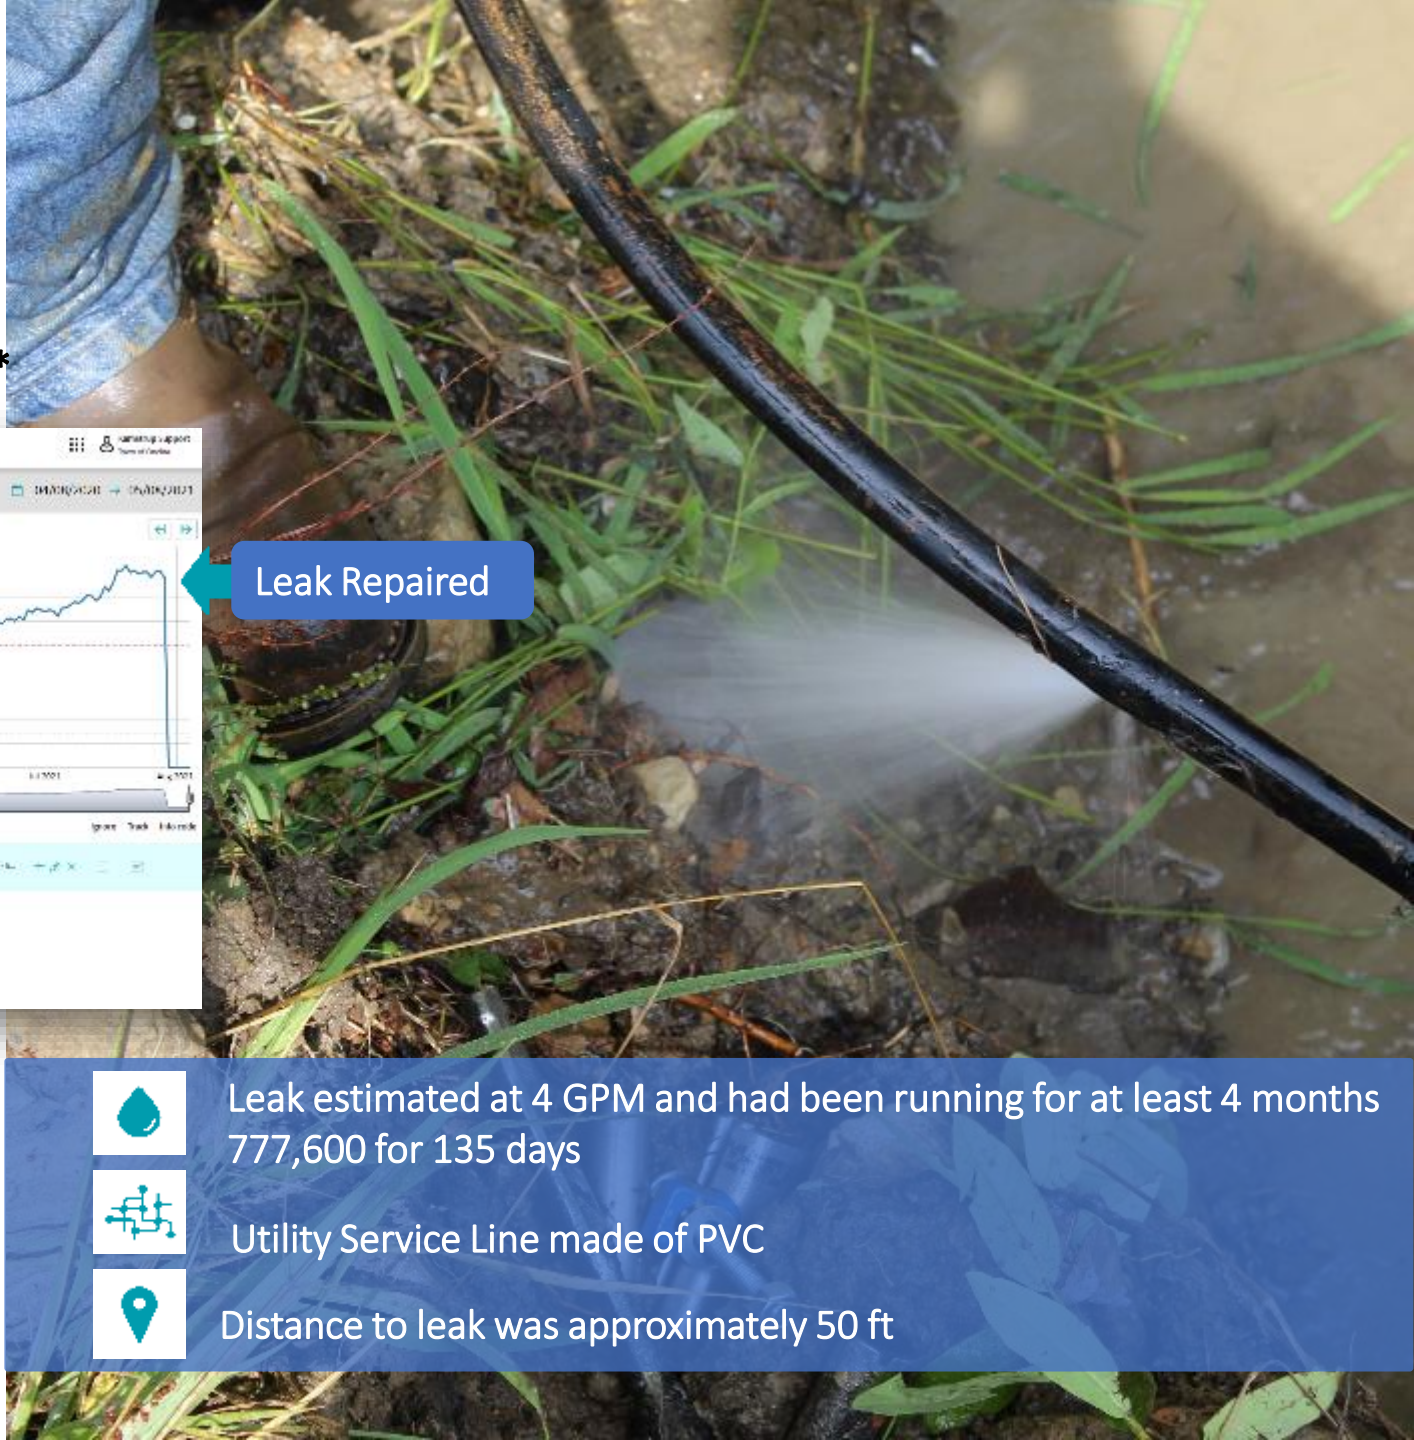
Oneida, TN

- High noise detected on single meter
- Service line leak had been running a minimum of **4.5 months**
- The total NRW would account to **\$21,000** in 12 months*

Leak Repaired

Leak estimated at 4 GPM and had been running for at least 4 months
777,600 for 135 days

Distance to leak was approximately 50 ft

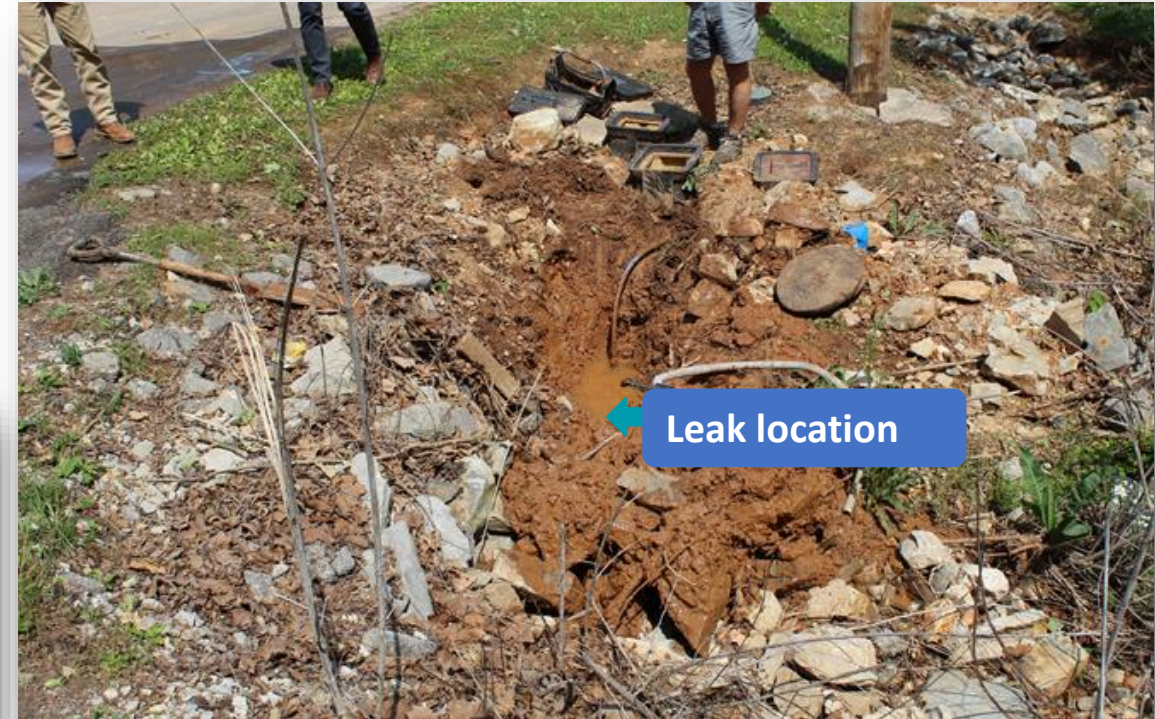
Madison County, AL

- Water leak never reached the surface (nearby creek absorbed it)
- Leak had been running for approximately **2 months**
- Total water lost accounted to **432,000 gallons**
- *If the leak had been running for 12 months: **2,628,000 gallons***

Leak Detector

Leak was estimated around 5 GPM and had been running for at least 2 months

Distance to leak was approximately 6 feet

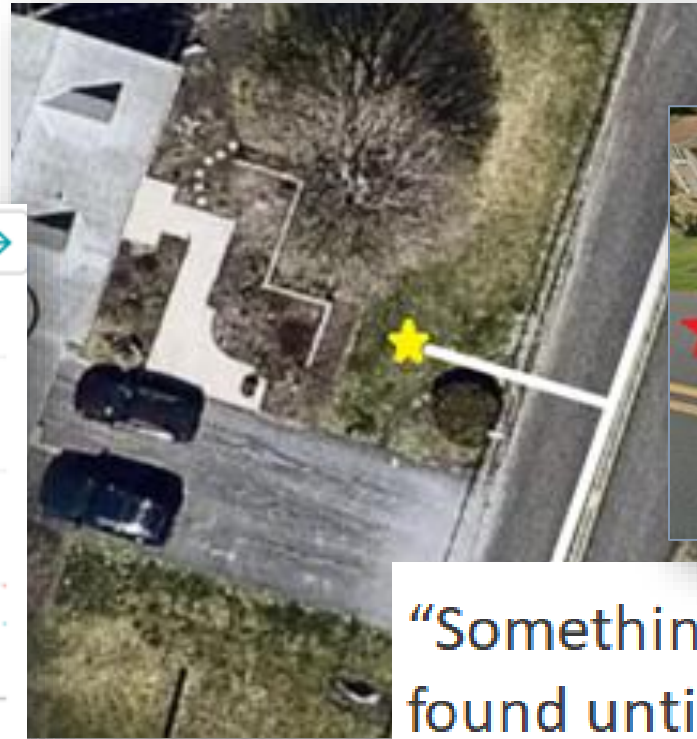
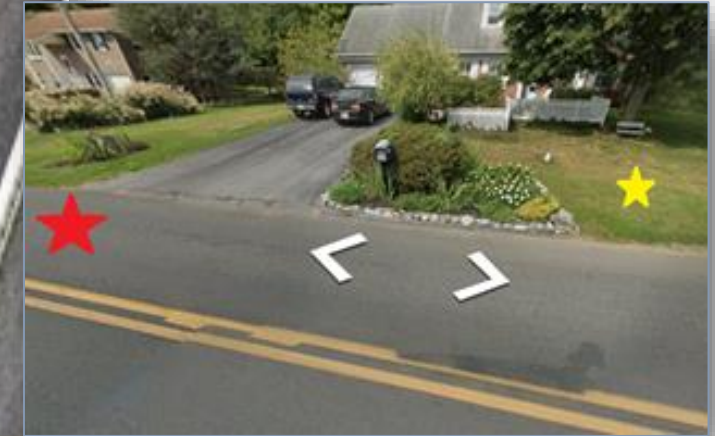
Ephrata, PA

- Main line leak found before water surfaced or worse

Leak on 12” Main

Leaking from stainless steel clamp

55 ft from copper service line
